Bear Brook and Ramsay Creek Watersheds Fluvial Geomorphological Study

Existing Conditions Summary Report
Tewin Lands

December 12, 2024

GEO Morphix Project No. 21063

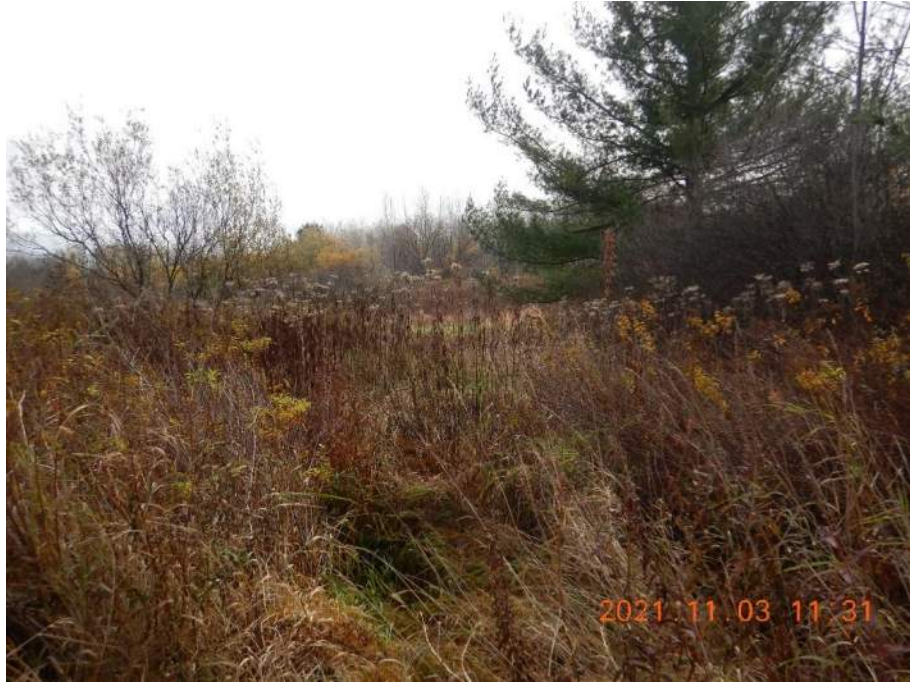
Photo 13
Bear Brook: BB5 1 2

Channel was poorly defined; water was present in the channel however no flows were observed. Riparian vegetation was primarily mature shrubs and immature grasses.

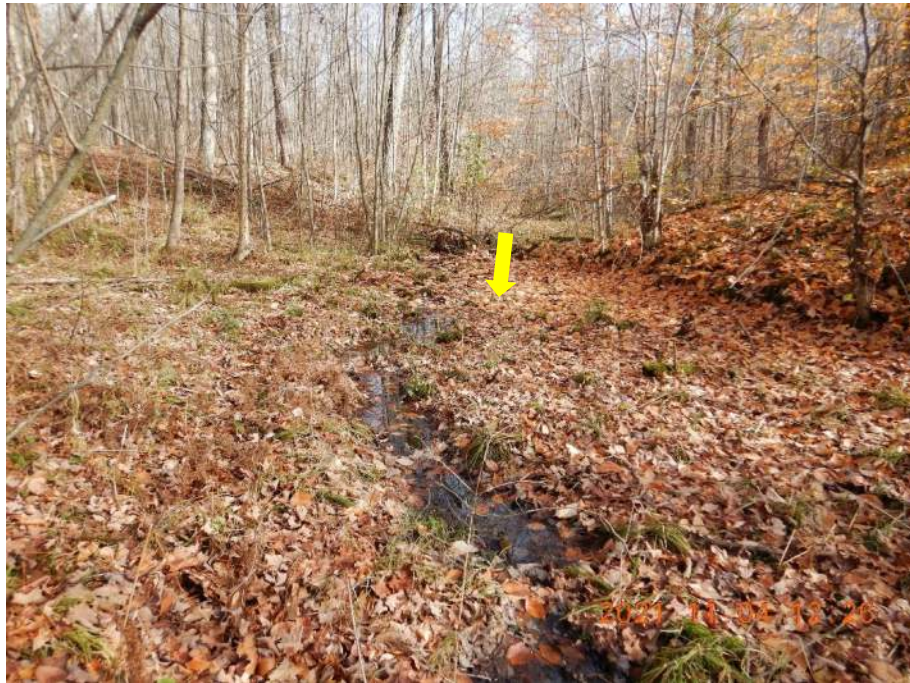
Photo 14
Bear Brook: BB5 2

Channel develops multiple threads as it enters the main branch **BB5** floodplain. Riparian vegetation consists of mature hardwoods and immature grasses.

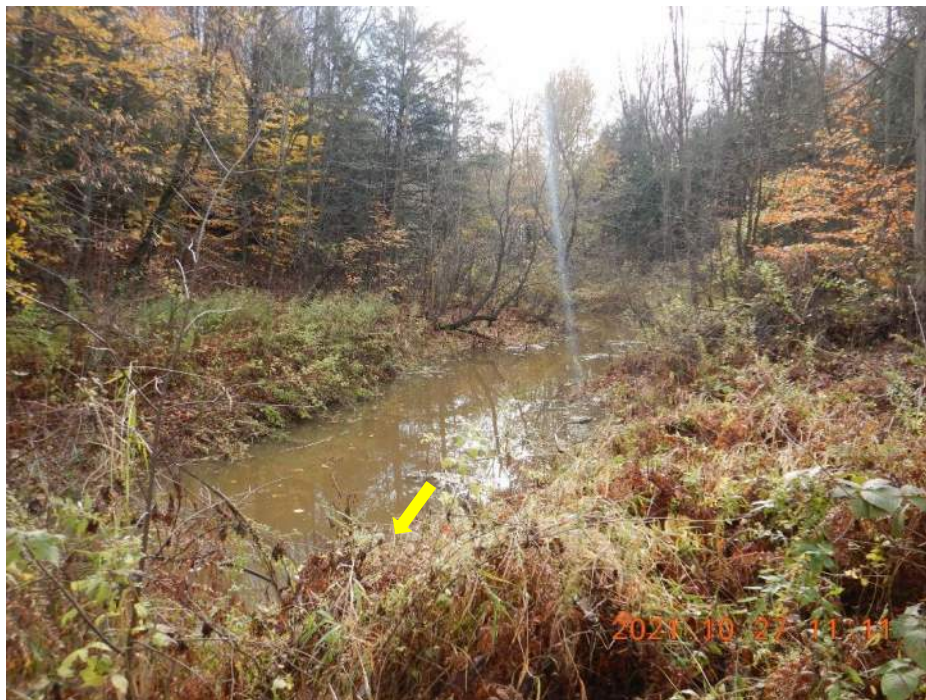
Photo: 19
Bear Brook: BB5 5A 3

| Reach | Avg. Bankfull Width (m) | Avg. Bankfull Depth (m) | Substrate | | Valley Type | Riparian Vegetation | Notes |
|---|--|---|---|---|---|---|--|
| BB5-5A-3 | 7.2 | 0.9 | Gravel, Small Cobble, Large Cobble | Silt, Sand, Gravel | Confined | Trees | Reach modified by previous upstream beaver dam failure, evidence of undercutting, active bed and outer bank erosion |

Reach modified by historic beaver dam, undercutting, active bed and banks observed

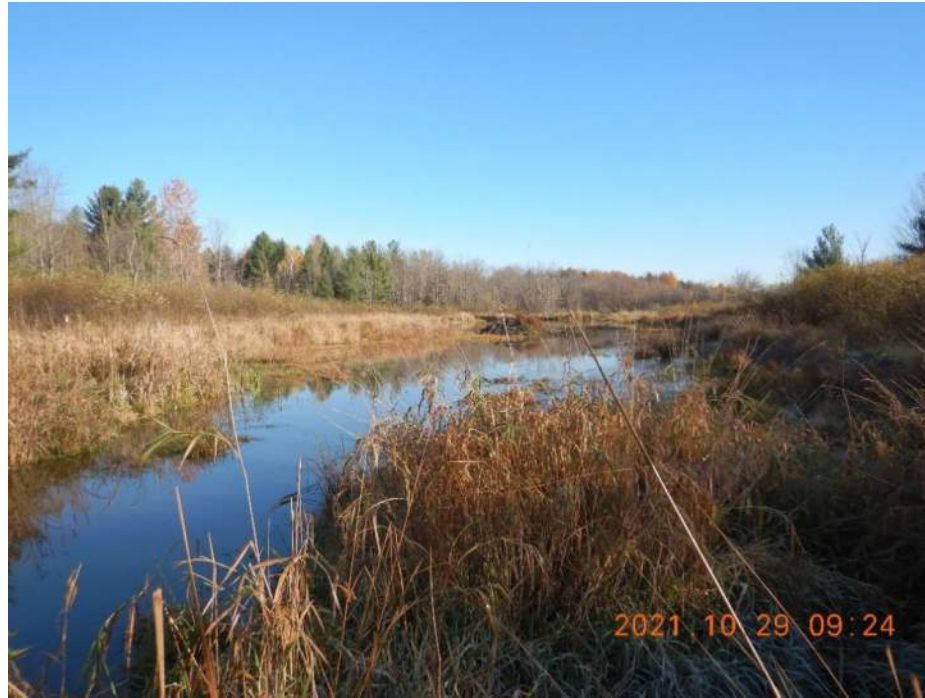
Photo: 20
Bear Brook: BB5 5A 3 1

Feature characteristic of a large pond due to back watering from a beaver dam.

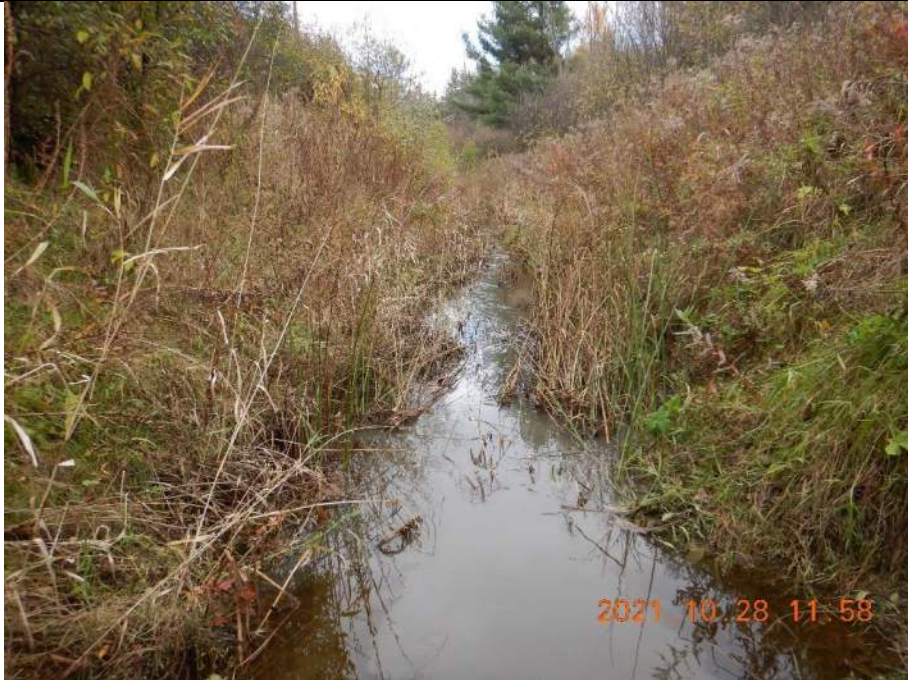
Photo: 22
Bear Brook: BB5 5A 3A

| Reach | Avg. Bankfull Width (m) | Avg. Bankfull Depth (m) | Substrate | | Valley Type | Riparian Vegetation | Notes |
|---|--|---|---|---|---|---|--|
| BB5-5A-3A | 5.4 | 1.5 | Clay, Silt, Gravel, Small Cobble | Clay, Silt | Confined | Trees, grasses, herbaceous | Reach backwatered due to large downstream beaver dam, instream logs and trees observed from bank failure, riffle-run development present |

Reach backwatered due to large downstream beaver dam, instream logs and trees observed due to bank failure.

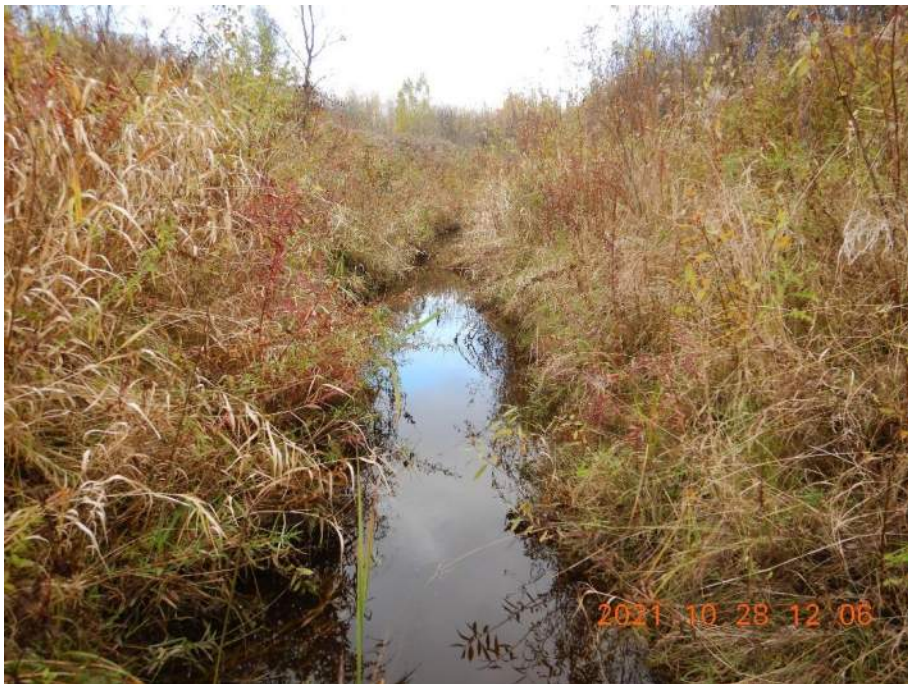
Photo: 23
Bear Brook: BB5 5A 3B

| Reach | Avg. Bankfull Width (m) | Avg. Bankfull Depth (m) | Substrate | | Valley Type | Riparian Vegetation | Notes |
|---|--|---|---|---|---|---|--|
| BB5-5A-3B | 3.2 | 1.0 | Clay, Silt, Sand, Gravel | Clay, Silt, Sand | Unconfined | Grasses, Herbaceous | Increased sinuosity moving downstream, massive banks and valley wall failure observed, riffle-run development present |

Conveyed flows through entrenched channel with large banks. Riparian vegetation consisting of grasses and hardwoods.

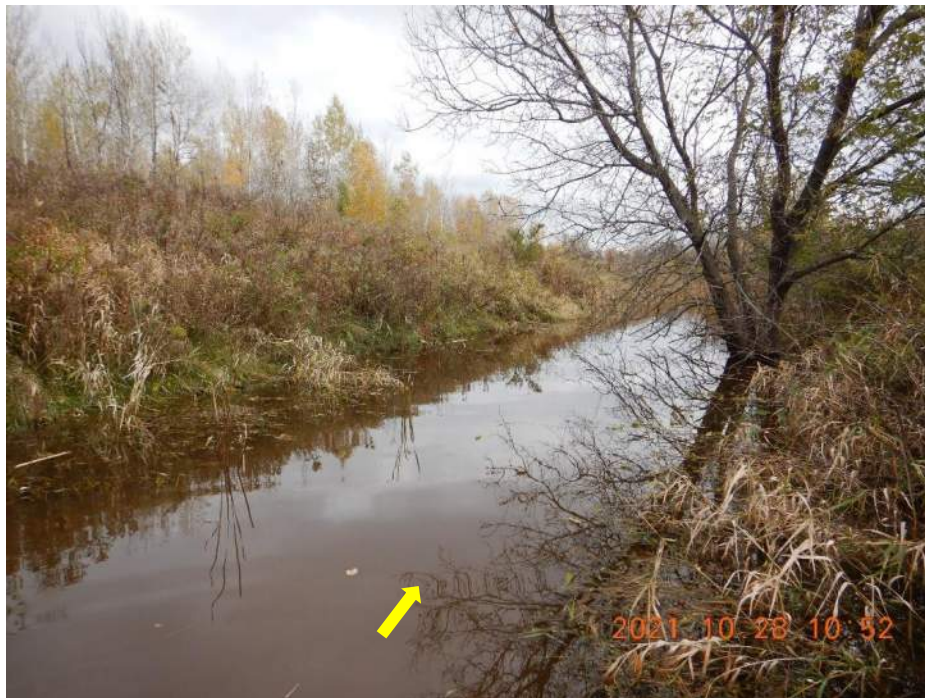
Photo 27
Bear Brook: BB5 5A 3D

| Reach | Avg. Bankfull Width (m) | Avg. Bankfull Depth (m) | Substrate | | Valley Type | Riparian Vegetation | Notes |
|---|--|---|---|---|---|---|--|
| BB5-5A-3D | 6.3 | 2.5 | No riffle-pool development | | Unconfined | Grasses | Channel backwatered from downstream beaver dam, high water levels, reach may have riffle-pool development under in absence of backwater conditions |

Channel backwatered from downstream beaver dam, high water levels, reach may have riffle-pool development under in absence of backwater conditions

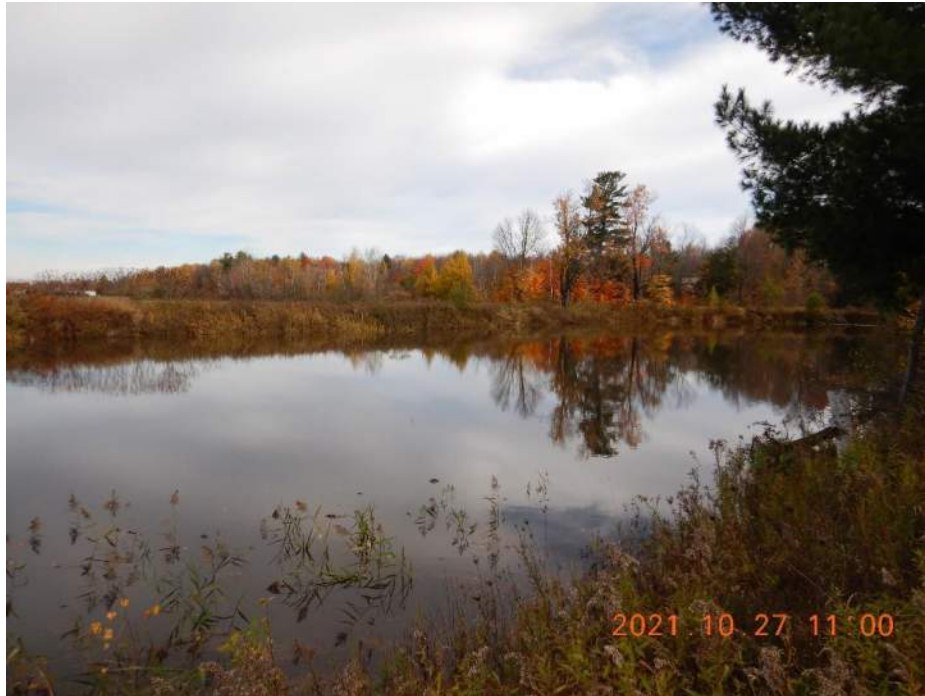
Photo 28
Bear Brook: BB5 5B

Feature was characteristic of a large online pond at the time of assessment. Flows are restricted through a drain at the downstream extent prior to converging with **BB5-5A**

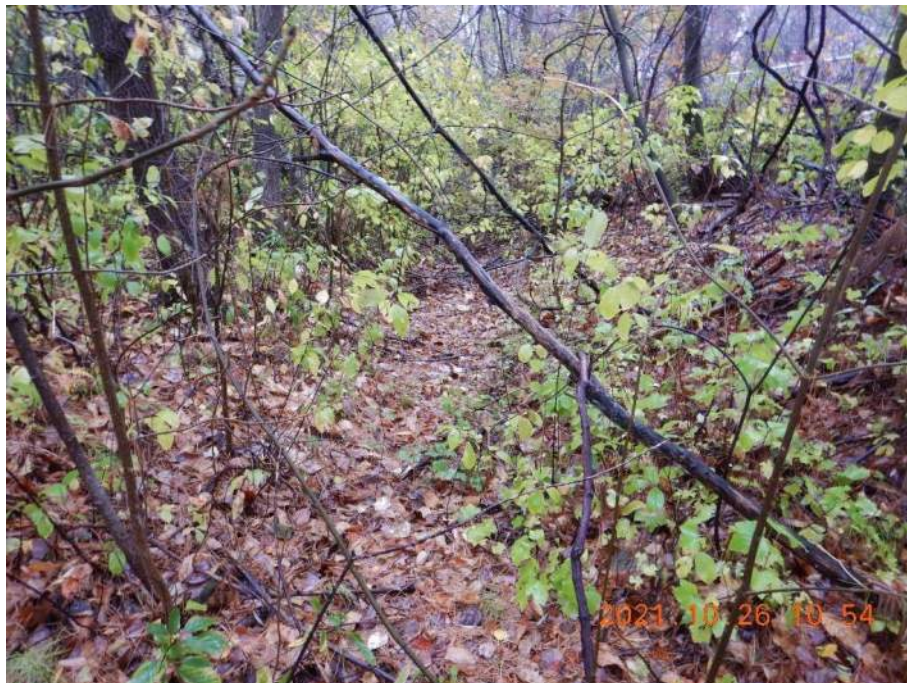
Photo 35
Bear Brook: BB5 5D 1

Poorly defined feature travelling behind residential lots. Trees and shrubs were found in the channel and herbaceous materials on the banks.

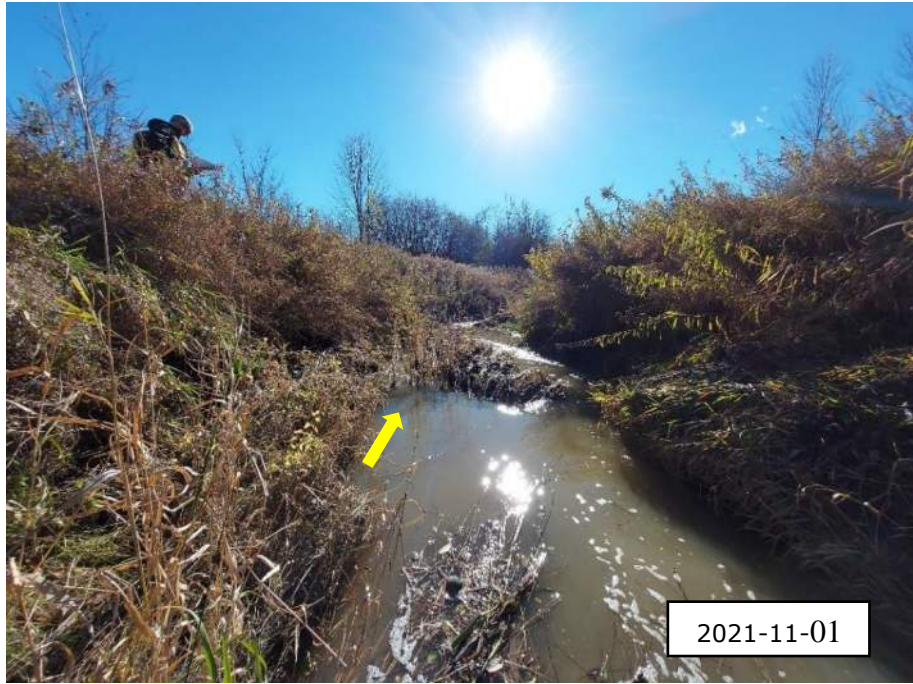
Photo 36
Bear Brook: BB6

The feature was well defined, slumping and undercutting was common. Riparian vegetation composed of grasses.

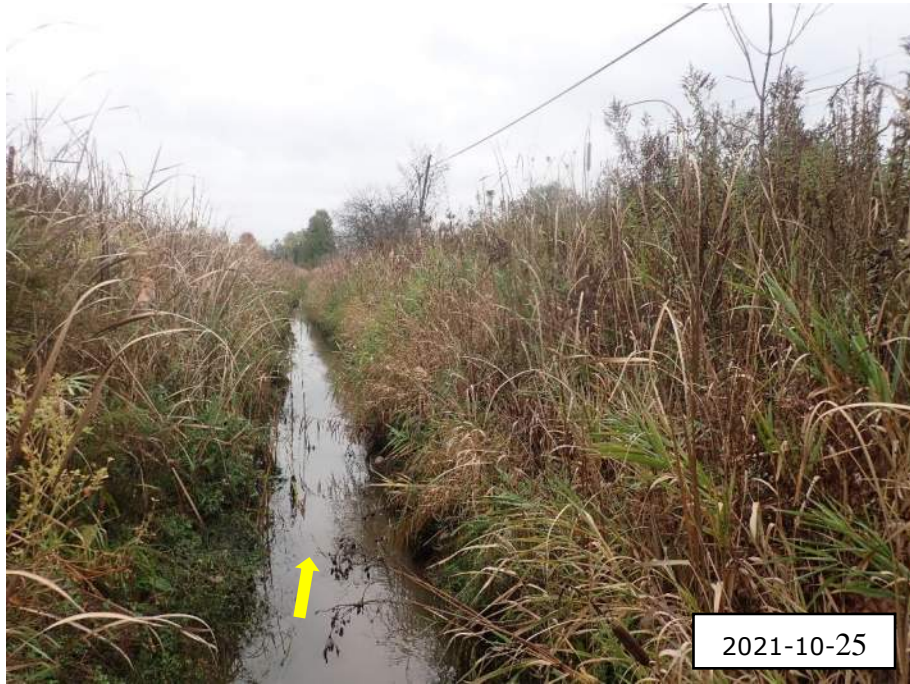
Photo 46
Bear Brook: BB10 1B

| Reach | Avg. Bankfull Width (m) | Avg. Bankfull Depth (m) | Substrate | | Valley Type | Riparian Vegetation | Notes |
|---|--|---|---|---|---|---|---|
| BB10-1B | 1.6 | 0.3 | Clay, Silt | Clay, Silt | Unconfined | Grasses | Straight ditch, all runs observed, algae and few cattails present, minor slumping observed, little geomorphic activity overall |

Reach identified as a straight ditch with little geomorphologic activity. Some minor slumping observed. Riparian vegetation consisted primarily of grasses.

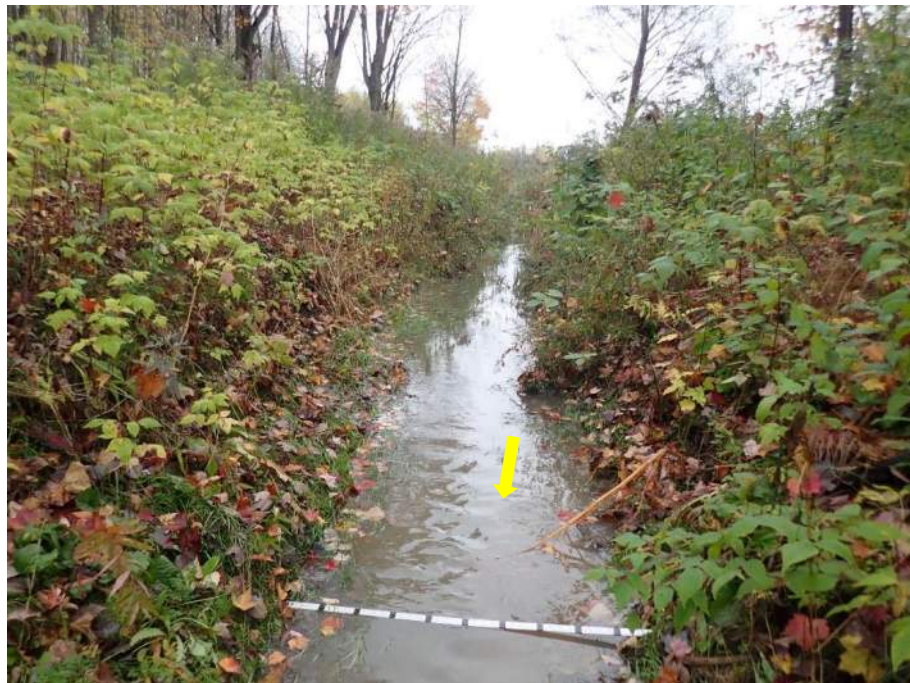
Photo 47
Bear Brook: BB11

Reach was a straight ditch with limited geomorphic activity.

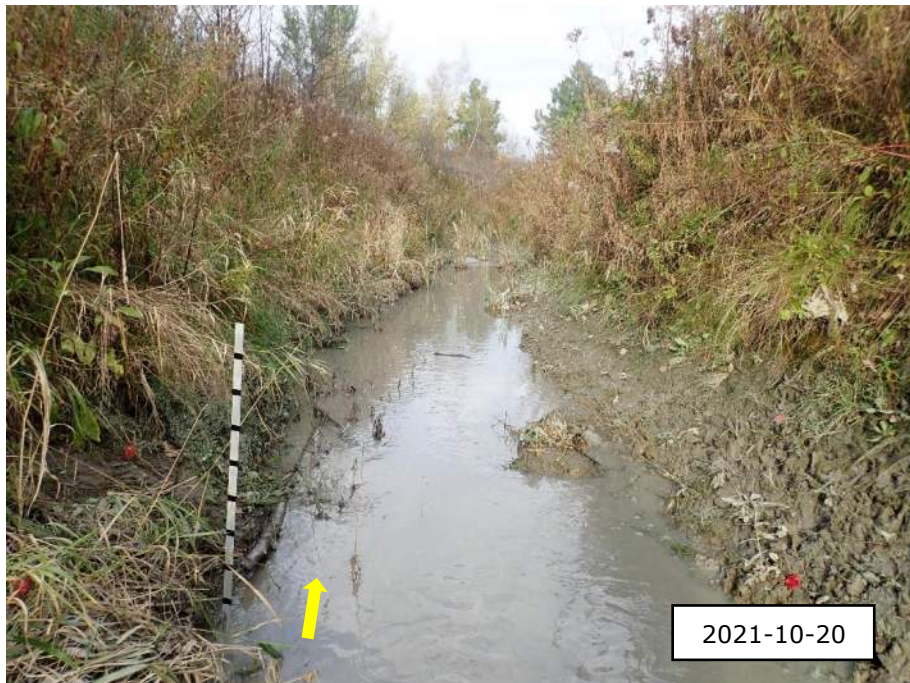
Photo 51
Bear Brook: BB14

Channel was observed as a straight ditch. Riparian vegetation primarily grasses.

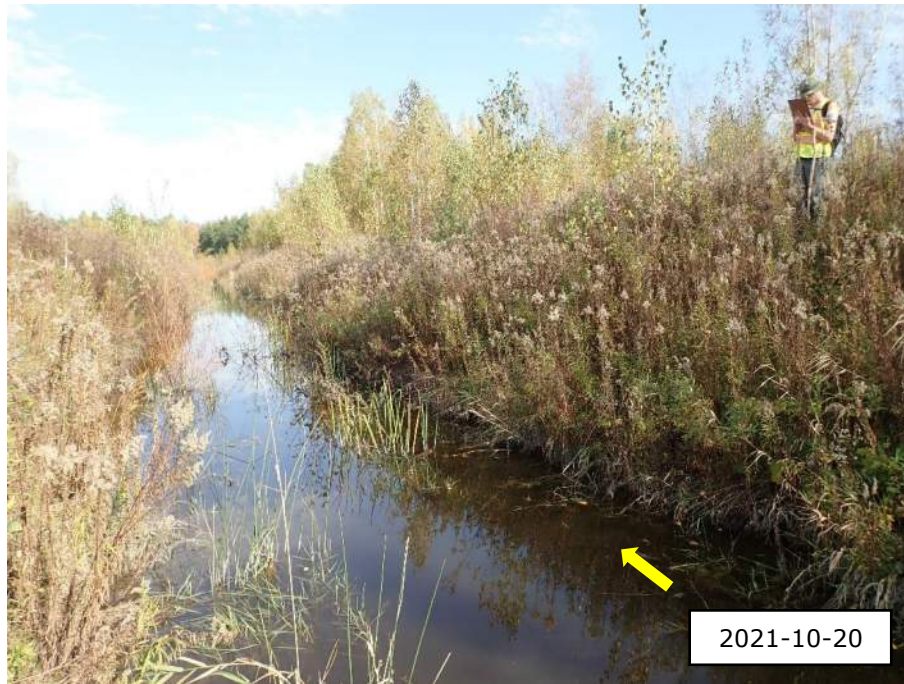
Photo 52
Bear Brook: BB15

Straight ditched channel with mostly runs. Riparian vegetation was primarily grasses.

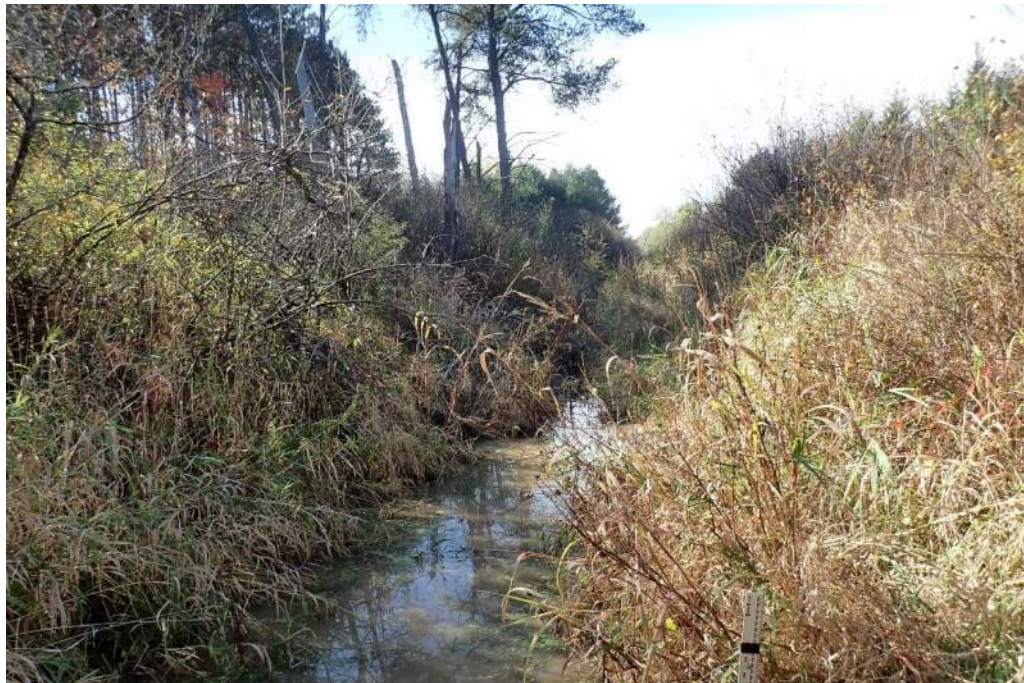
Photo 63
Ramsay Creek: Rc4 1 1A 3

Former agricultural ditch, no flow observed, trees growing on channel bed, mostly stable

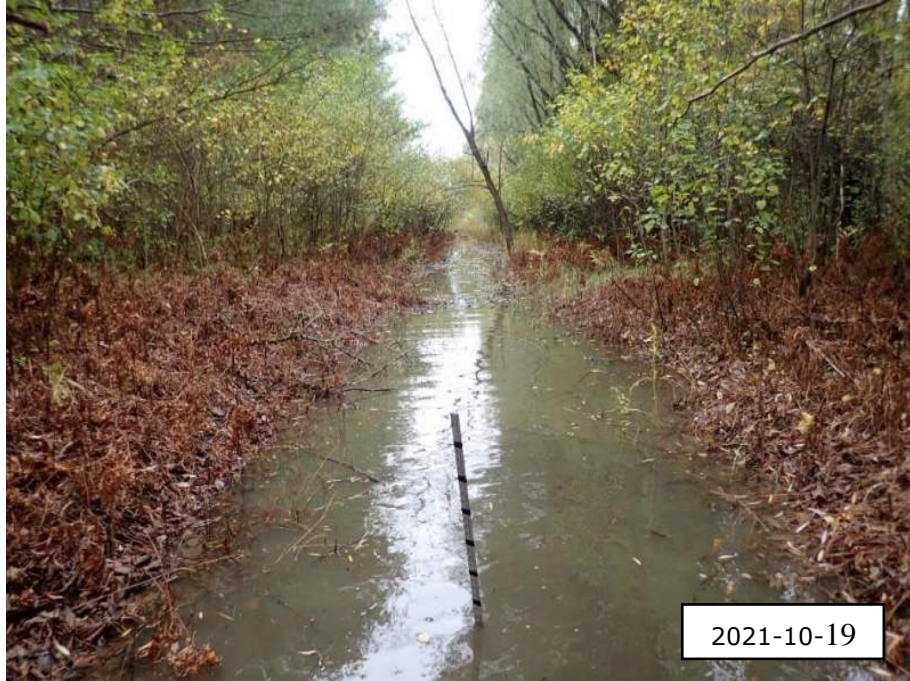
Photo 64
Ramsay Creek: RC5

| Reach | Avg. Bankfull Width (m) | Avg. Bankfull Depth (m) | Substrate | | Valley Type | Riparian Vegetation | Notes |
|---|---|---|---|---|---|---|--|
| RC5 | 5.1 | 0.7 | Clay, Silt | Clay, Silt | Unconfined | Trees, Herbaceous, Grasses | Shallow pooled water but no flow observed, grasses and wetland species observed growing on semi-dry bed, minimal geomorphic activity |

Channel lacked defined banks; water was shallow/absent during visit.

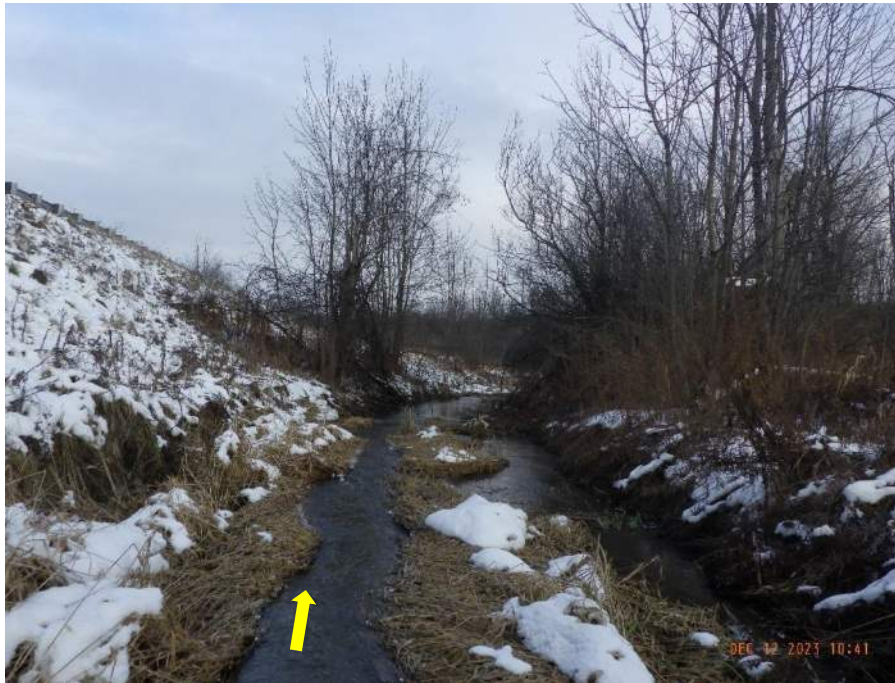
Photo 69
Ramsay Creek: RCA

Channel flowed adjacent to a road. Riffle-pool formations were observed. Channel bed composed of fines up to cobbles. Erosion was observed,

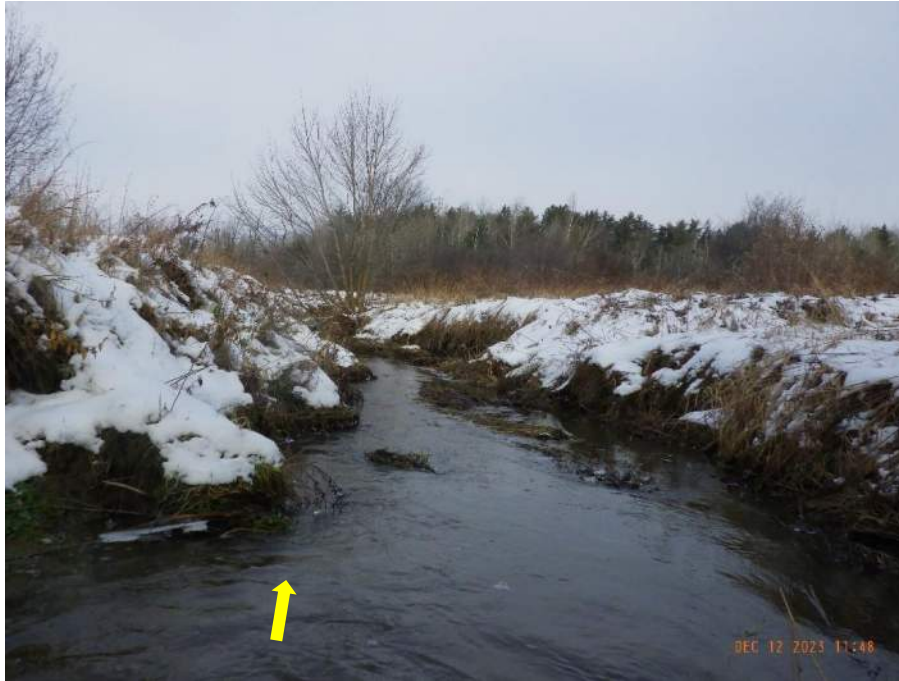
Photo 70
Ramsay Creek: RCB

Channel meandered through agricultural fields. No riffle-pool formations. Slumping and undercutting was common.

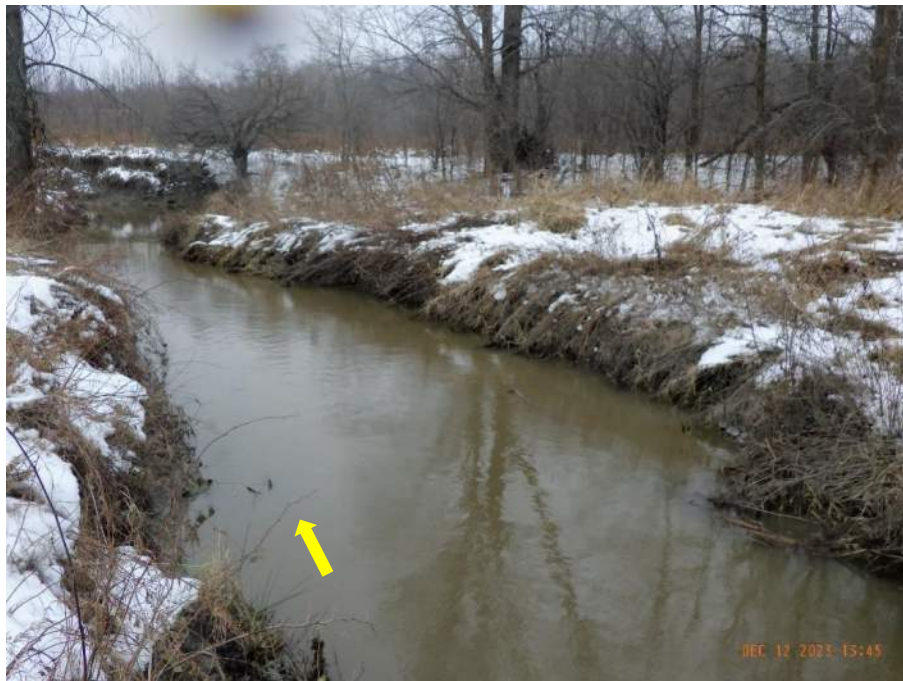
Photo 71
Ramsay Creek: RCC

Channel meandered through agricultural fields. Signs of enlarging observed. Riparian vegetation was predominantly grasses and herbaceous vegetation.

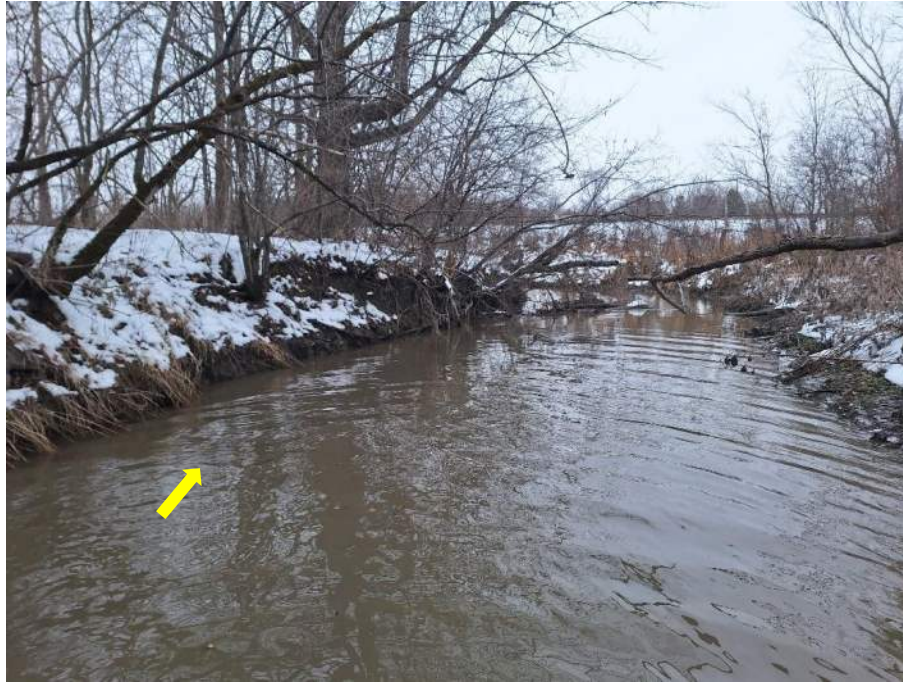
Photo 72
Ramsay Creek: RCD

Channel transitions to a woody riparian edge. No riffle-pool formations observed. Slumping and scour observed.

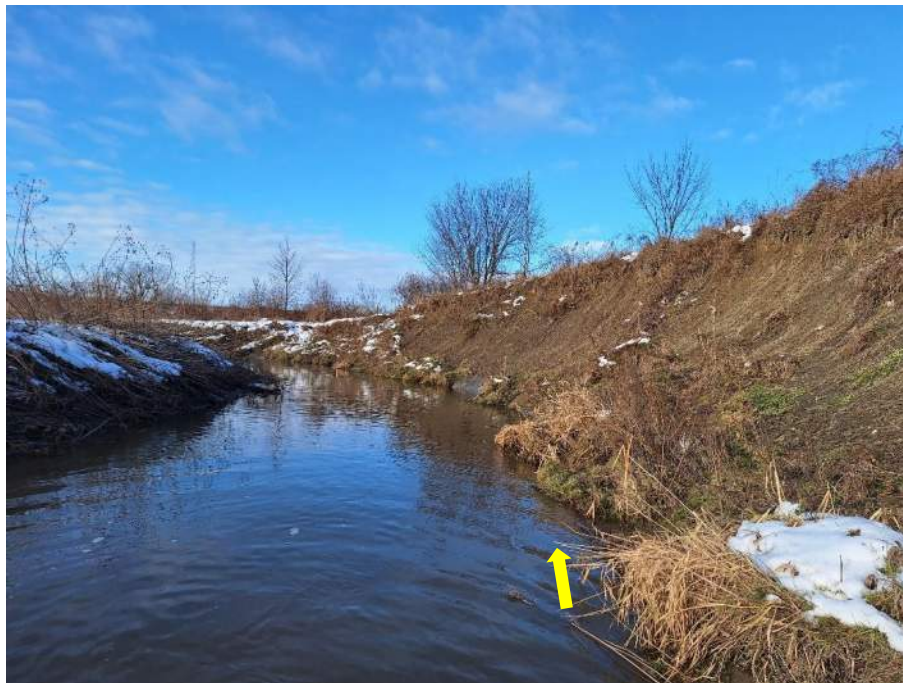
Photo 73
Ramsay Creek: RCE

Channel meanders through historic farm fields. Several tall scours were observed along the length of the channel. Riparian vegetation predominantly grasses and herbaceous vegetation.

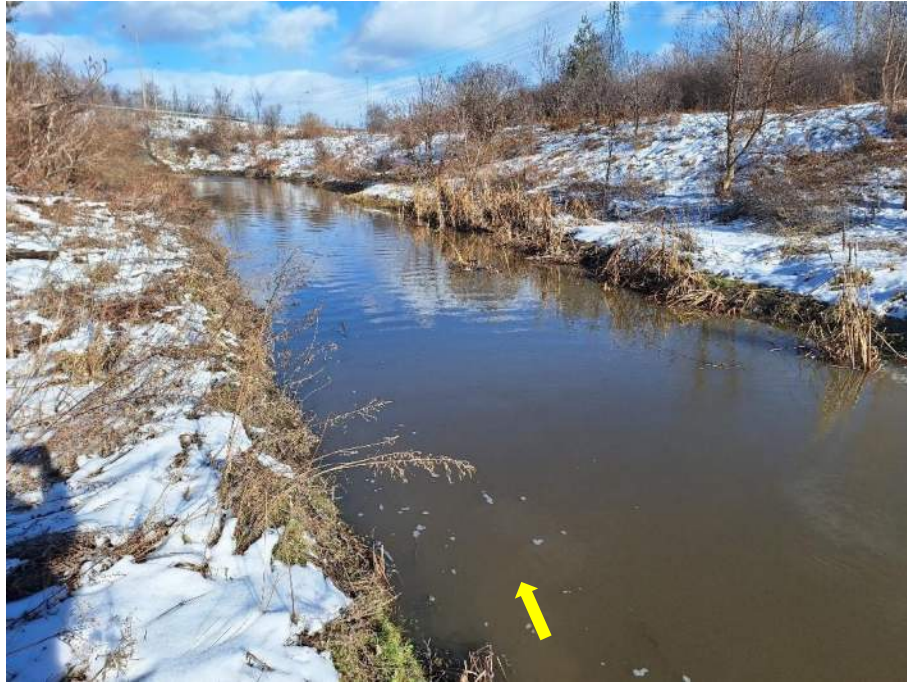
Photo 74
Ramsay Creek: RCF

The channel passes under highway 417 twice along the reach. Channel banks were well vegetated and generally stable.

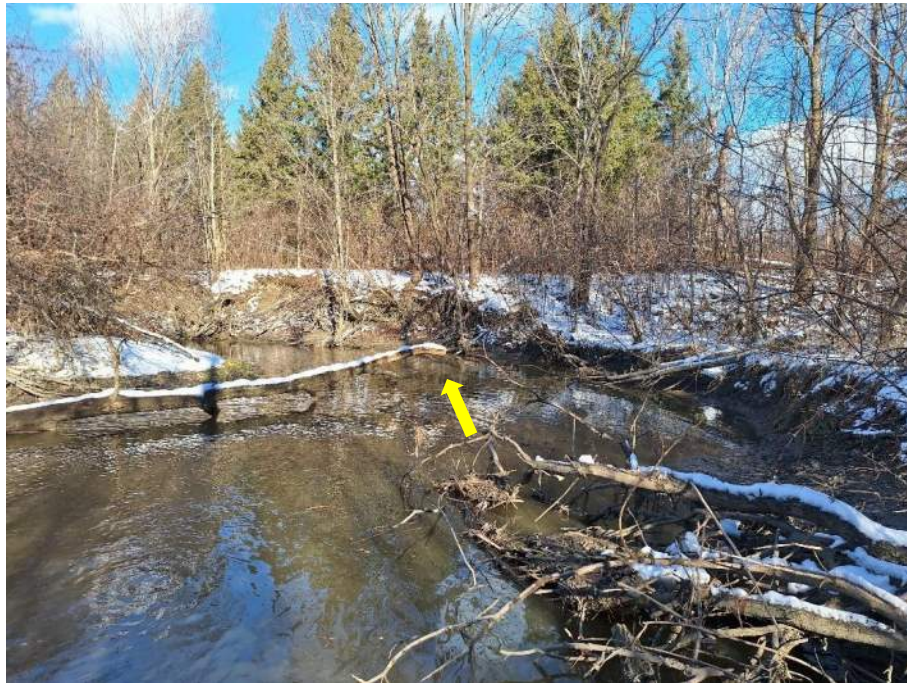
Photo 75
Ramsay Creek: RCG

Channel meanders through a forested valley setting. Valley wall contacts and evidence of widening observed. Riparian vegetation composed of trees and herbaceous vegetation.

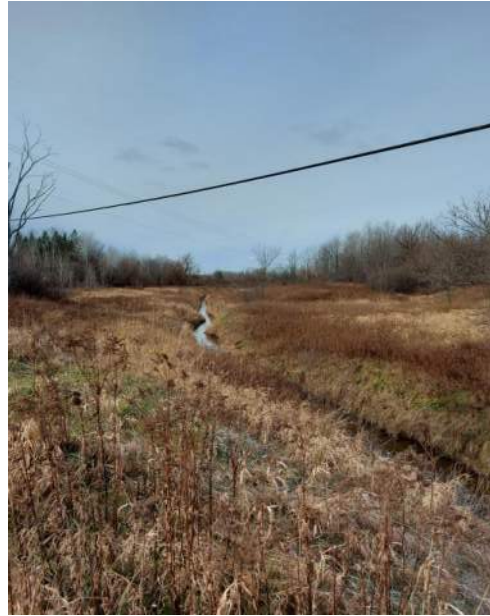
Existing conditions at **Crossing 6** on the north side of Piperville Road. Left photo is facing northeast from the road; right photo is facing northwest. Some slumping was observed along the banks.

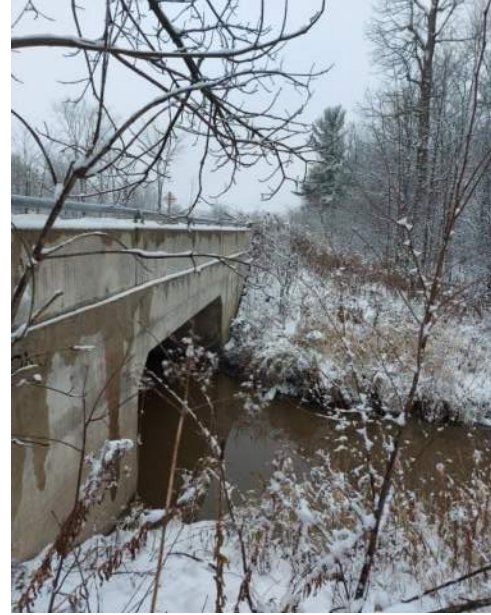
Existing conditions at **Crossing 18** on the west side of Ramsayville Road. Left photo is facing west, upstream; right photo is facing south. Some slumping and undercutting was observed.

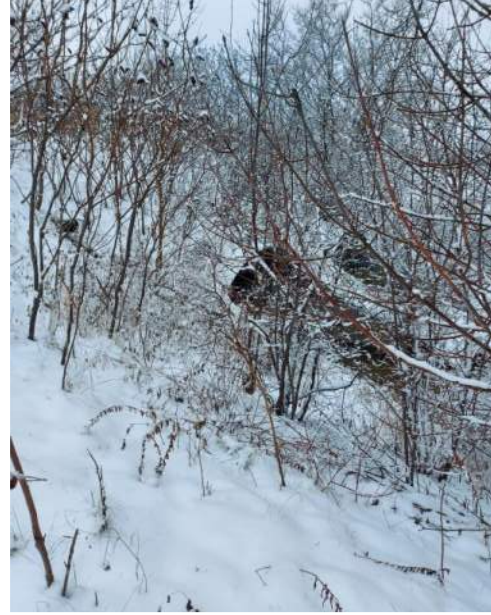
Existing conditions at **Crossing 22** on the north side of Walkley Road. Left photograph is facing northwest; left photograph is facing southwest at the dual culverts. Undercutting was observed.

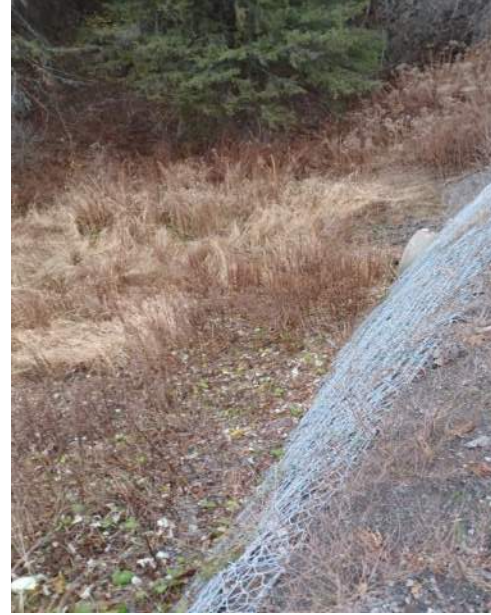
Existing conditions at **Crossing 27** on the east side of Ramsayville Road. Left photo is facing east, upstream; right photograph is facing northeast, down towards the mouth of the culvert. Channel lacked definition.

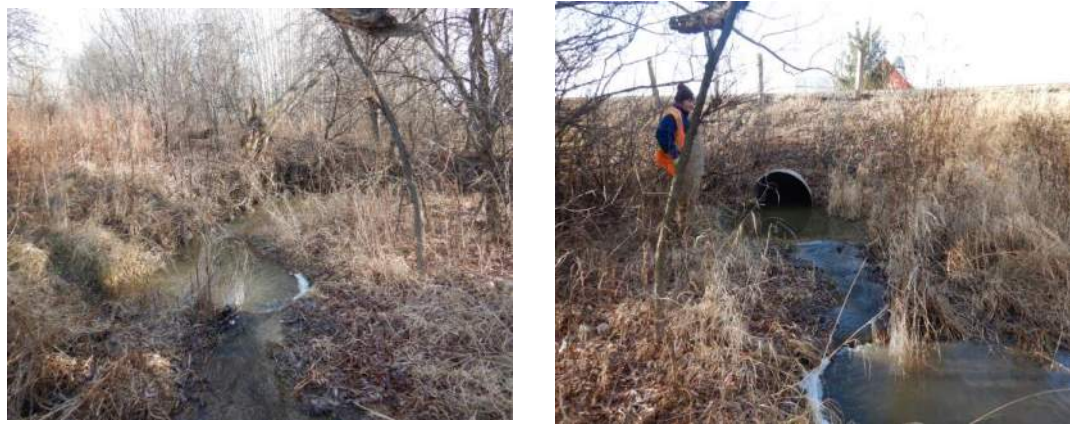
Existing conditions at **Crossing 28** on the east side of Ramsayville road. Left photo is facing east, downstream; right photograph is facing west at the culvert. Some erosion scars and slumping was observed downstream.

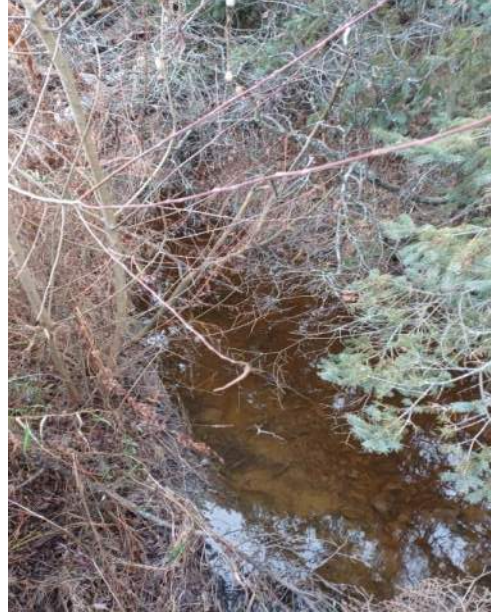
Existing conditions at **Crossing 32** on the west side of Ramsayville Road. Left photo is facing west, a large number of down trees from recent storm are present in the channel; right photo is facing down at the mouth of the culvert. An erosion scar was observed on the left bank.

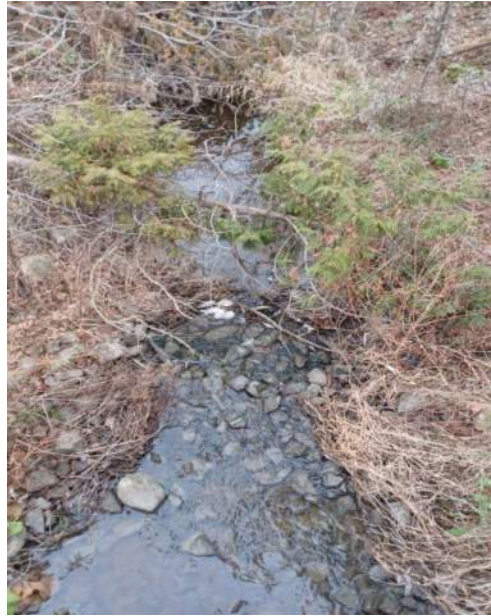
Existing conditions at **Crossing 32** on the east side of Ramsayville Road. Left photo is facing east, downstream; right photo is facing downwards. Erosion scars were observed.

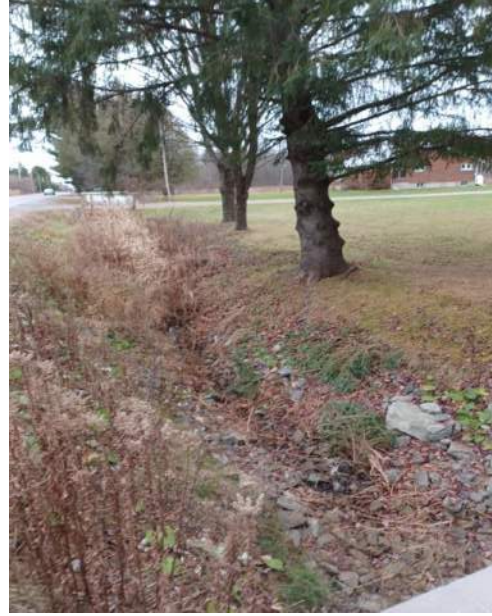
Existing conditions at **Crossing 35** on the west side of Ramsayville Road. Left photograph is taken facing west, upstream; right photograph is taken facing southwest at the roadside ditch. Some slumping was observed.

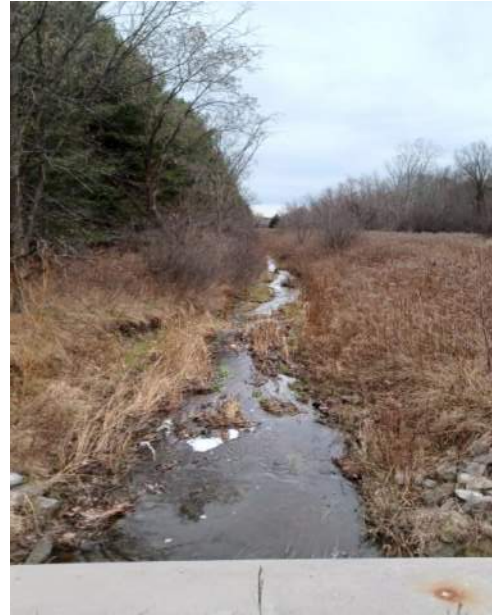
Existing conditions at **Crossing 35** on the east side of Ramsayville Road. Left photograph is facing southeast at the output from the roadside ditch; right photograph is facing east, downstream. Some slumping was observed.
