November 25, 2024

**Re: Background Review and Drainage Characterization of Ramsay Creek
Tewin Secondary Plan Area
City of Ottawa, Ontario
GEO Morphix Project No. 21063**

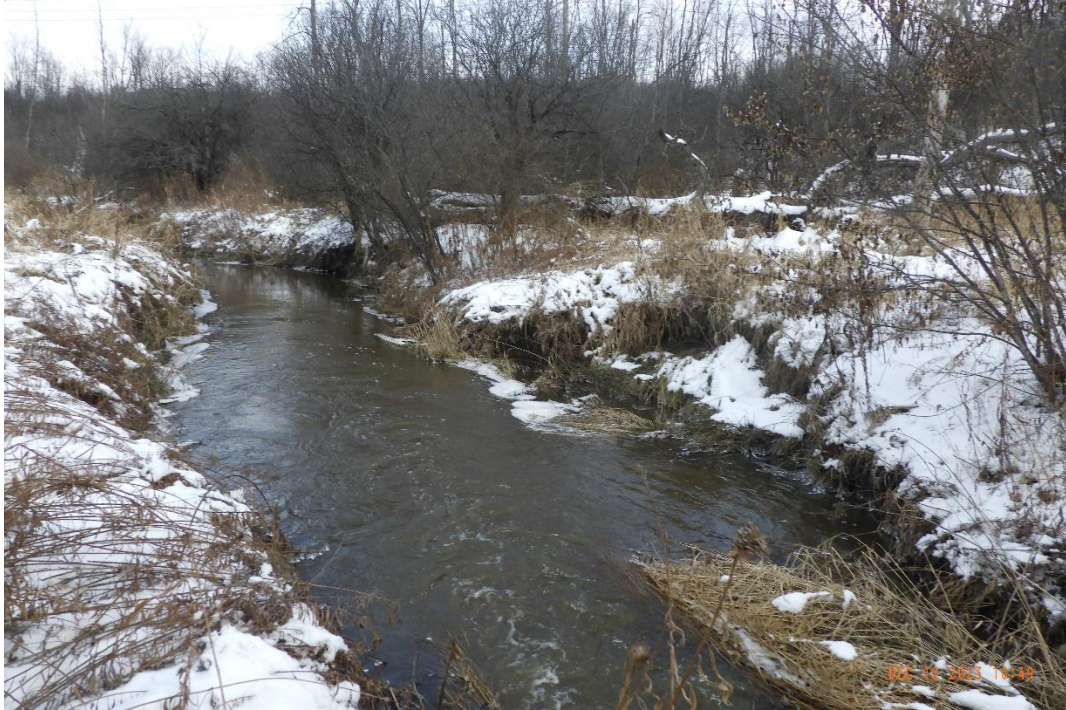
Photo 1
Ramsey Creek- Reach RCA, Ottawa, Ontario

Riffle pool morphology was observed well developed primarily along the downstream portion of the reach.

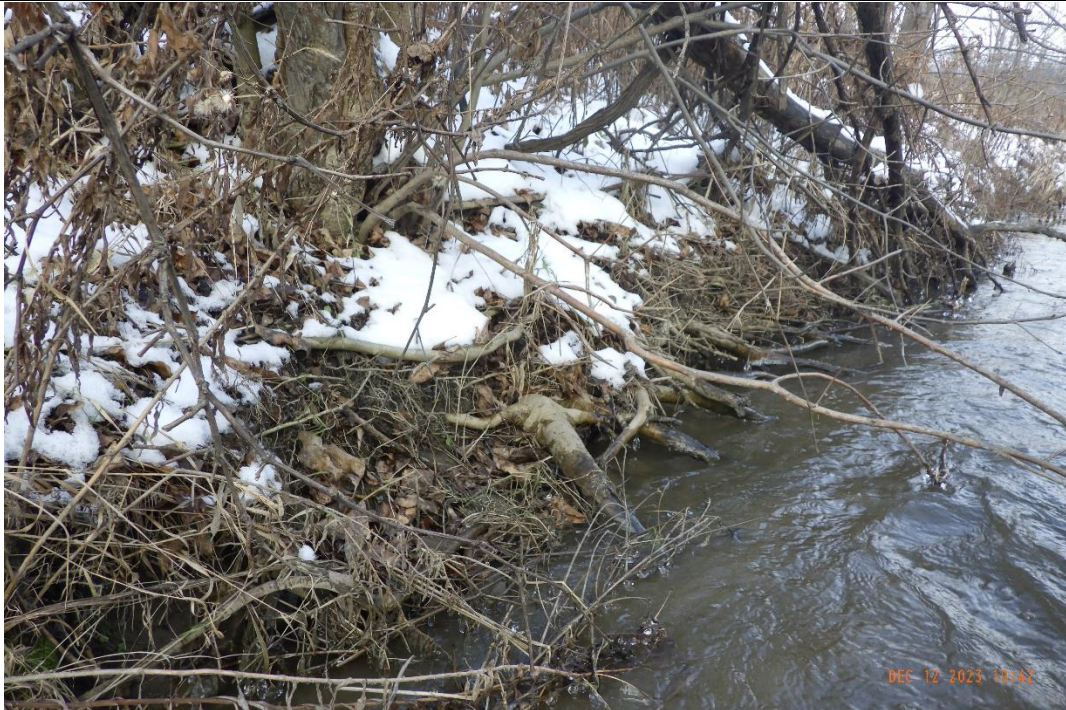
Photo 2
Ramsey Creek- Reach RCA, Ottawa, Ontario

Exposed roots were observed throughout the reach as were fallen and leaning trees.

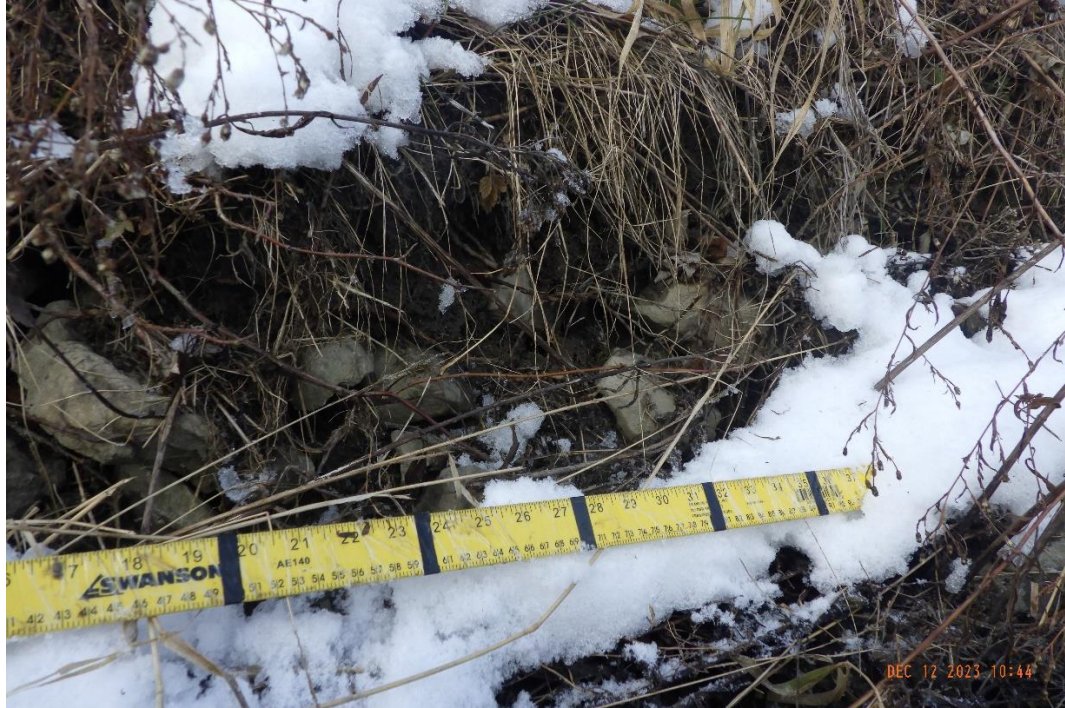
Photo 3
Ramsey Creek- Reach RCA, Ottawa, Ontario

A significant armour layer was identified to be suspended within the banks.

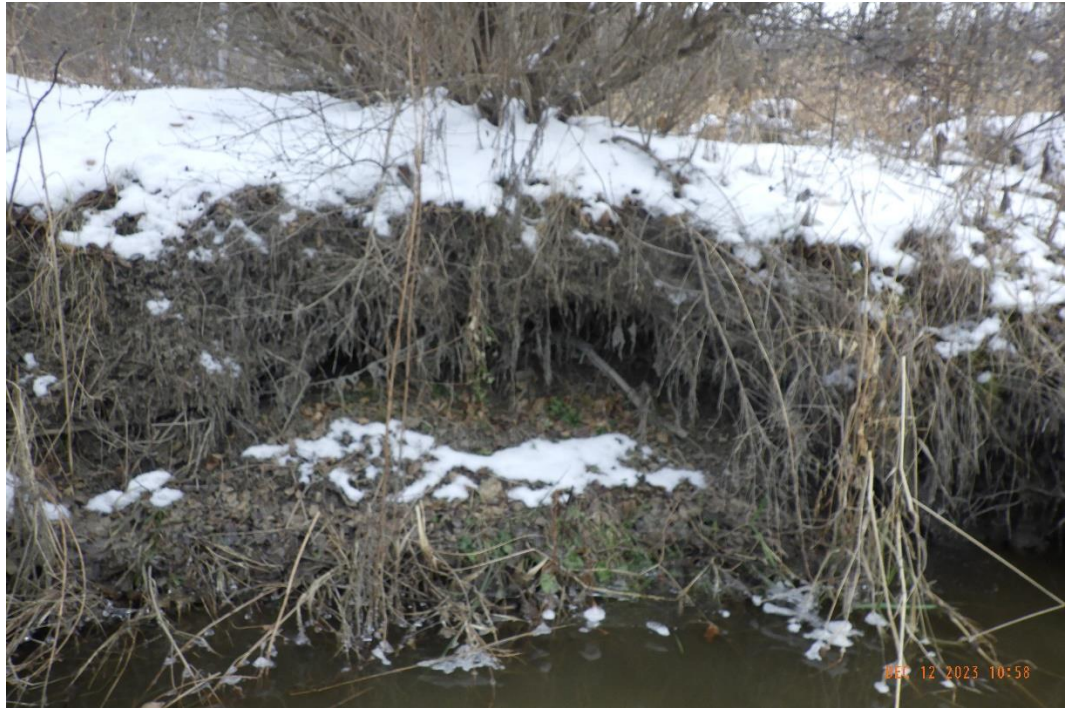
Photo 4
Ramsey Creek- Reach RCA, Ottawa, Ontario

Slumping occurred in localized areas along the reach primarily in the downstream portion. Basal scour was also observed through more than 50% of the reach.

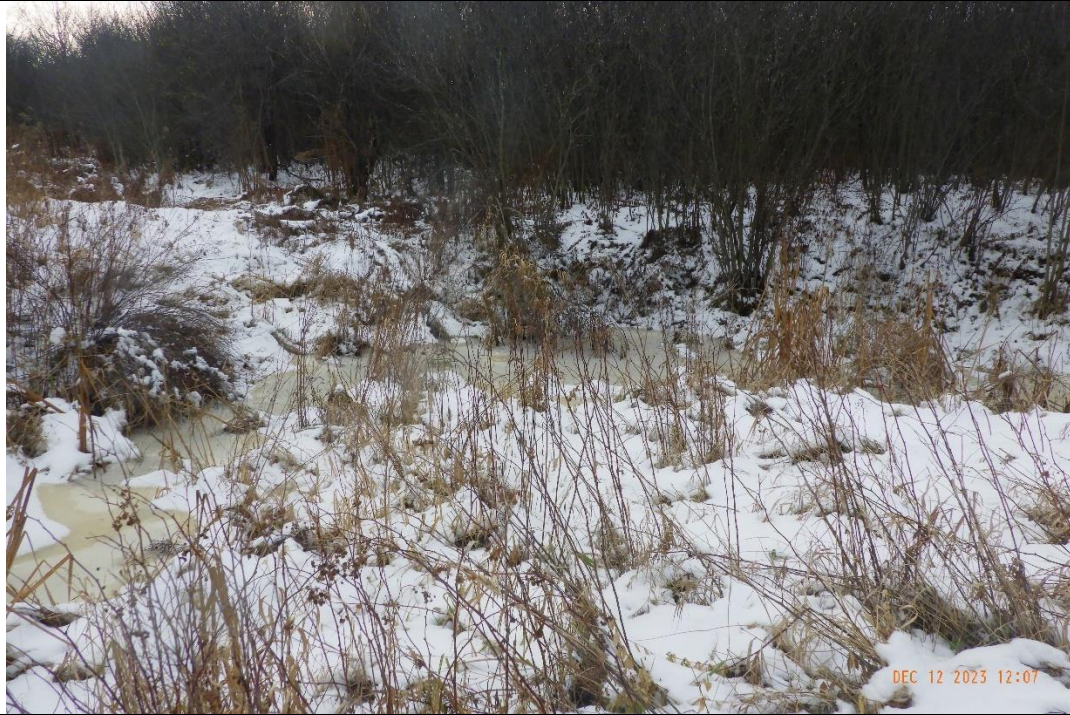
Photo 6
Ramsey Creek- Reach RCB, Ottawa, Ontario

Multiple cutoff channels and old meanders were noted throughout the reach.

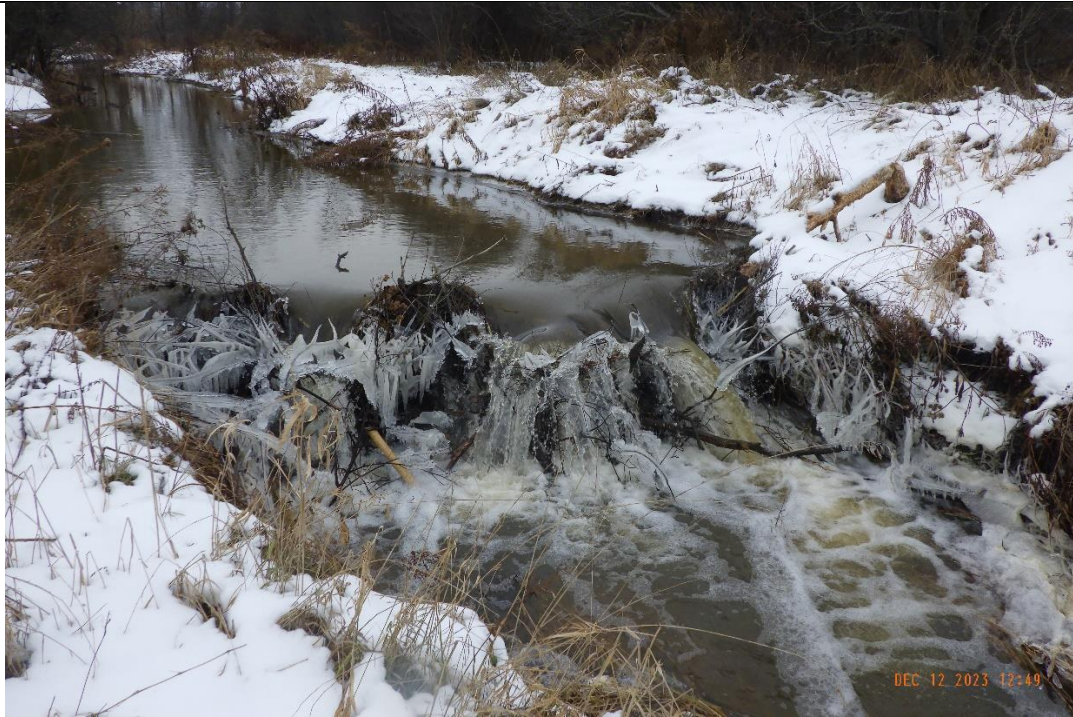
Photo 8
Ramsey Creek- Reach RCB, Ottawa, Ontario

Beaver activity was present throughout this area with observations of pointed tree and beaver dams along the creek.

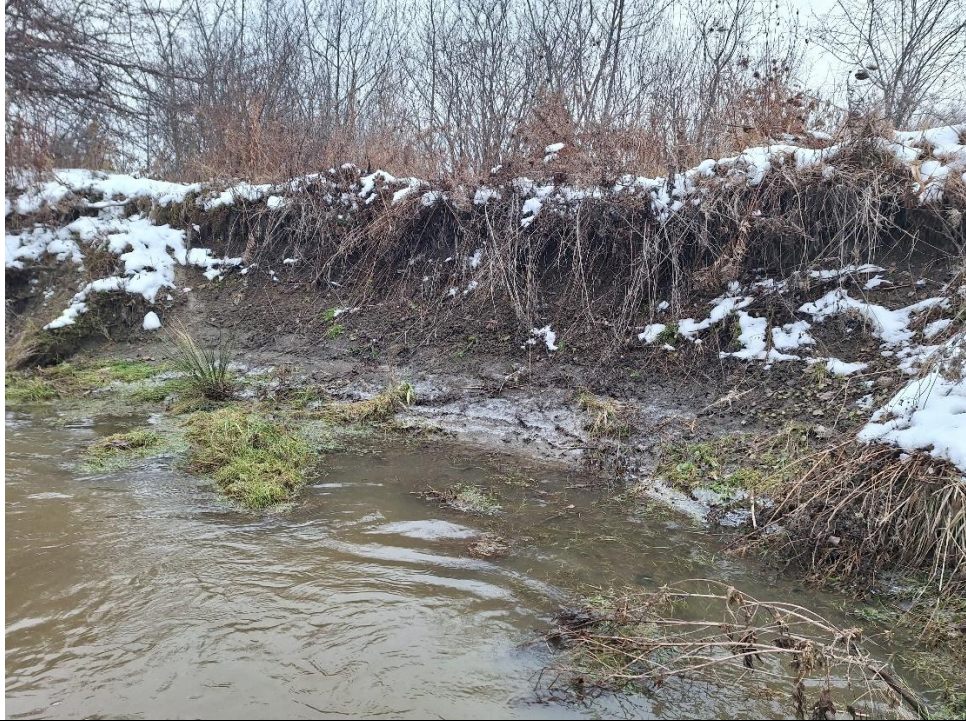
Photo 9
Ramsey Creek- Reach RCC, Ottawa, Ontario

Basal scour and undercutting were observed throughout more than 50% of the reach with scour occurring along the inside of meander bends and through the riffles.

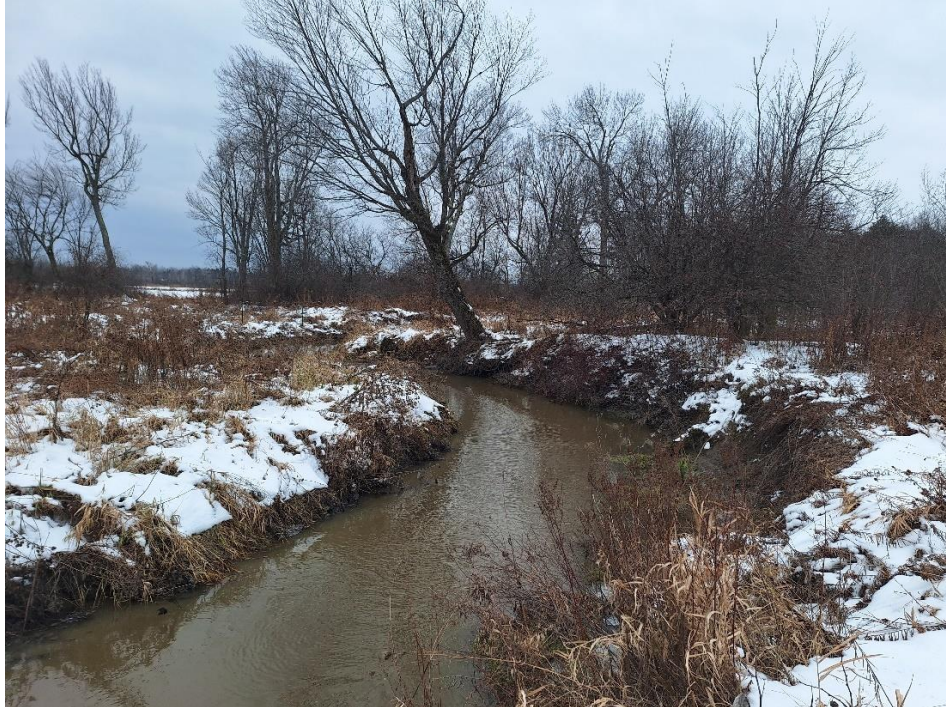
Photo 10
Ramsey Creek- Reach RCC, Ottawa, Ontario

The creek was observed to be run dominated with turbid water. No odour was detected at the time of site assessment.

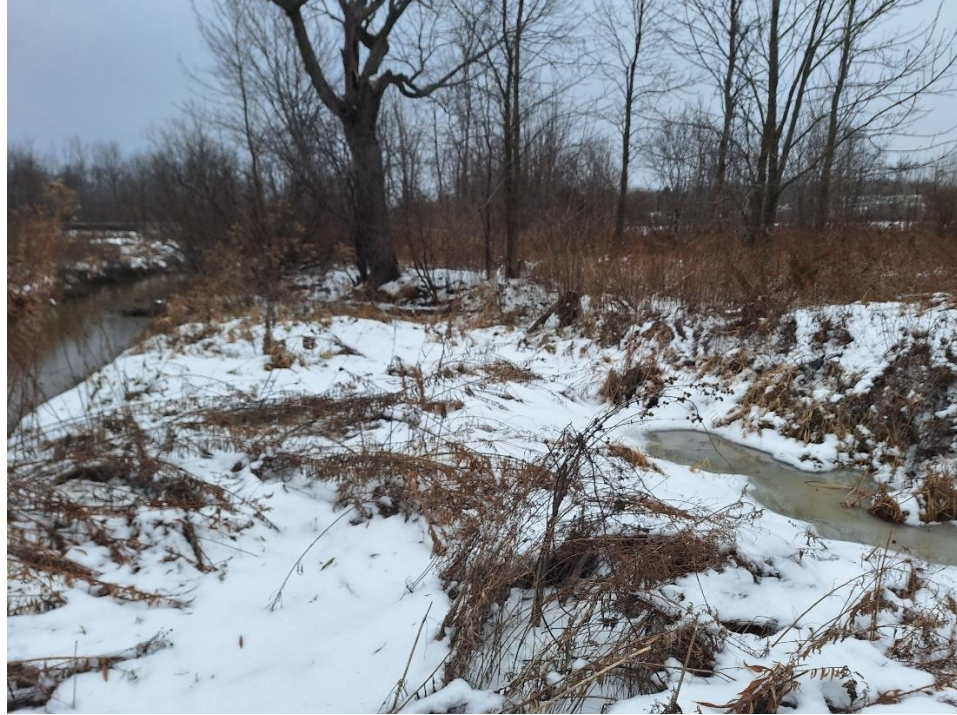
Photo 11
Ramsey Creek- Reach RCC, Ottawa, Ontario

Midway through the reach a cut off channel was observed at a higher elevation with remnant water present.

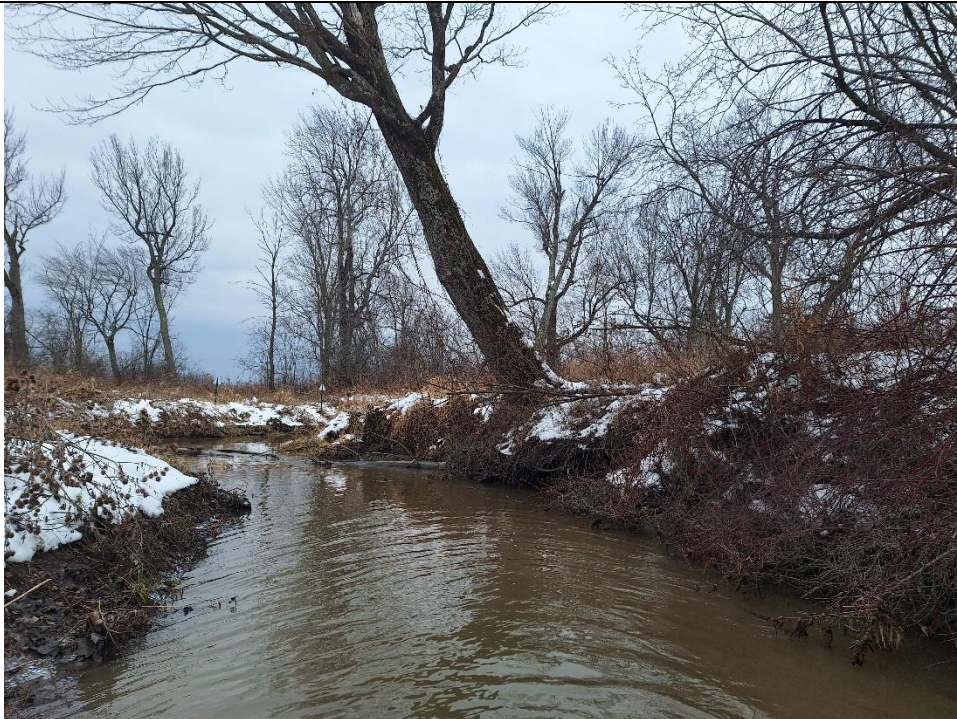
Photo 12
Ramsey Creek- Reach RCC, Ottawa, Ontario

Leaning and fallen trees, organic debris, and exposed roots were commonly observed throughout the reach.

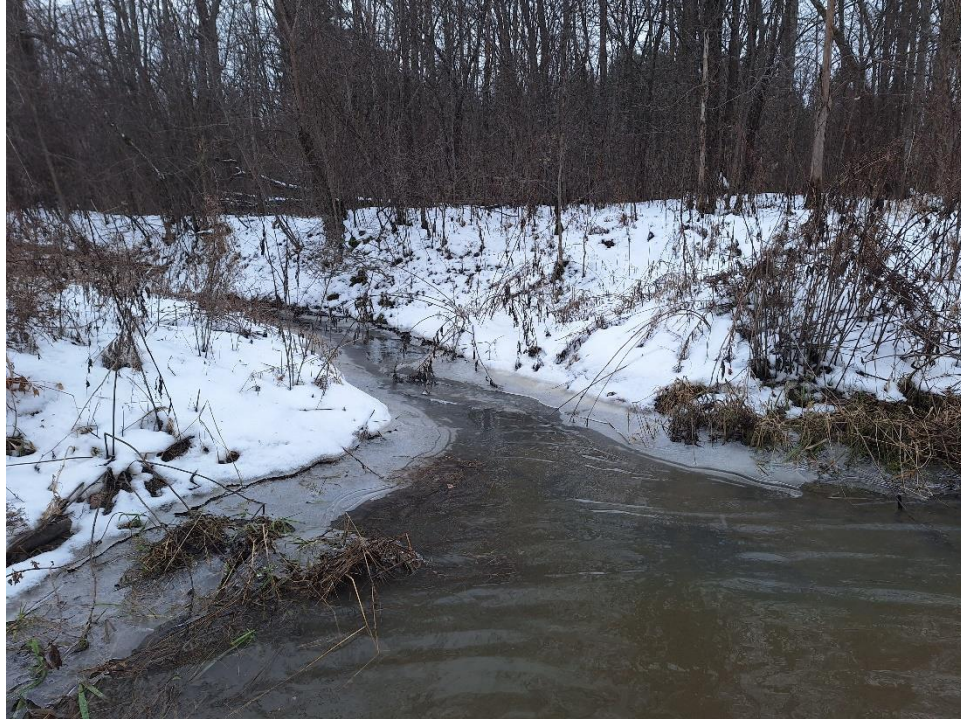
Photo 13
Ramsey Creek- Reach RCD, Ottawa, Ontario

At the upstream extent of the reach, two tributaries were inputting water to the main channel.

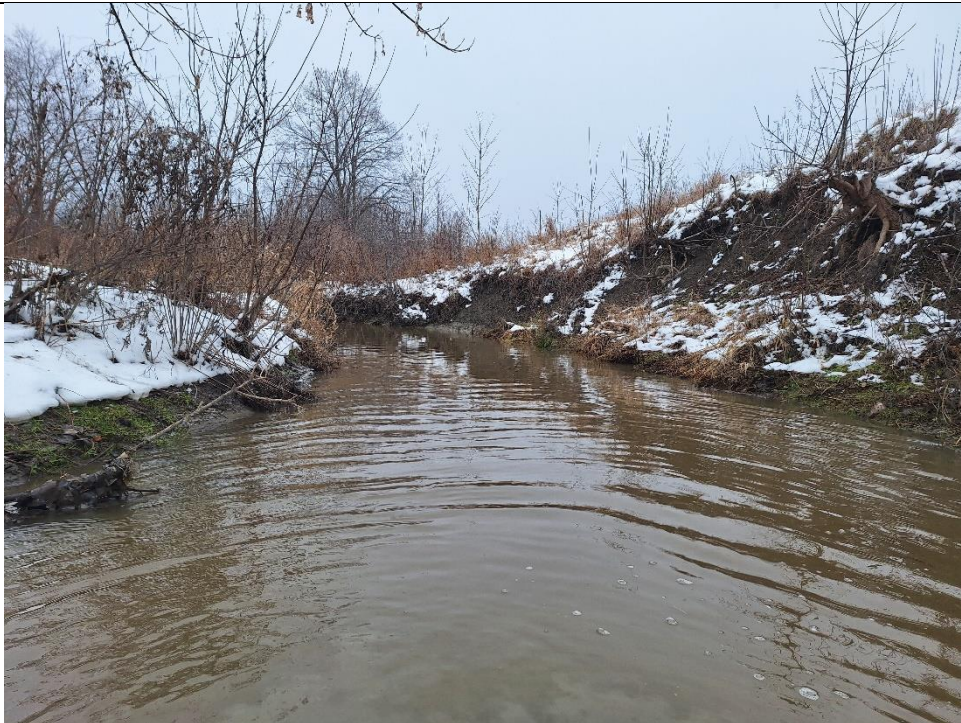
Photo 14
Ramsey Creek- Reach RCD, Ottawa, Ontario

The channel bank was observed to be eroding adjacent to the train tracks.

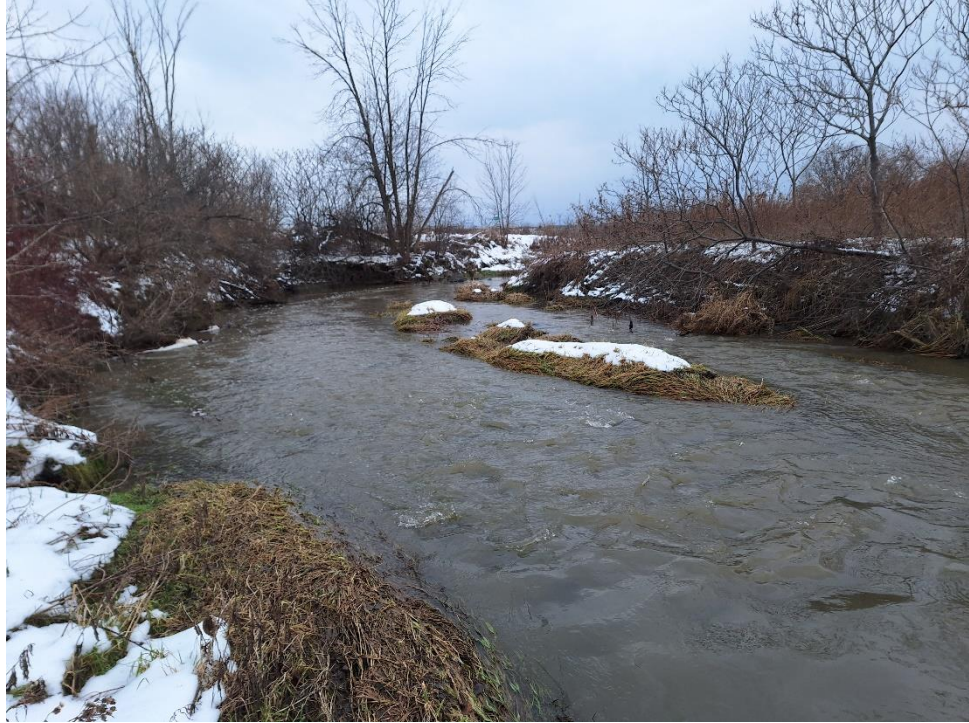
Photo 15
Ramsey Creek- Reach RCD, Ottawa, Ontario

Riffle pool morphology was not observed except for the depicted one riffle location which was approximately 12 metres long.

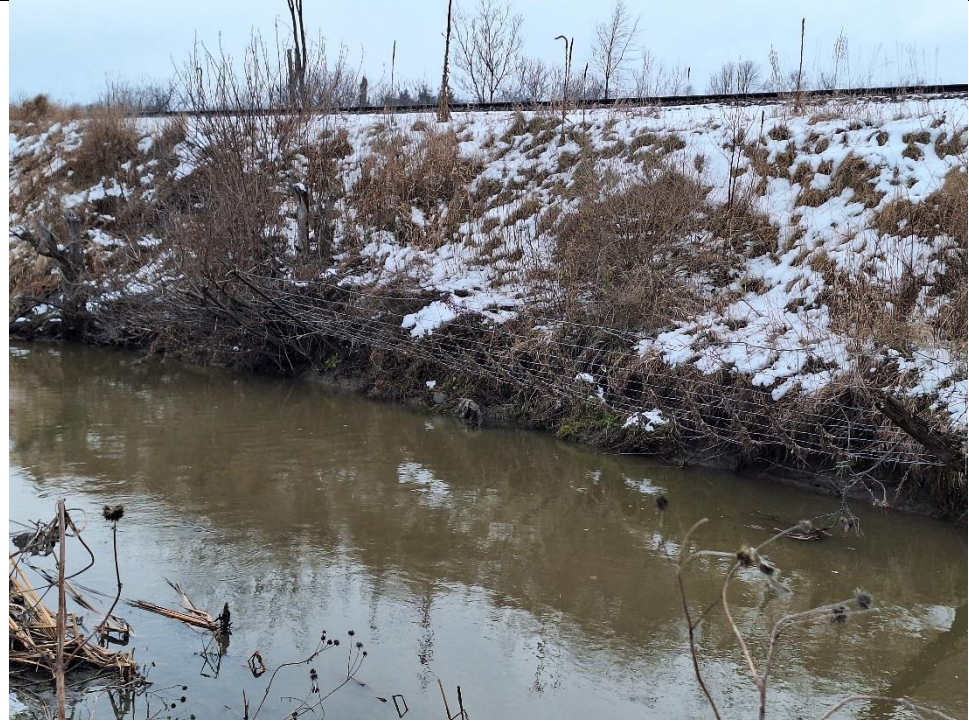
Photo 16
Ramsey Creek- Reach RCD, Ottawa, Ontario

Undermined fencing was observed along the reach due to erosion and basal scour. Basal scour and undercutting was observed commonly throughout the reach.

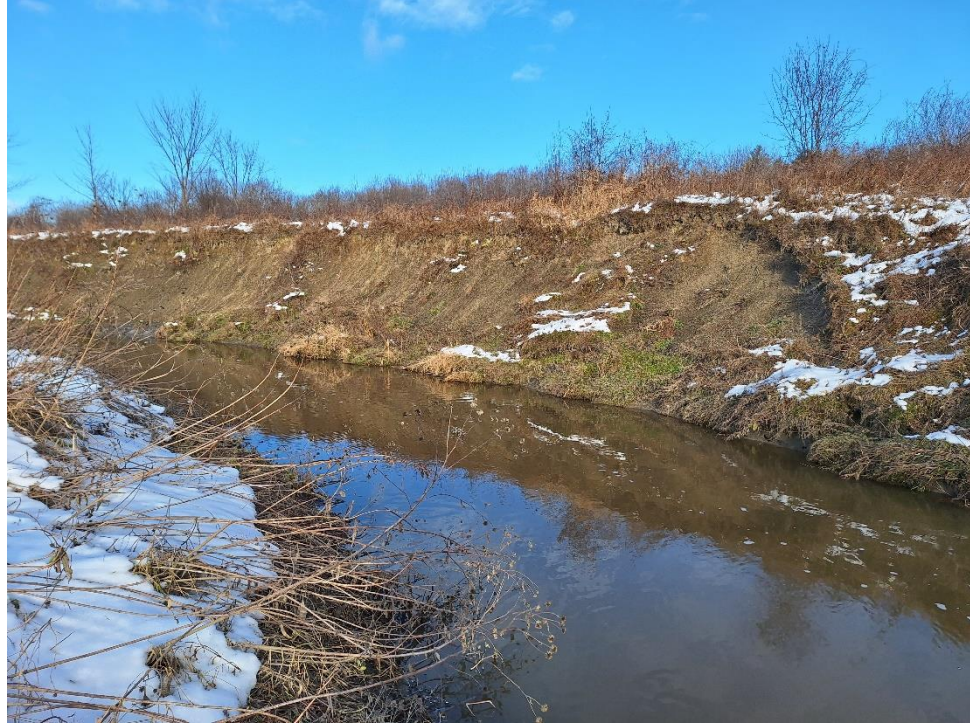
Photo 17
Ramsey Creek- Reach RCE, Ottawa, Ontario

Large cutfaces were observed where the channel came in contact with the edge of agricultural fields. Basal scour was observed along both banks throughout the reach.

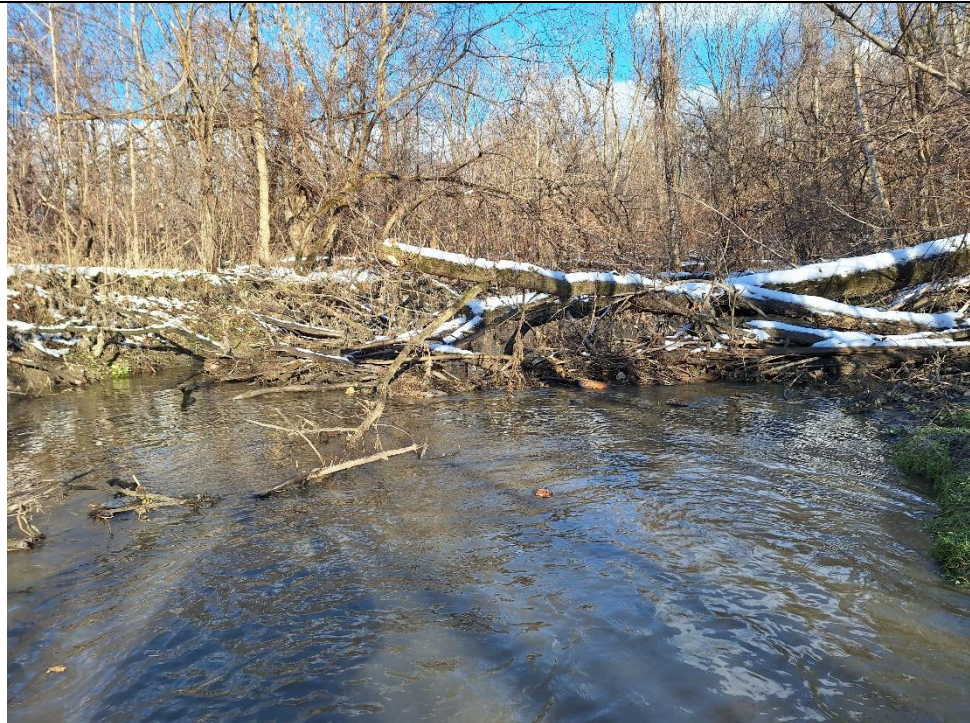
Photo 18
Ramsey Creek- Reach RCE, Ottawa, Ontario

Large woody debris and down trees became more frequent relative to upstream reaches.

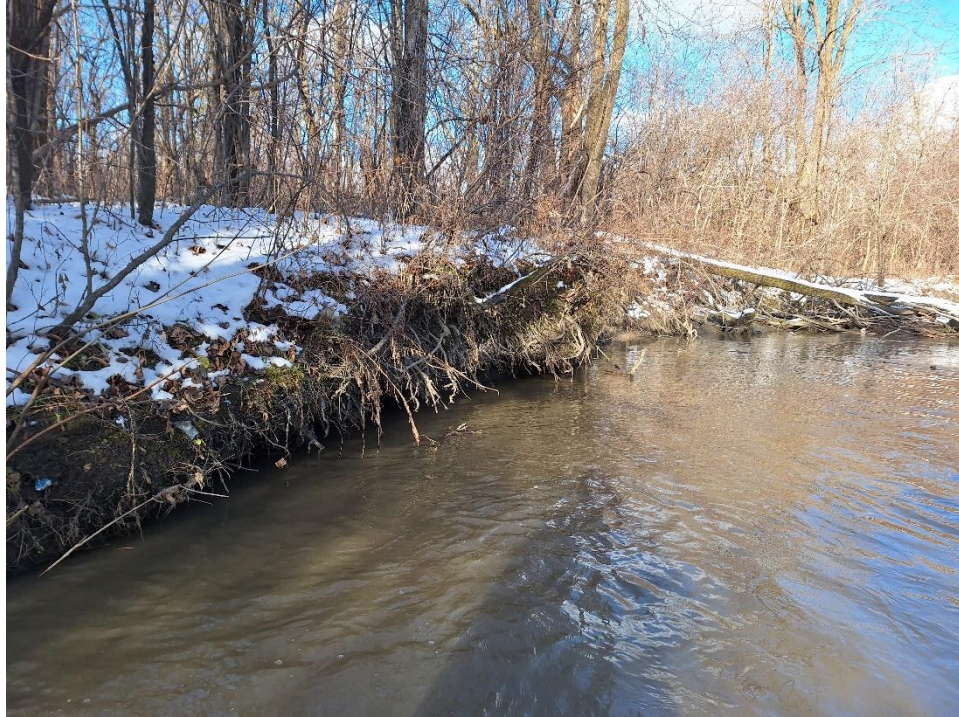
Photo 19
 Ramsey Creek- Reach RCE, Ottawa, Ontario

Undercutting and exposed roots was observed at several locations along the reach. The channel substrate was composed of fine silts over compact clay.

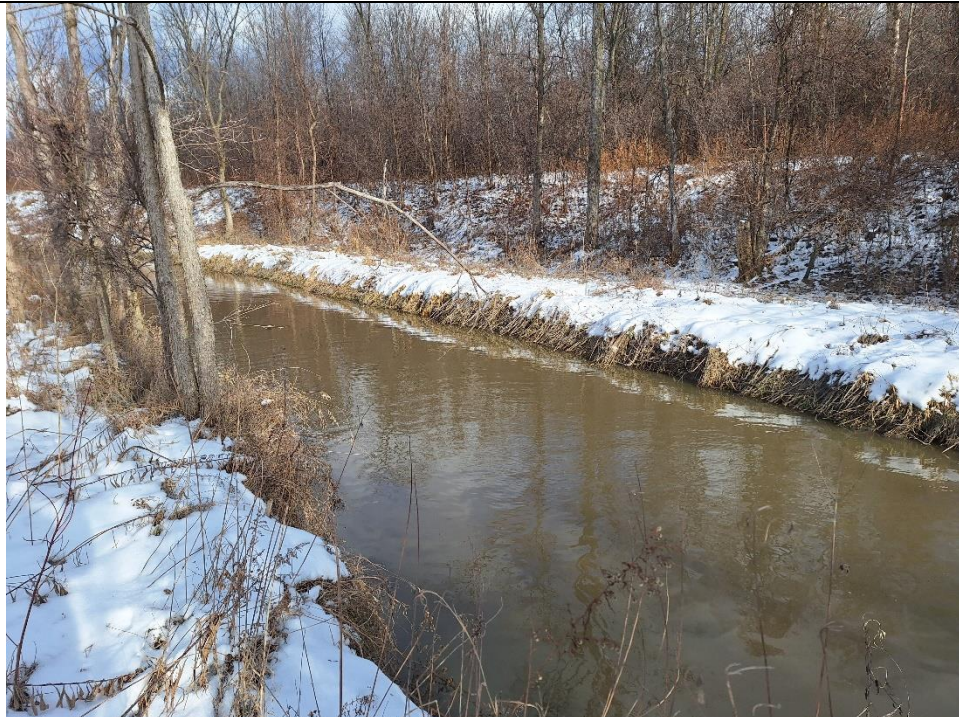
Photo 20
 Ramsey Creek- Reach RCE, Ottawa, Ontario

The downstream extent of the reach had grassy banks and exhibited a wide flat floodplain within a partially confined valley. The channel was dominated with runs and lack riffle-pool features.

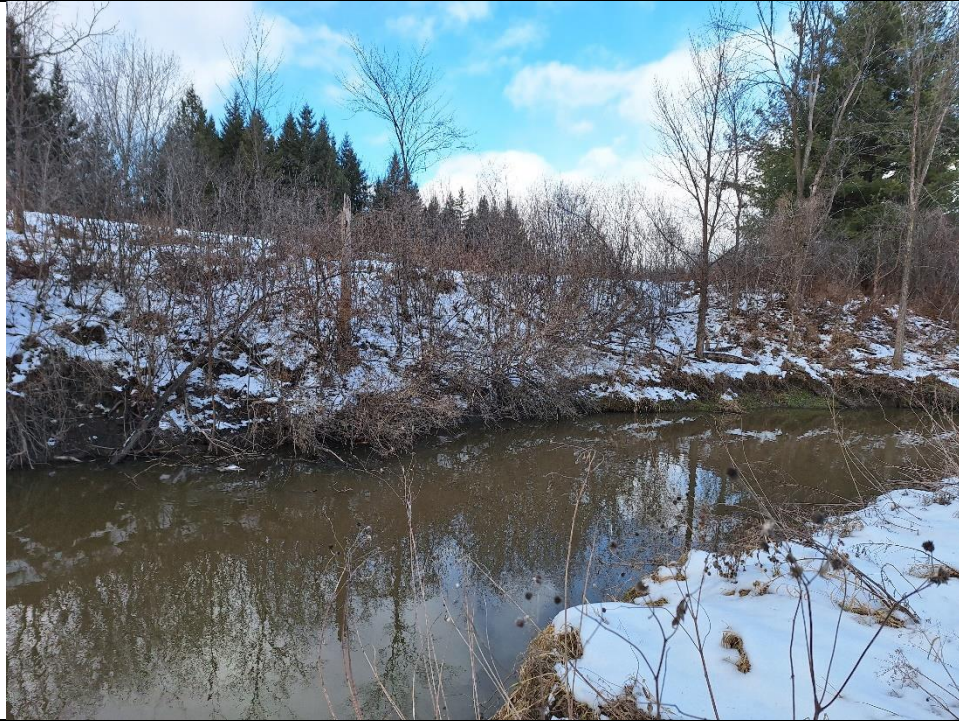
Photo 21
 Ramsey Creek- Reach RCF Ottawa, Ontario

Throughout the reach, scour was observed, however not as continuous as observed at upstream reaches. The reach was dominated by runs and lacked riffle-pool features.

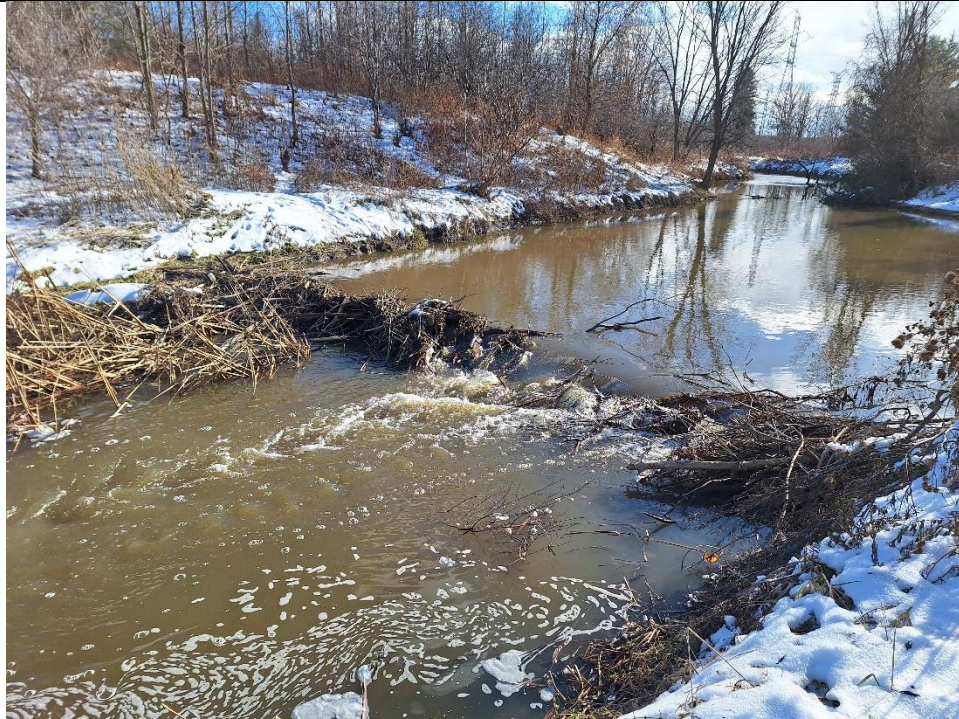
Photo 22
 Ramsey Creek- Reach RCF, Ottawa, Ontario

A large beaver dam was observed towards the downstream extent of the reach, causing backwatering. Extensive evidence of beaver activity was observed throughout the reach.

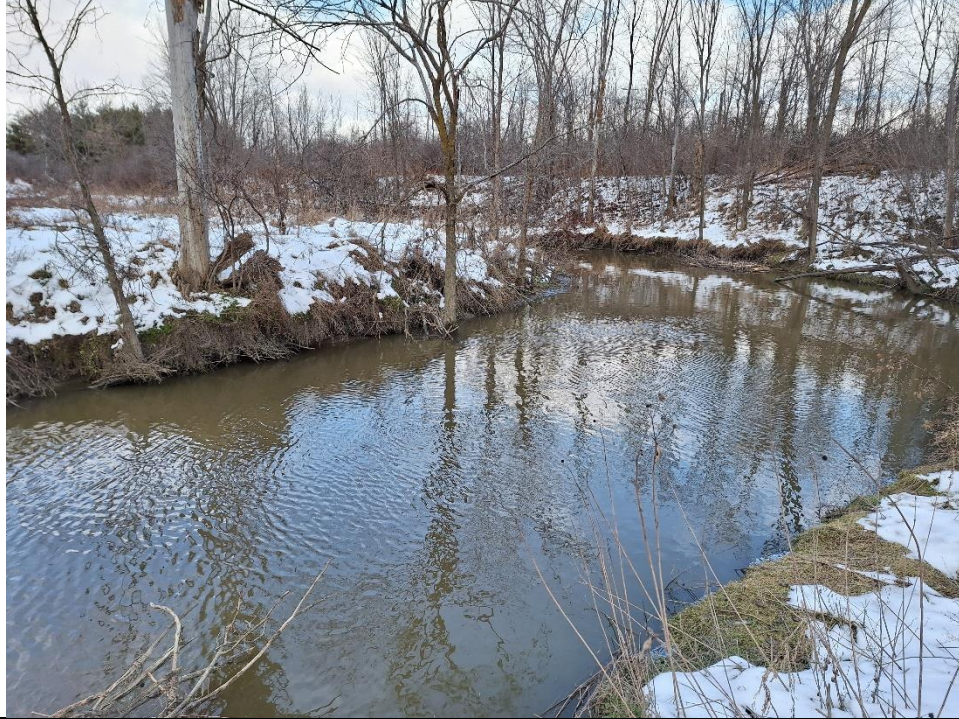
Photo 23
Ramsey Creek- Reach RCF, Ottawa, Ontario

Undercutting was observed at two locations along the reach, concentrated along inside banks. Exposed tree roots were commonly observed.

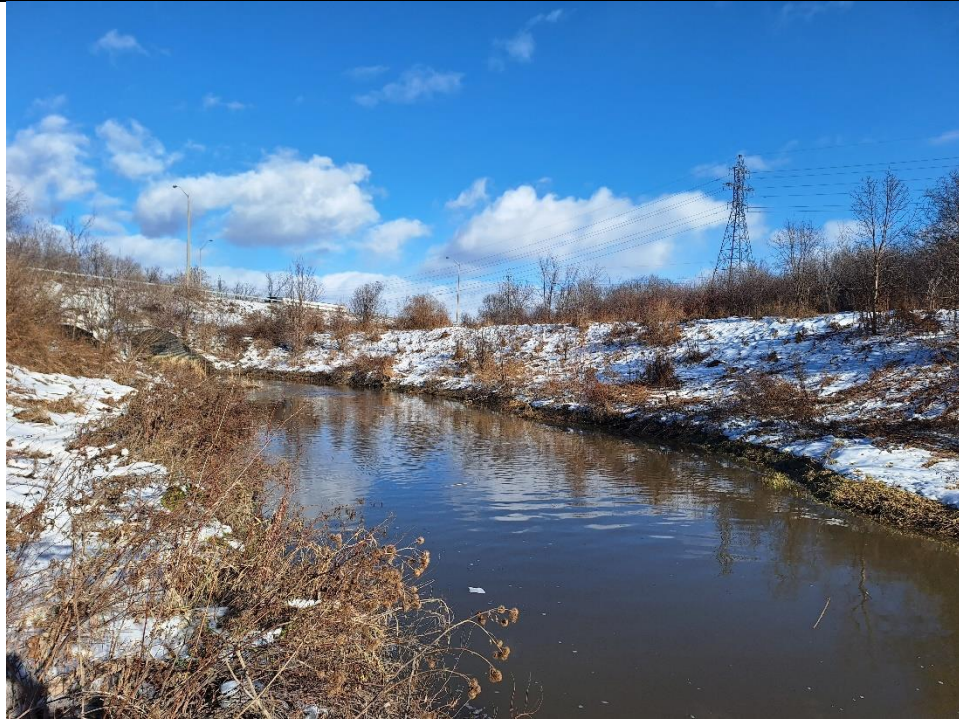
Photo 24
Ramsey Creek- Reach RCF, Ottawa, Ontario

Towards the downstream extent, the channel banks were well vegetated with little signs of erosion. The channel substrate was composed of fine silts over compact clay.

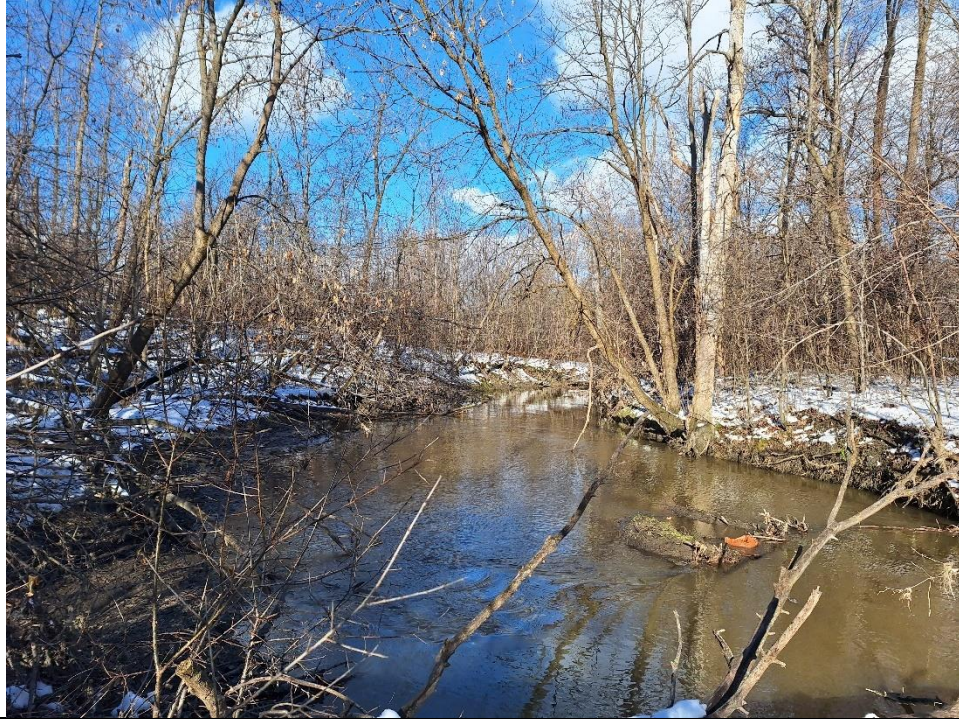
Photo 25
 Ramsey Creek- Reach RCG, Ottawa, Ontario

The reach travels within a forested area, leaning trees and exposed roots were commonly observed. The channel exhibited a meandering planform and was dominated by runs.

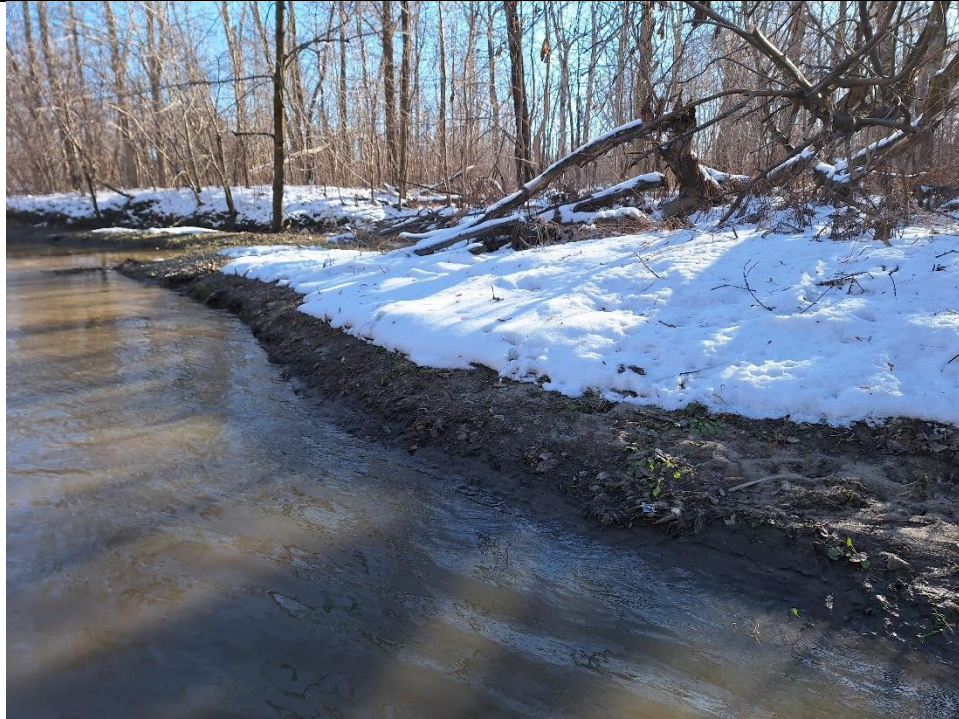
Photo 26
 Ramsey Creek- Reach RCG, Ottawa, Ontario

Point bars were commonly observed along the inside meanders, most appeared stable, and a few were vegetated. The channel substrate was composed of clay and silt.

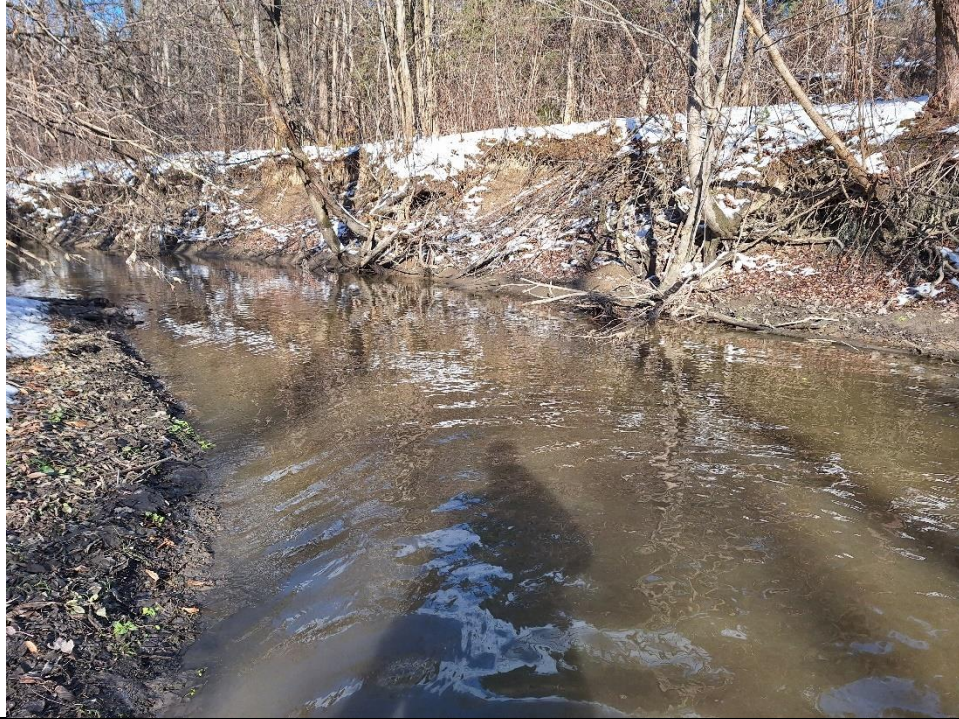
Photo 27
Ramsey Creek- Reach RCG, Ottawa, Ontario

Valley wall contact along outside meanders were observed at several locations along the reach.

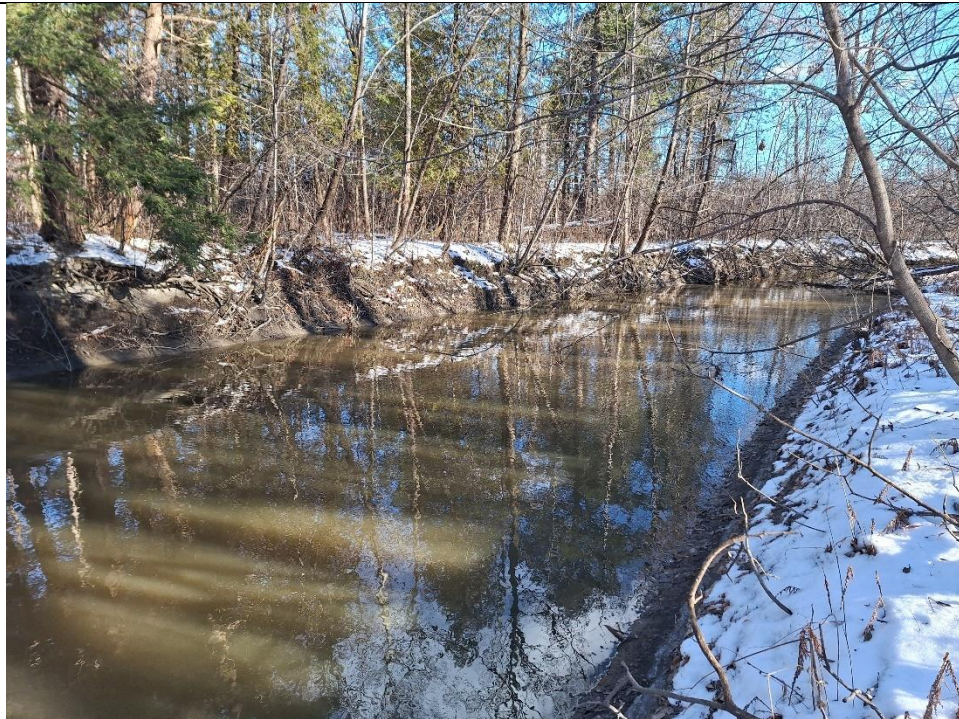
Photo 28
Ramsey Creek- Reach RCG, Ottawa, Ontario

The downstream extent of the reach exhibited a straight planform and tall vertical banks.

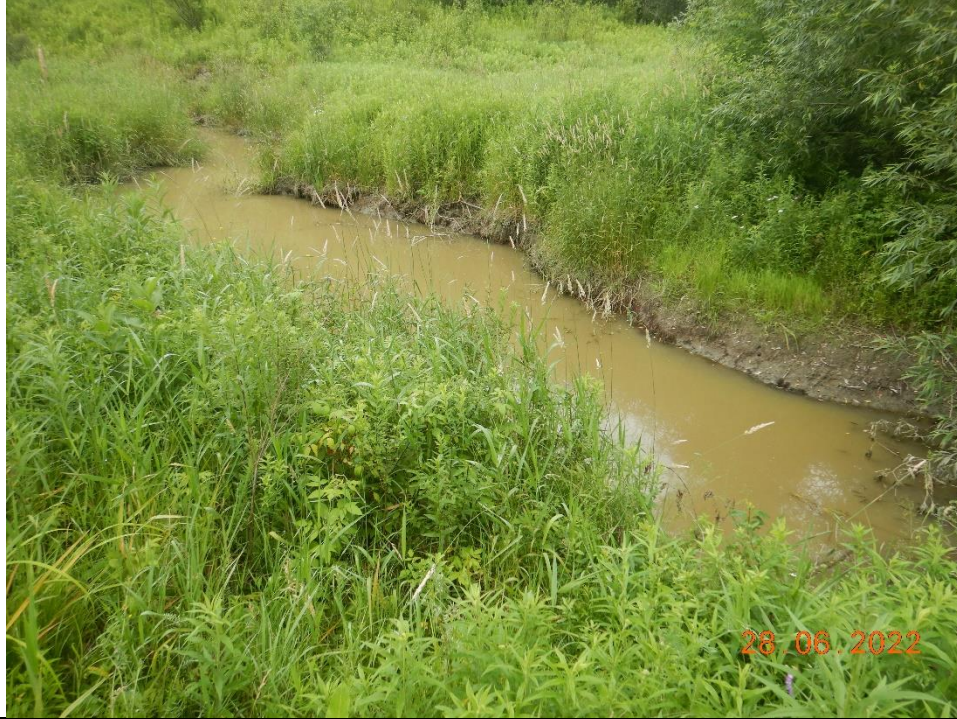
Photo 29
Ramsey Creek- Reach RC1, Ottawa, Ontario

The reach exhibited a meandering planform throughout a large grassy meadow. The banks were well vegetated.

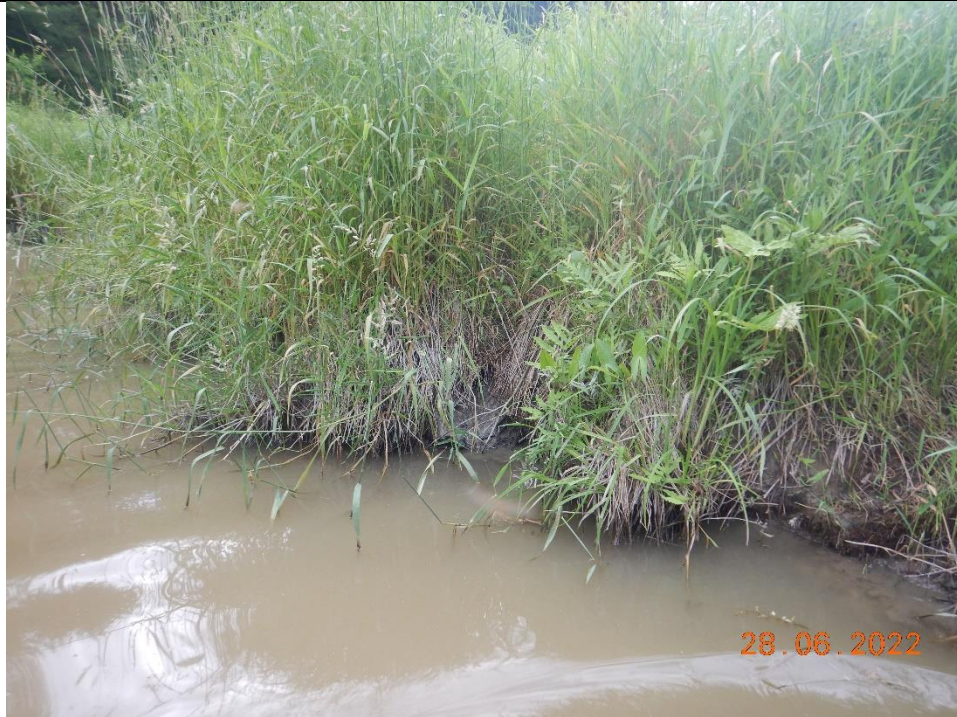
Photo 30
Ramsey Creek- Reach RC1, Ottawa, Ontario

Slumping was commonly observed throughout the banks on both sides of the channel.

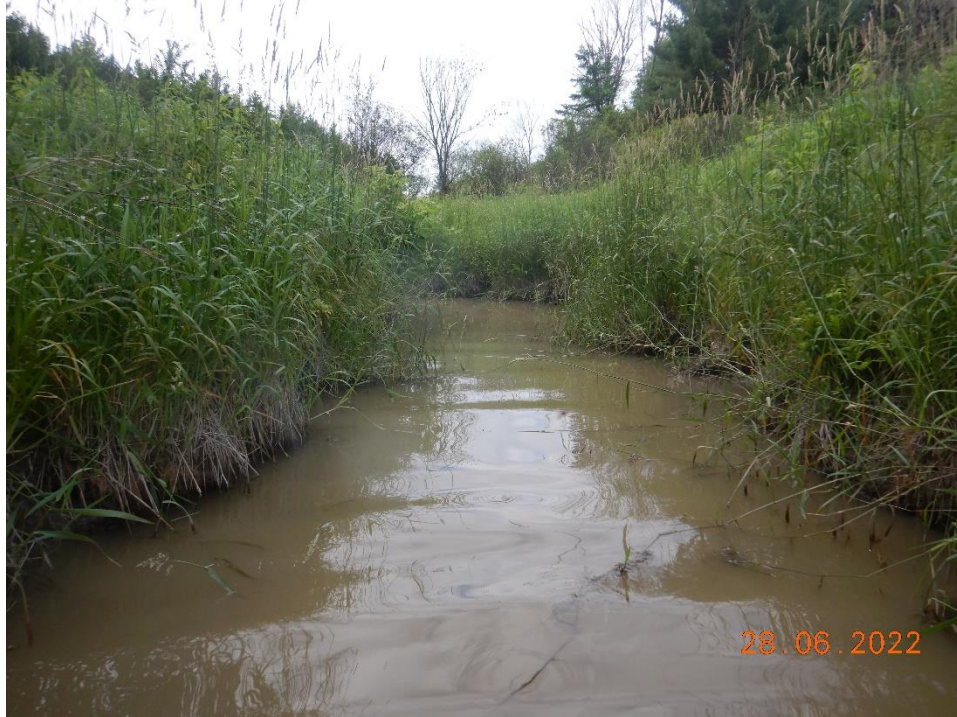
Photo 31
Ramsey Creek- Reach RC1, Ottawa, Ontario

The reach was dominated by runs and no pool-riffle formations were observed. The water was turbid at the time of the assessment.

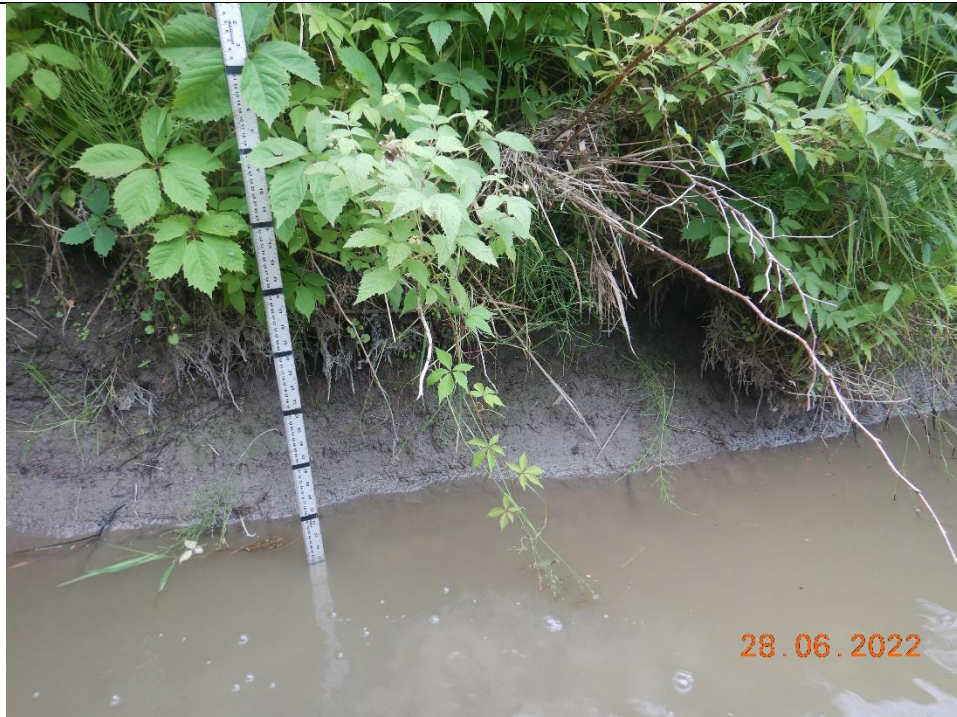
Photo 32
Ramsey Creek- Reach RC1, Ottawa, Ontario

Minor basal scour was common throughout the reach. The channel substrate was composed of fine silt over compact clays.
