November 25, 2024

**Re: Background Review and Drainage Characterization of Ramsay Creek
Tewin Secondary Plan Area
City of Ottawa, Ontario
GEO Morphix Project No. 21063**

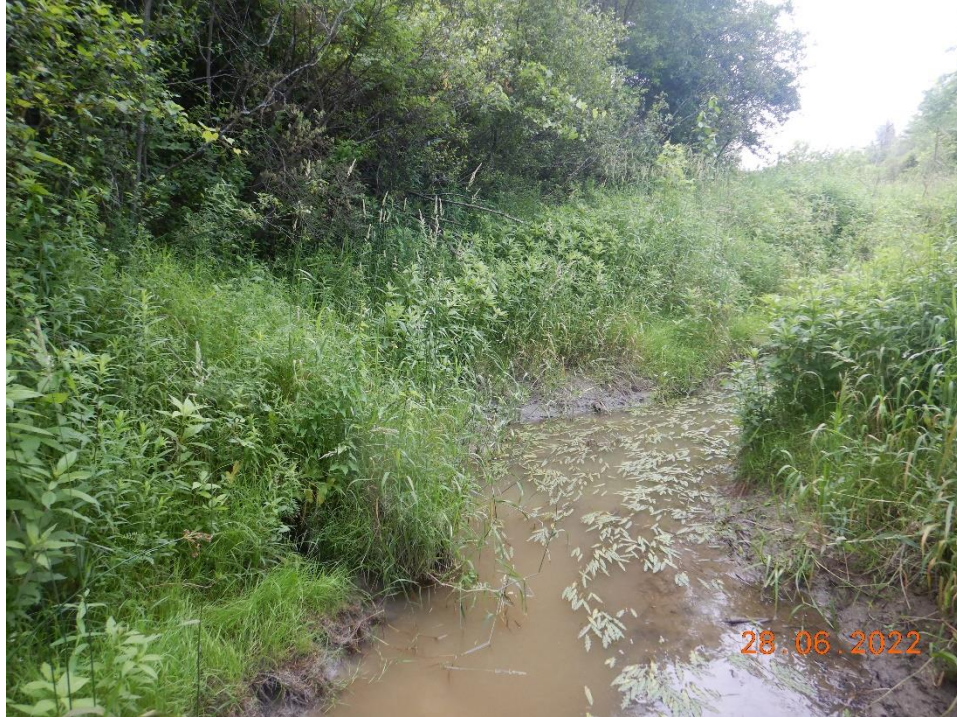
Photo 33
 Ramsey Creek- Reach RC2, Ottawa, Ontario

The reach exhibits a meandering planform through a large meadow. The riparian zone is primarily grasses and the banks were well vegetated. The reach was dominated by runs.

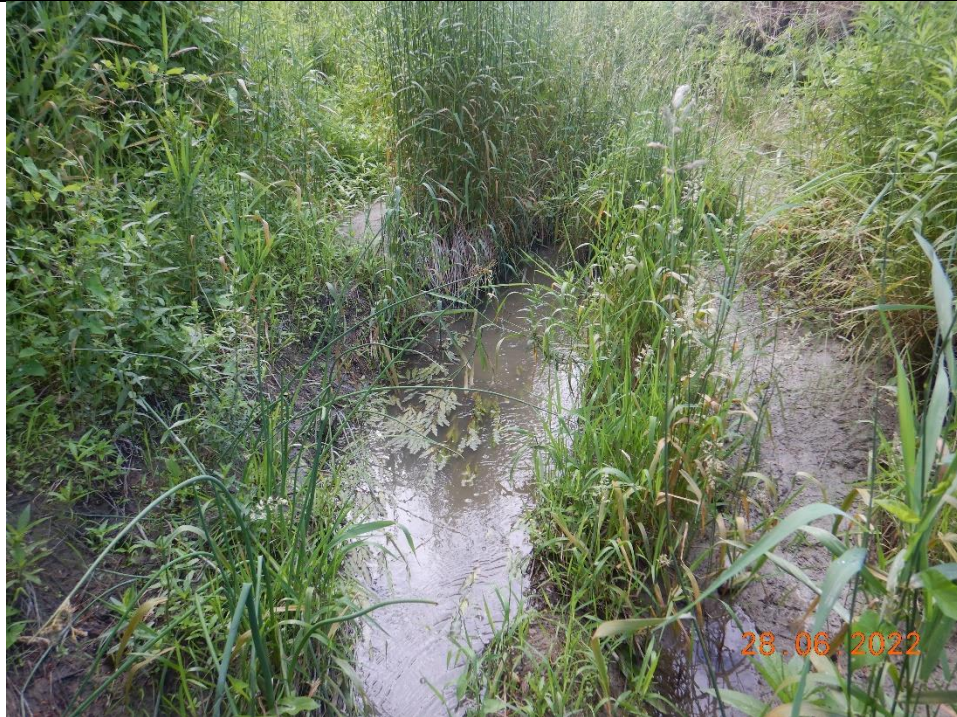
Photo 34
 Ramsey Creek- Reach RC2, Ottawa, Ontario

Instream vegetation was observed throughout the reach, and vegetation encroachment was heavy. Overbank deposition was observed at several locations along the downstream extent.

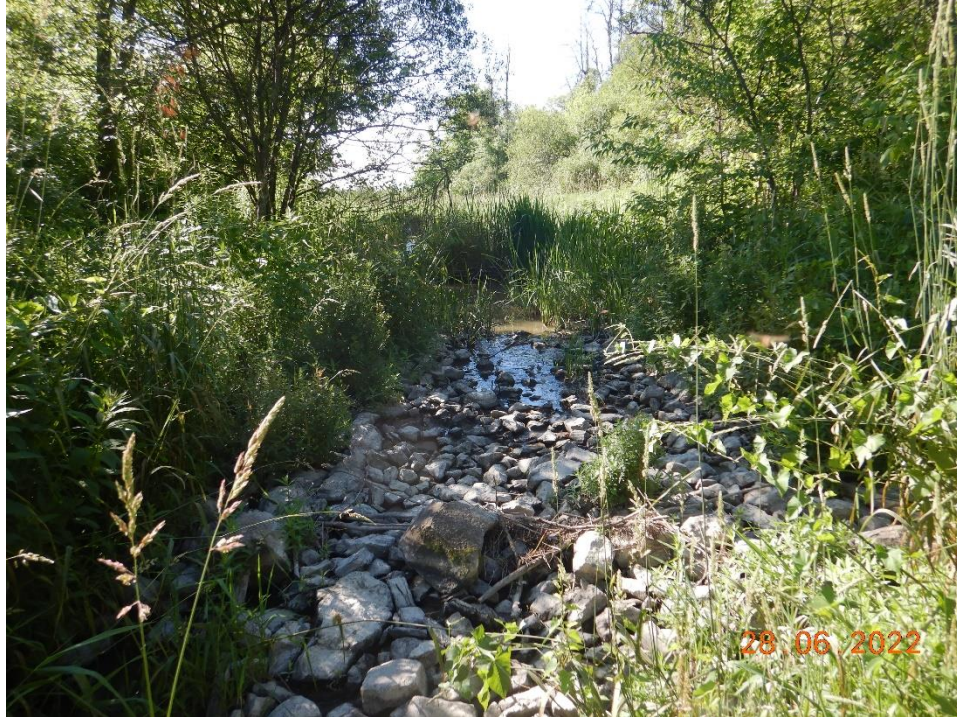
Photo 35
 Ramsey Creek- Reach RC2, Ottawa, Ontario

Placed cobbles were observed halfway through the reach. This caused a back water effect upstream, where the channel is wide a flat.

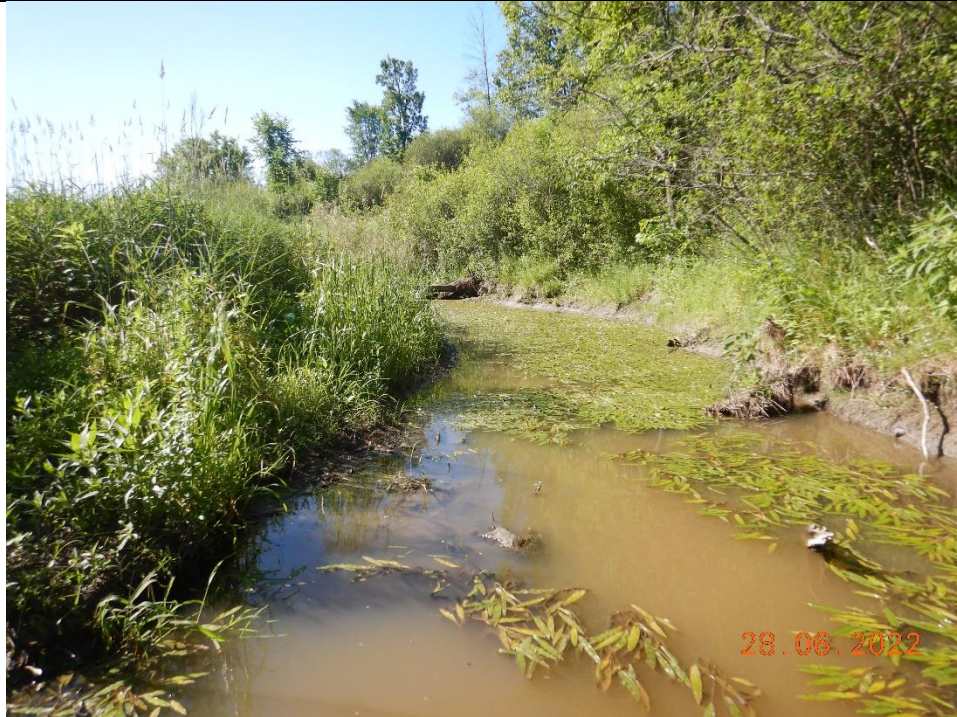
Photo 36
 Ramsey Creek- Reach RC2, Ottawa, Ontario

Minor basal scour was commonly observed along on or both banks at the upstream extent of the reach. The channel bed substrate throughout the reach was composed of fine silt over compact clay.

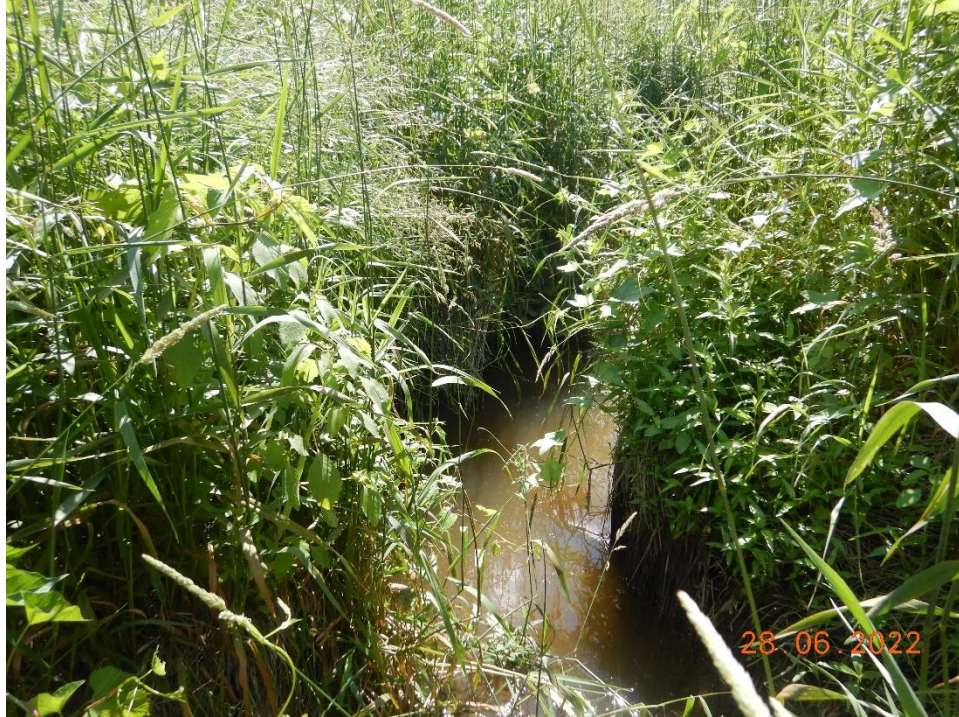
Photo 37
 Ramsey Creek- Reach RC3, Ottawa, Ontario

The reach meanders through a large grassy meadow and had well vegetated banks. Vegetation encroachment was moderate to extreme in some locations.

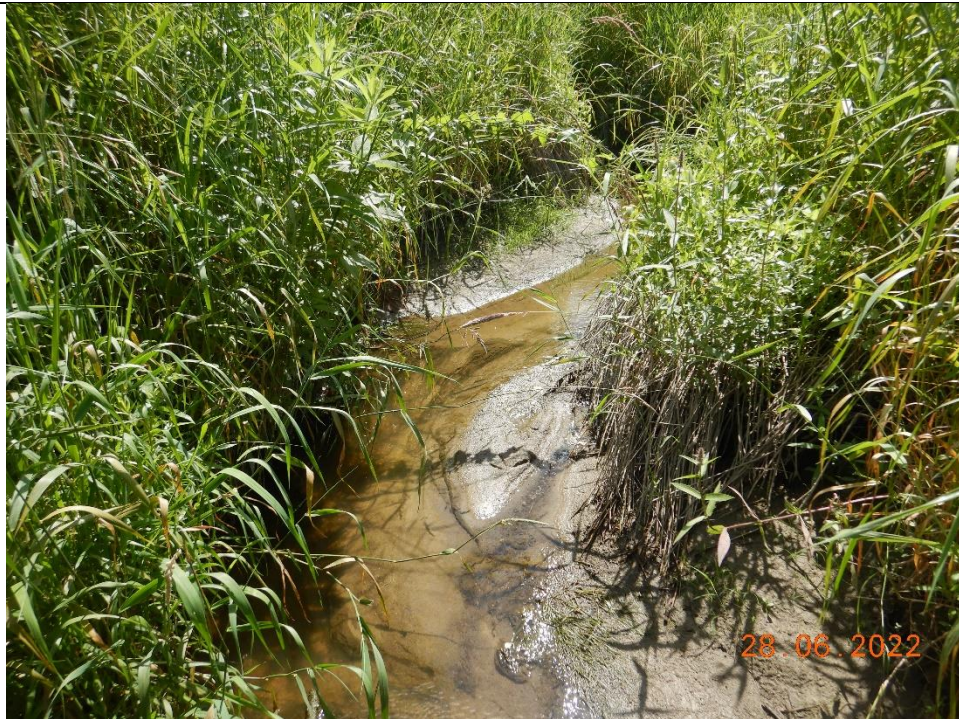
Photo 38
 Ramsey Creek- Reach RC3, Ottawa, Ontario

Deposition was commonly observed throughout the reach. Channel bed substrate was composed of fine silt over compact clays.

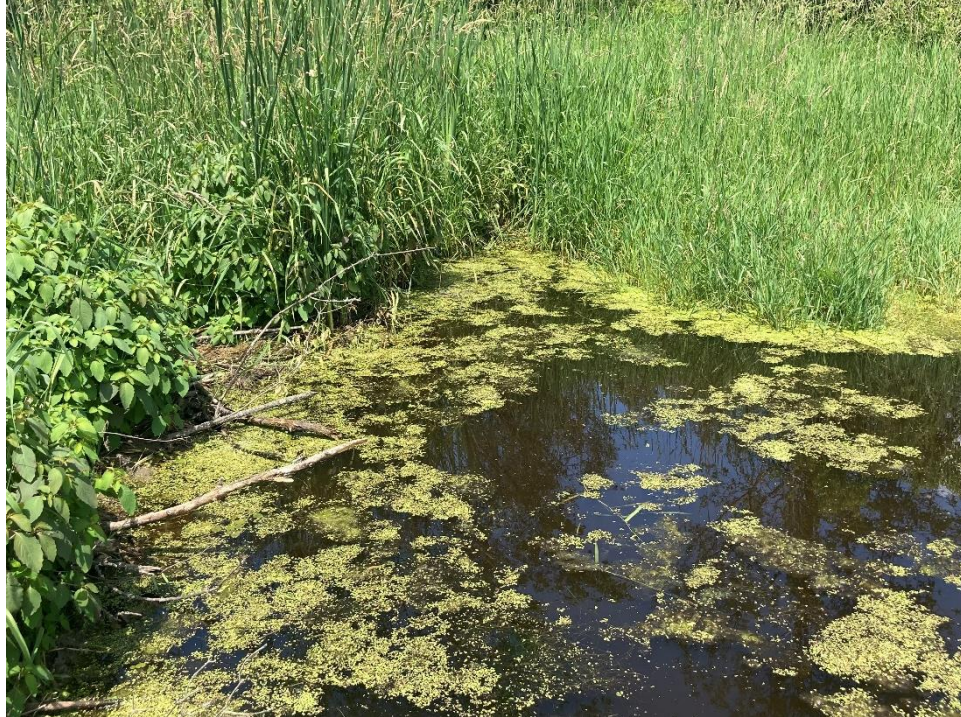
Photo 39
Ramsey Creek- Reach RC3, Ottawa, Ontario

A large, well established beaver dam was located halfway throughout the reach, causing a large area of backwater.

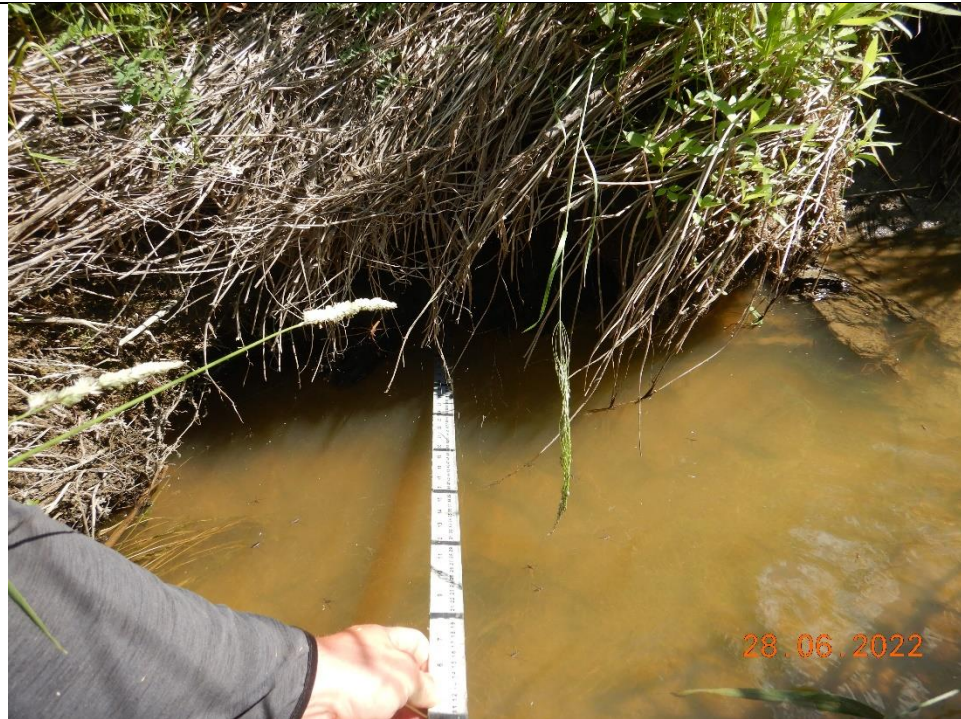
Photo 40
Ramsey Creek- Reach RC3, Ottawa, Ontario

Channel bank slumping and undercutting were observed frequently.

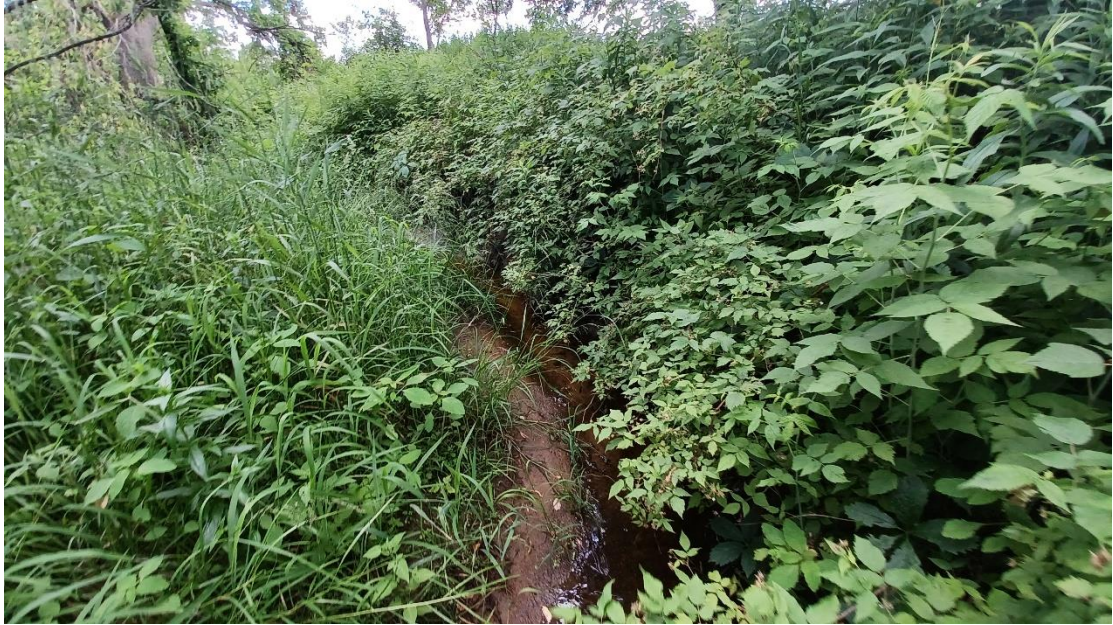
Photo 41
 Ramsey Creek- Reach RC4, Ottawa, Ontario

The reach exhibits a straightened planform as it travels between two actively cultivated fields. The channel was dominated by runs with no riffle-pool features observed. The riparian edges were composed of grasses and trees in forested sections.

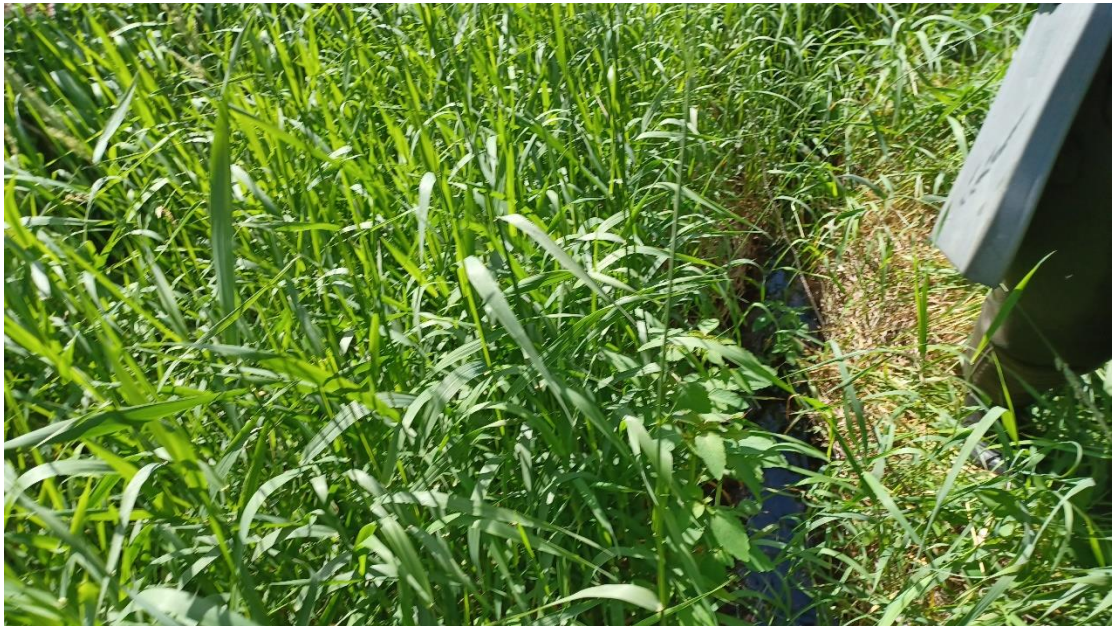
Photo 42
 Ramsey Creek- Reach RC4, Ottawa, Ontario

Between sections of forest, the channel is narrow, and at times, poorly defined. Vegetation encroachment is extreme along most of the reach. Little signs of erosion were observed.

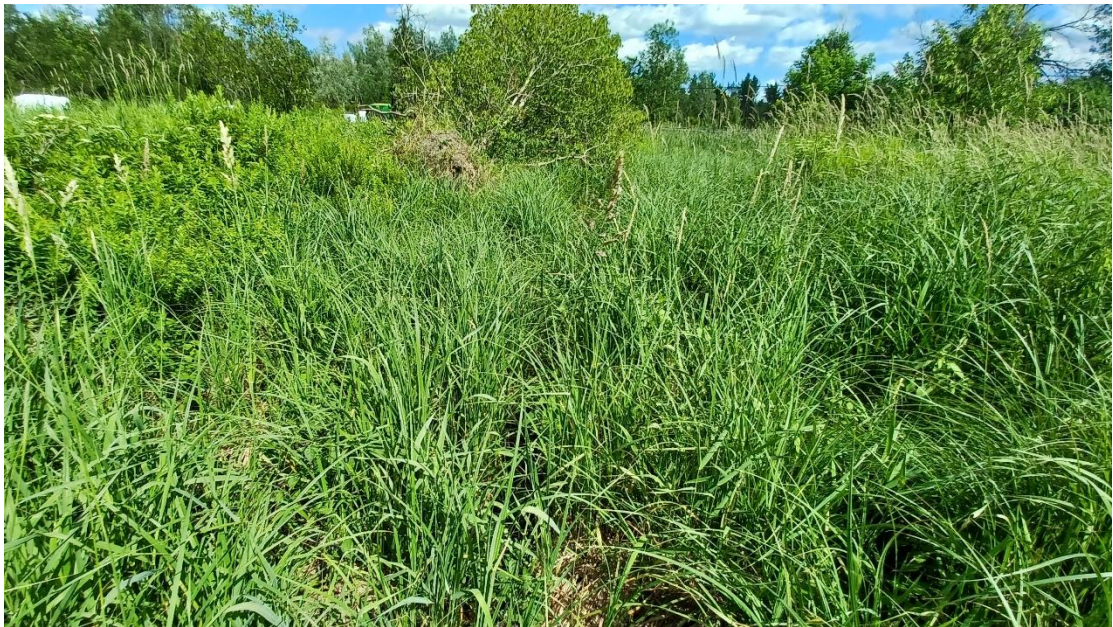
Photo 44
Ramsey Creek- Reach RC4, Ottawa, Ontario

Along the upstream extent of the reach, the channel loses definition and flows interstitially through grasses and cattails.
