CLIENT Taggart Investments FILE NO. PG5827  
 PROJECT Geotechnical Investigation - Proposed Mixed-Use DATE 14 Mar 22  
 Community Development

### TEWIN LANDS

### LIMIT OF HAZARD LANDS PLAN

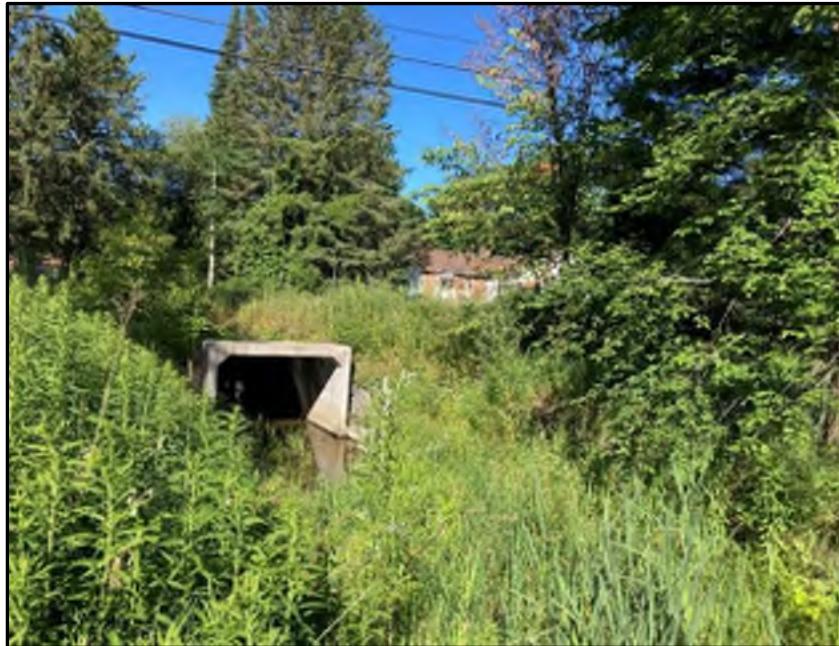
**Photo 1:** Area of Section A facing west and located along the Smith-Gooding municipal drain. The slope face was observed to be heavily vegetated with brush and mature trees. No notable erosion was observed in this area. The area of Section A was further observed to have a slope height of 2 m and an approximate steepness of 2.1H:1V.

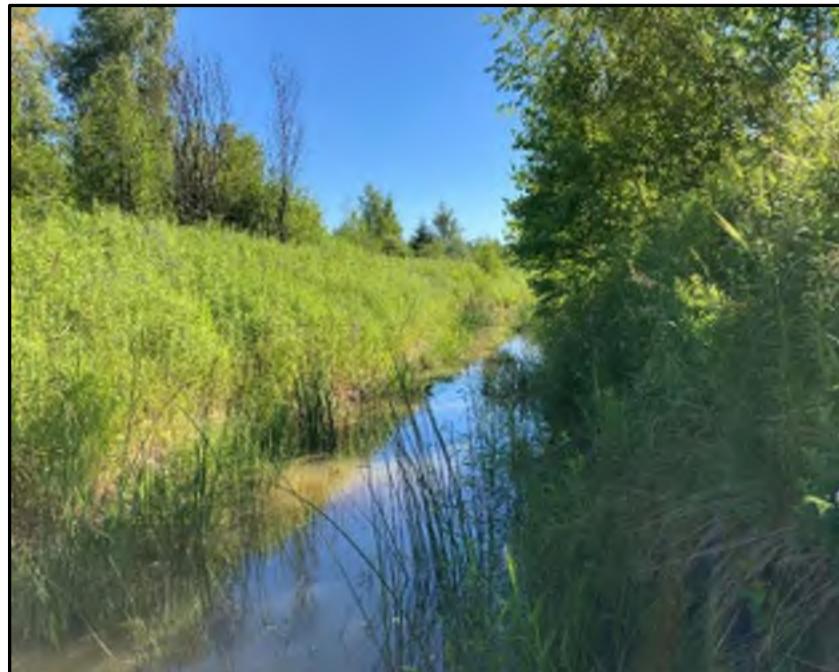
**Photo 2:** Area of Section B and facing east. The slope face was observed to be heavily vegetated with brush and mature trees. Some minor erosion was observed along the toe of the slope consisting of exposed bare soil at the water level surface.

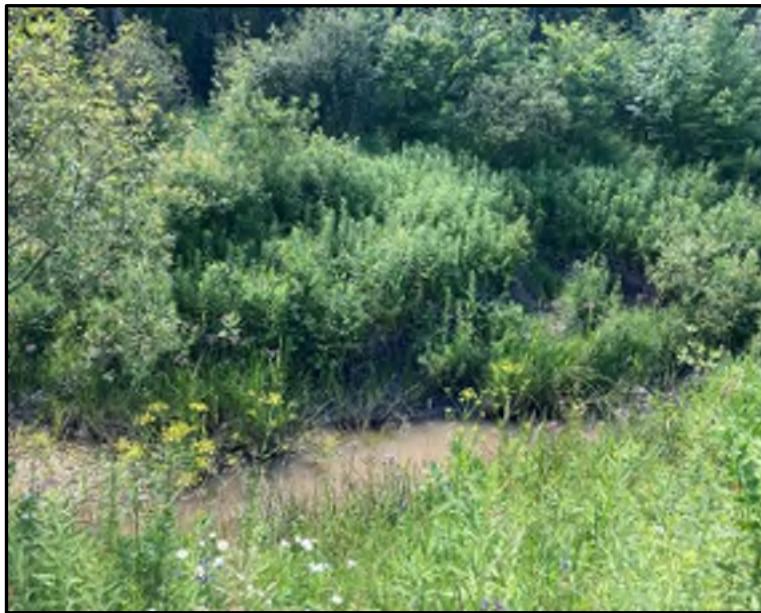
**Photo 3:** Area of Section E and facing south and located along the Smith-Gooding municipal drain. The slope face was observed to be heavily vegetated with brush, small and mature trees. Some portions of the slope face near the water surface were observed to lack mature vegetation and consist of almost bare soil. The area of Section E was further observed to have a slope height of 2.1 m and an approximate steepness of 1.7H:1V.

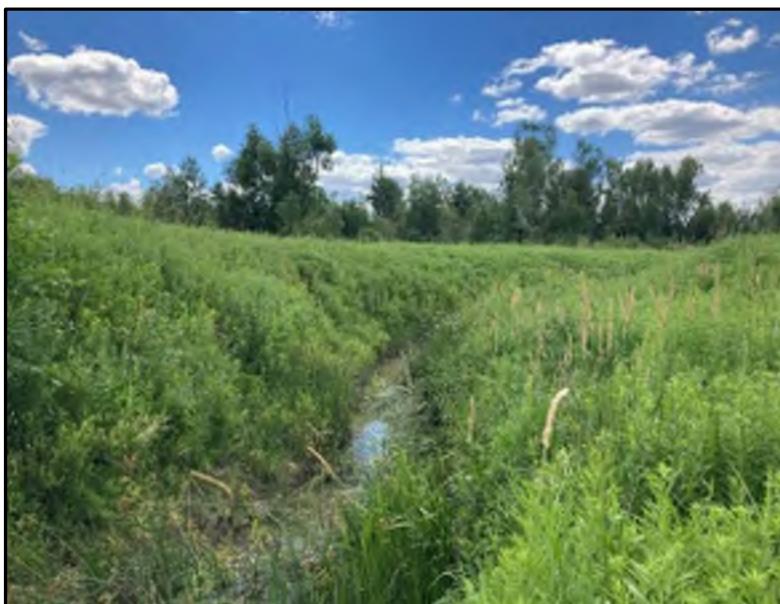
**Photo 4:** Area of Section F facing north and located along the Smith-Gooding municipal drain. The slope face was observed to be heavily vegetated with brush and mature trees on the abutting table lands. No notable erosion was observed in this area. The area of Section F was further observed to have a slope height of 1.6 m and an approximate steepness of 2.7H:1V.

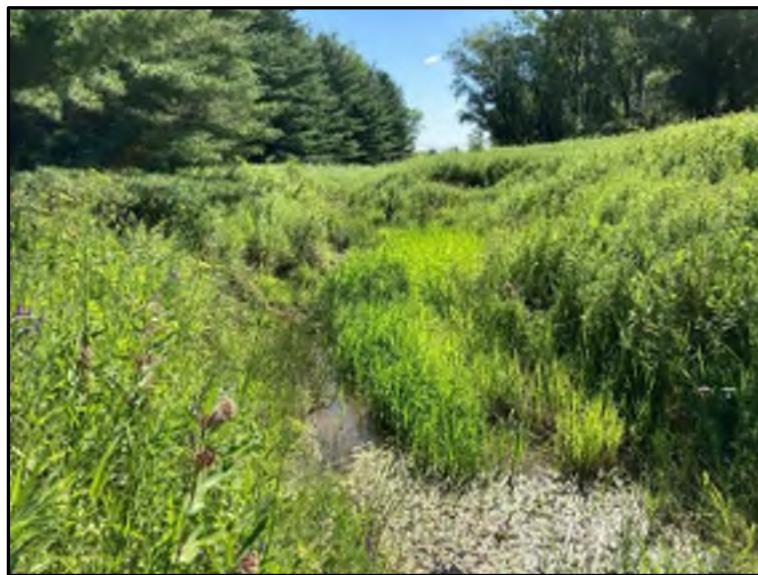
**Photo 5:** Area of Section H facing east and located along the Smith-Gooding municipal drain. The slope face was observed to be heavily vegetated with brush. Signs of previous slip surfaces assumed to have been caused by erosion were observed in this area, however, vegetation appeared established in the affected slope face. The area of Section H was further observed to have a slope height of 1.5 m and an approximate steepness of 1.1H:1V.

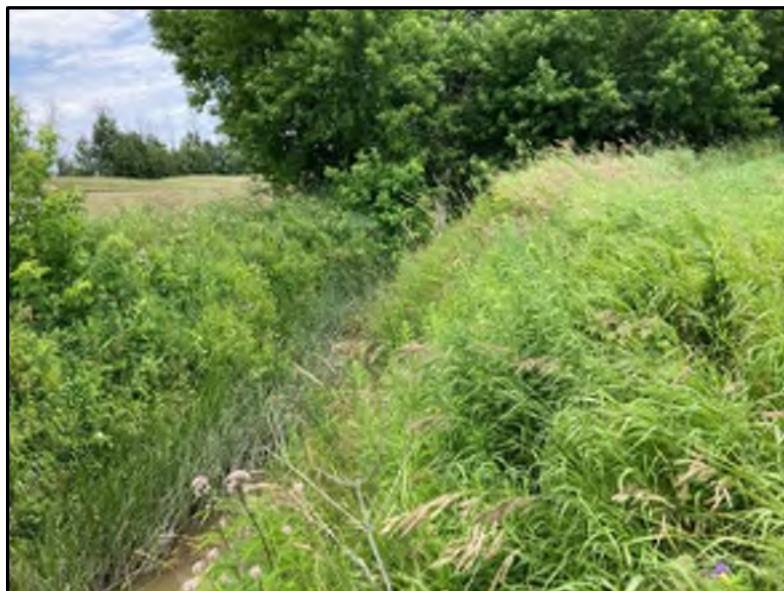
**Photo 6:** Area of Section K facing west and located along the Smith-Gooding municipal drain. The slope face was observed to be heavily vegetated with brush and mature trees located on the slope and the adjacent golf course. No notable erosion was observed in this area.

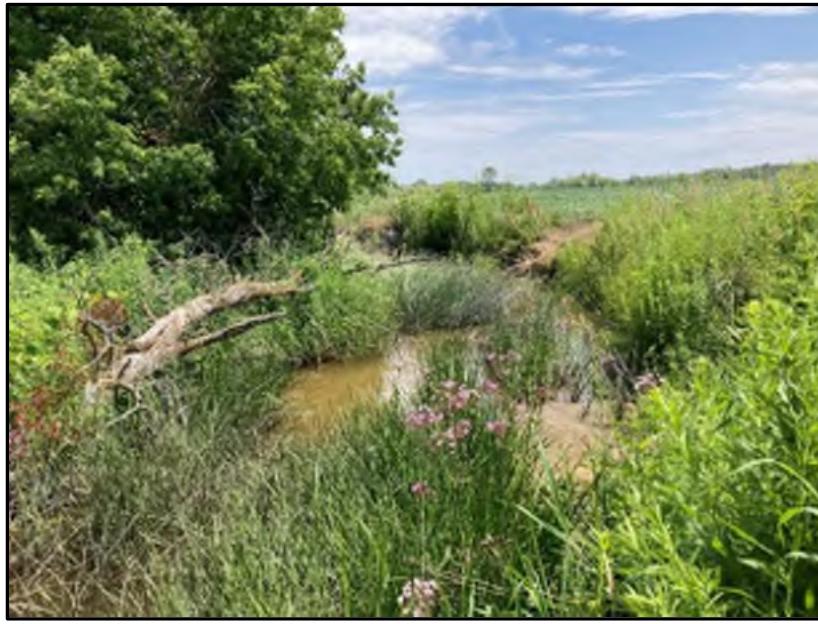
**Photo 7:** Area of Section L facing east and located along the Smith-Gooding municipal drain. The slope face was observed to be heavily vegetated with brush, mature trees, with agricultural land on the abutting table lands. No notable erosion was observed in this area. The area of Section L was further observed to have a slope height of 0.5 m and an approximate steepness of 1.0H:1V.

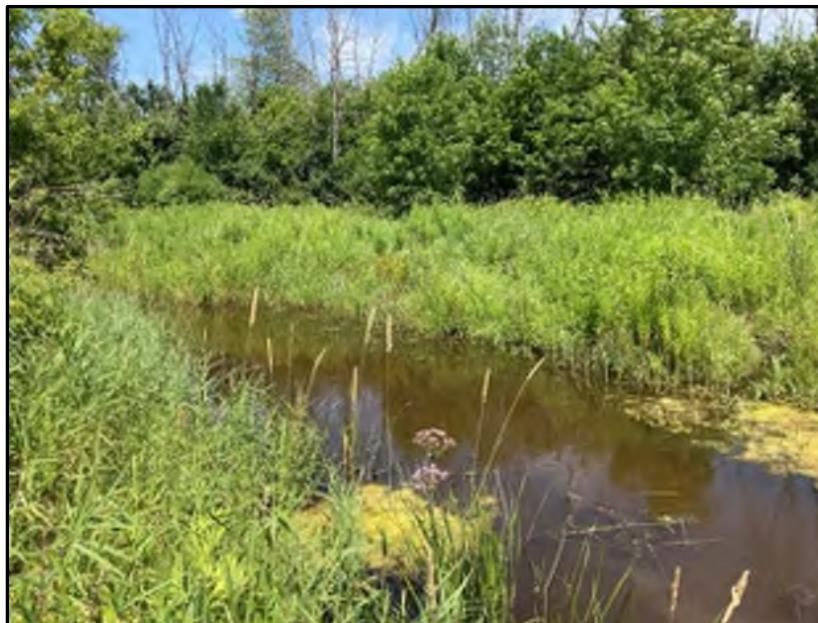
**Photo 8:** Area of Section N facing northwest and located along the Smith-Gooding municipal drain. The slope face was observed to be heavily vegetated with brush and mature trees. No notable erosion was observed in this area. The area of Section N was further observed to have a slope height of 0.5 m and an approximate steepness of 1.3H:1V.

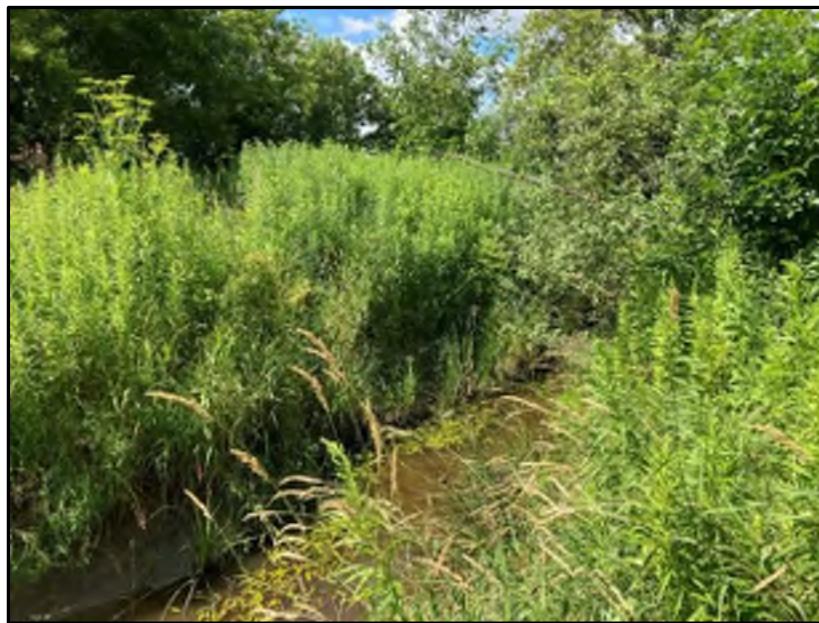
**Photo 9:** Area of Section O, facing west and located along the Smith-Gooding municipal drain. The slope face was observed to be heavily vegetated with brush and mature trees. The toe of the slope, which generally consisted of the banks edge, was observed to consist of bare soil which indicated some erosion was present throughout this area. The area of Section O was further observed to have a slope height of 0.5 m and an approximate steepness of 0.8H:1V.

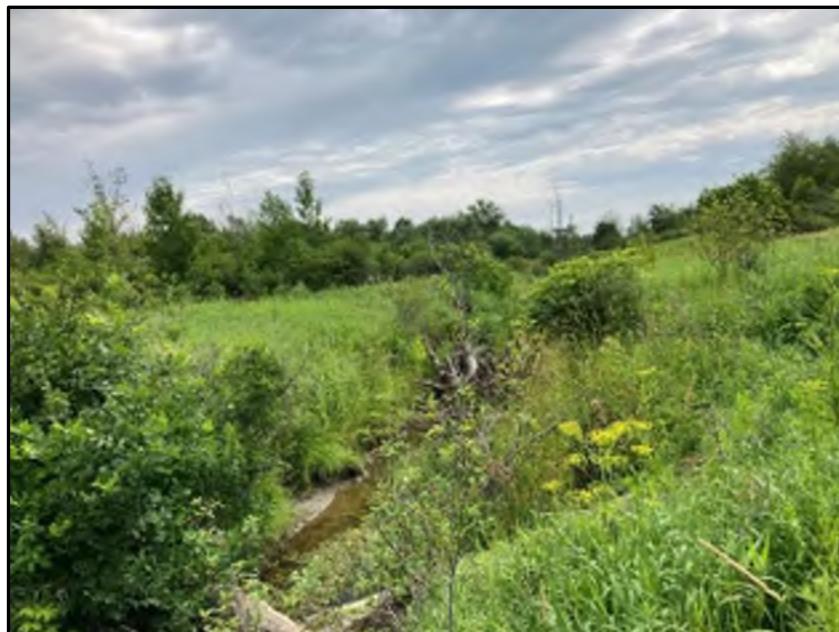
**Photo 10:** Area of Section P and facing east. The slope face was observed to be heavily vegetated with brush and some mature trees on the slope face and abutting table lands, respectively. Signs of erosion consisting of bare soil with lack of mature vegetation was observed along some portions of the toe of the slope.

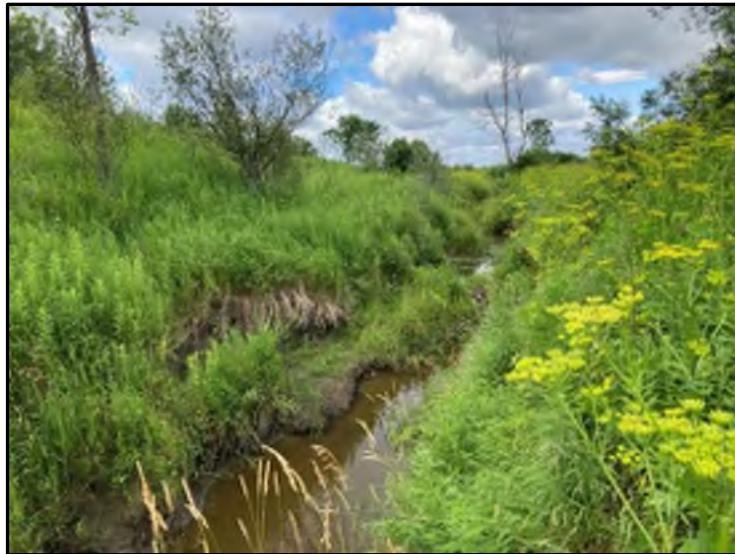
**Photo 11:** Area of Section Q, facing east and located along the Smith-Gooding municipal drain. The slope face was observed to be heavily vegetated with brush and mature trees. The toe of slope for some portions of the channel appeared to consist of a bare soil surface at the observed water level. Further, previous slip surface slough was observed at the toe of slope, however, the remaining slope face was observed to be covered in mature vegetation. The area of Section P was further observed to have a slope height of 3.0 m and an approximate steepness of 3.5H:1V.

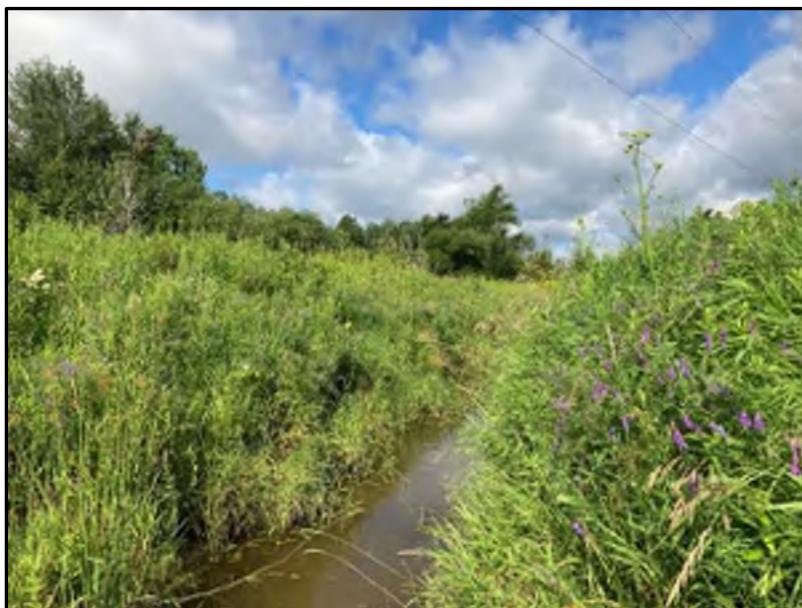
**Photo 12:** Area of Section R and facing. The slope face was observed to be heavily vegetated with brush and mature trees. No notable erosion was observed in this area. The area of Section O was further observed to have a slope height of 0.9 m and an approximate steepness of 0.9H:1V.

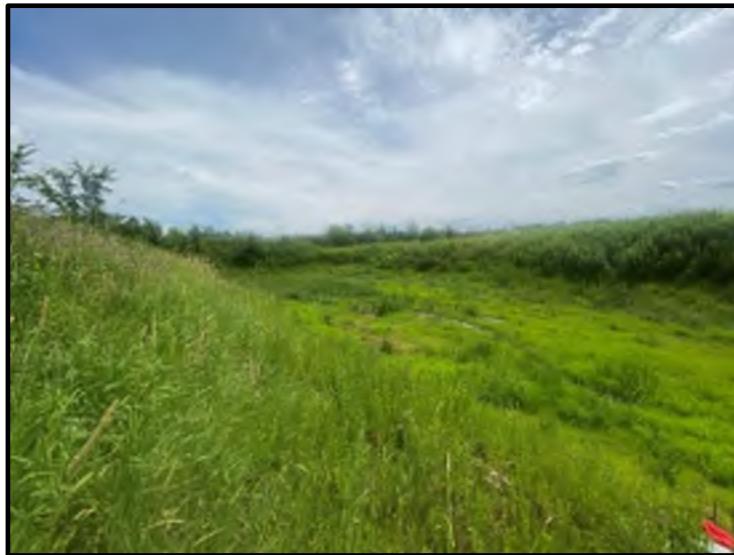
**Photo 13:** Area of Section U facing south and located along a small ditch northeast of the Johnston municipal drain. The slope face was observed to be heavily vegetated with brush and mature trees. No erosion or water was observed throughout this area at the time of our site visit.

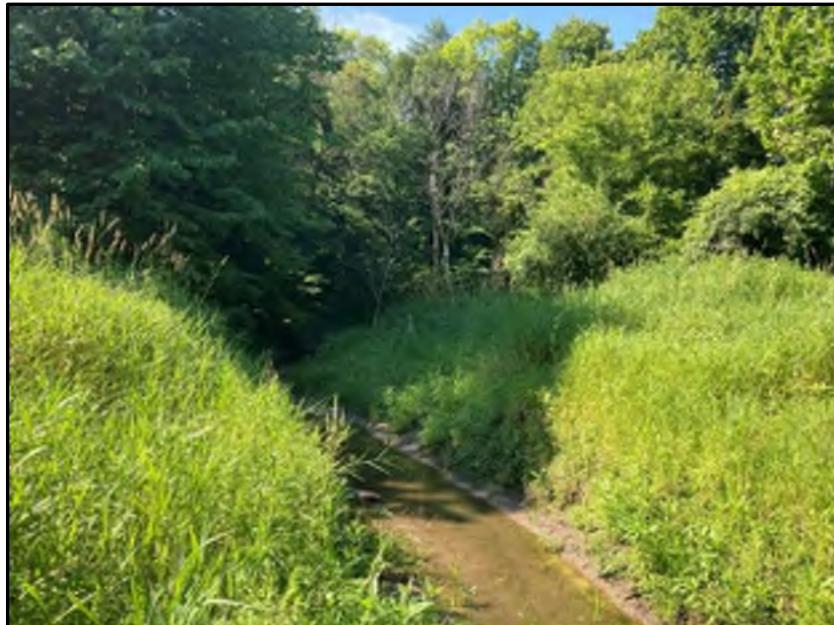
**Photo 15:** Area between Section Y and Section BB and facing southwest. The slope face was observed to be heavily vegetated with brush and mature trees. The toe of slope in contact with the water level was observed to bare from recent active erosion. However, the remainder of the slope face appeared to be covered with vegetation.

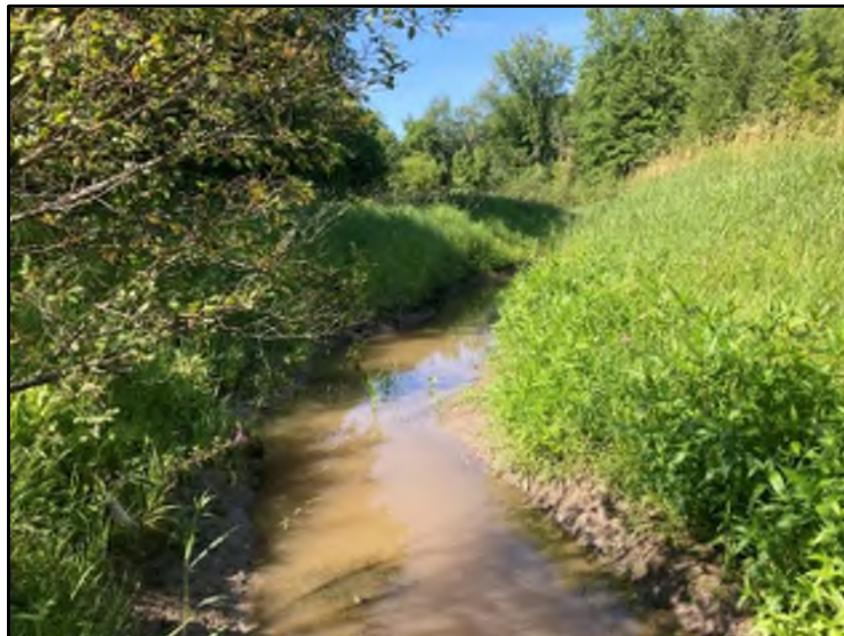
**Photo 16:** Area of Section AA and facing southwest. The slope face was observed to be heavily vegetated with brush and mature trees. Some minor erosion was noted along the toe of the slope along bends in the watercourse alignment.

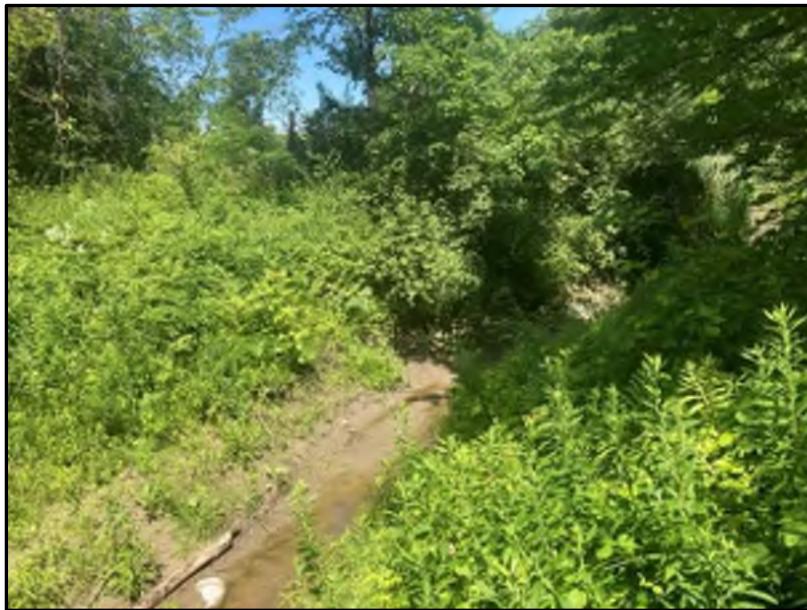
**Photo 17:** Area of Section DD and facing north. The slope face was observed to be heavily vegetated with brush and mature trees. Some portions of the toe of slope were observed to consist of bare soil with no mature vegetation, along with some undercutting below vegetated and unaffected portions of the watercourse alignment.

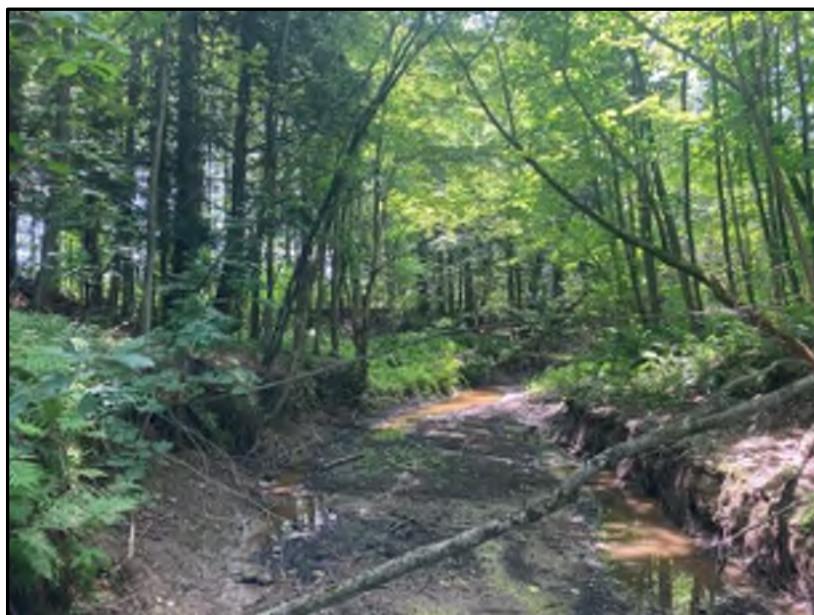
**Photo 18:** Area of Section EE, facing south and located along the Johnston municipal drain. The slope face was observed to be vegetated with brush, and heavily covered with mature trees. Undercutting and erosion was observed along the watercourse alignment. The undercutting and erosion generally resulted in the exposure of some tree roots and may have contributed to several trees to have fallen. The remaining slope surface appeared to be stable, however, did not have mature vegetation intact at the time of our visit.

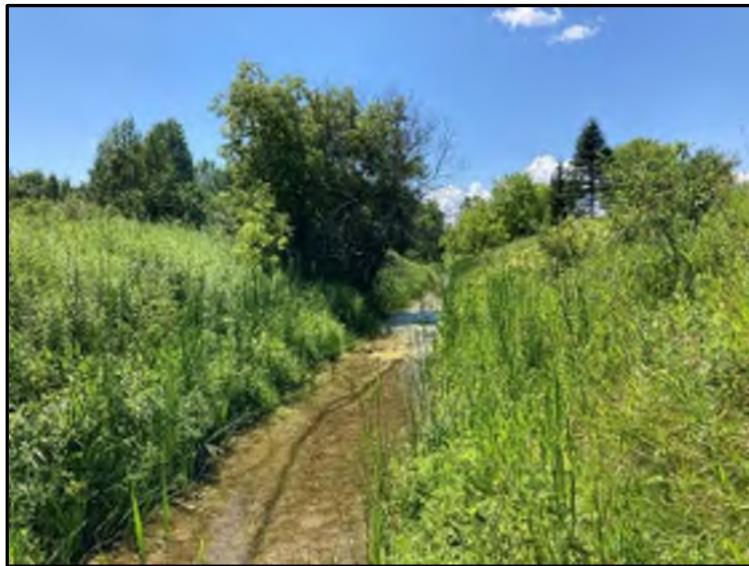
**Photo 19:** Area of Section GG facing northwest and located along the Johnston municipal drain. The slope face was observed to be heavily vegetated with brush and mature trees. No notable erosion was observed in this area. The area of Section GG was further observed to have a slope height of 2.4 m and an approximate steepness of 2.4H:1V.

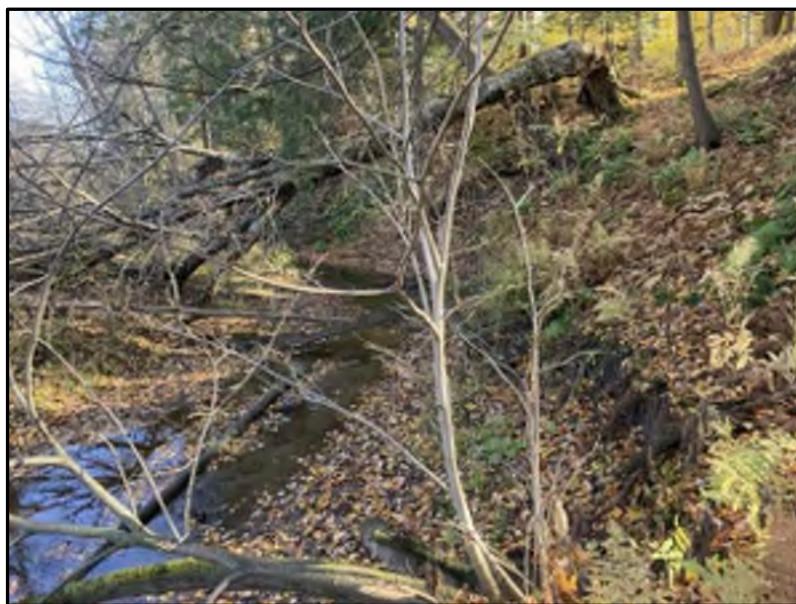
**Photo 20:** Area of Section CC and facing north. The slope face was observed to be slightly covered in vegetation and tree roots. Signs of erosion consisting of bare soil with lack of mature vegetation and undercutting along the channels edge was observed along some portions of the toe of the slope. The area of Section CC was further observed to have a slope height of 4.1 m and an approximate steepness of 6.6H:1V. (Photo taken October 2022)

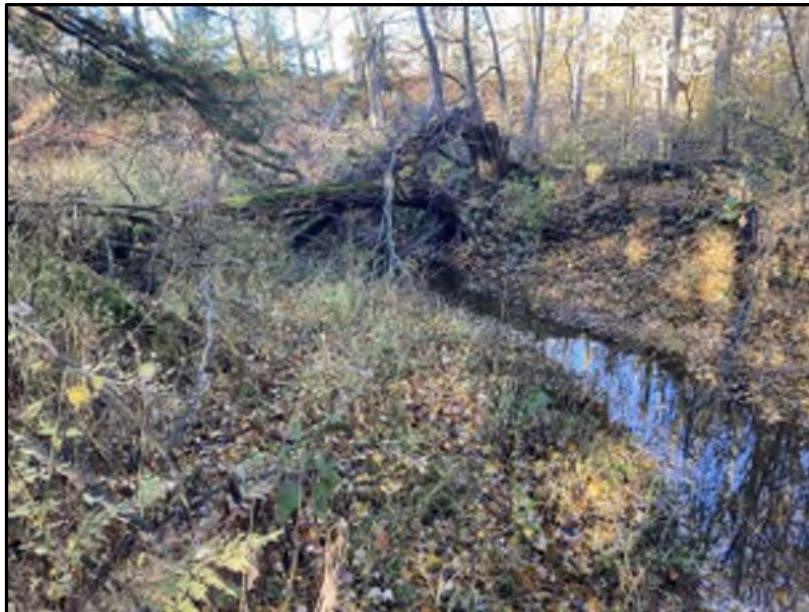
**Photo 21:** Area south of Section W and facing south. The slope face was observed to be covered with brush and mature trees. Signs of erosion consisting of bare soil with lack of mature vegetation and undercutting along the channels edge was observed along some portions of the toe of the slope. (Photo taken October 2022)

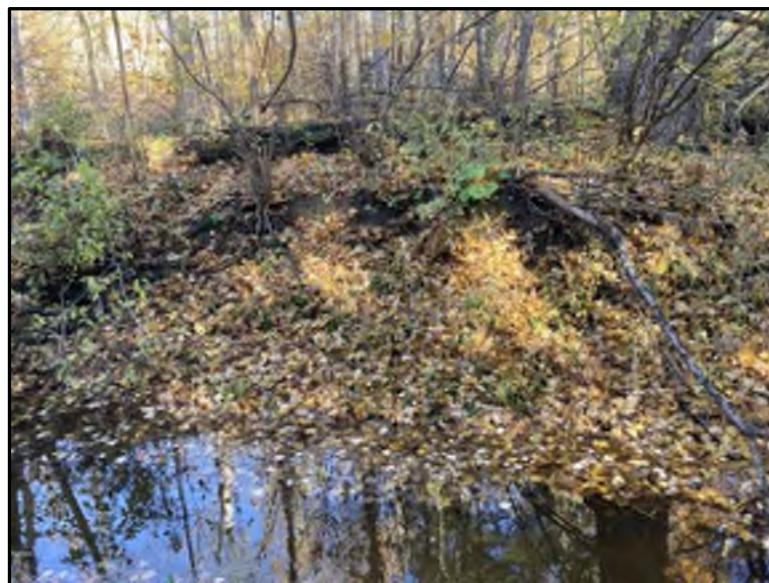
**Photo 22:** Area west of Section BB and facing southwest. The slope face was observed to be surfaced with vegetation consisting of brush and mature trees. Small slip surfaces were observed in proximity to the watercourse. Further, the toe of slope in proximity to the slip surfaces were observed to consist of bare soil lacking mature vegetation. The remainder of the slope surface appeared to be stable and be surfaced with mature vegetation (Photo taken October 2022).
