Bear Brook and Ramsay Creek Watersheds Fluvial Geomorphological Study

Existing Conditions Summary Report
Tewin Lands

December 12, 2024

GEO Morphix Project No. 21063

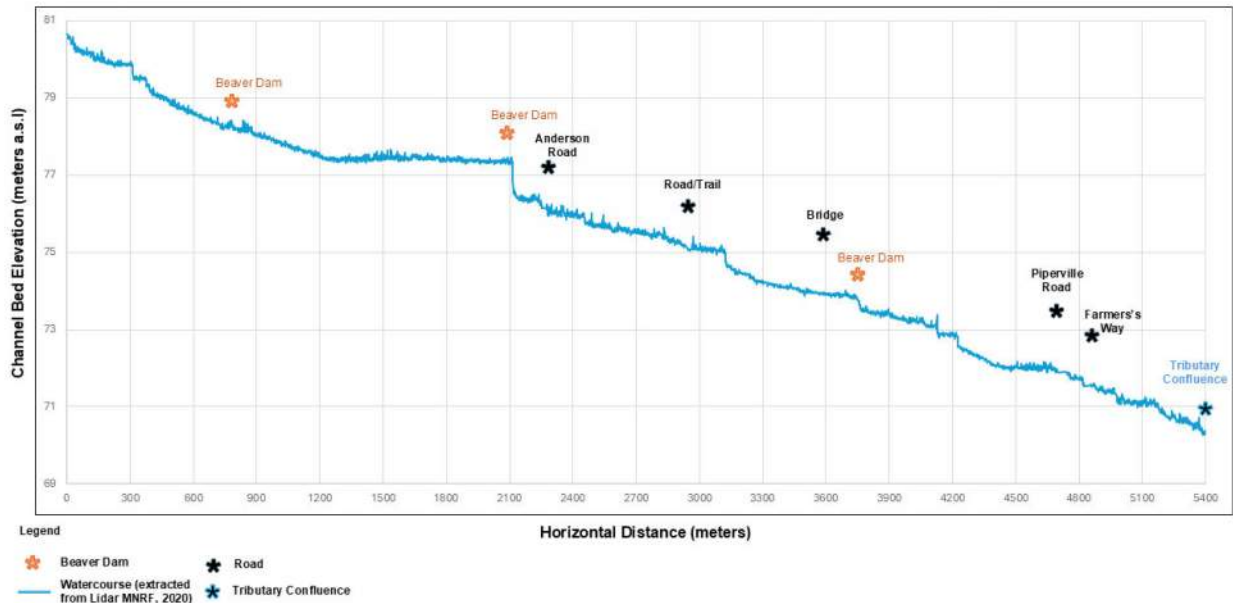
Figure 2. Longitudinal Profile of Bear Brook North Branch

Overall, the longitudinal profiles along the main branch of Bear Brook exhibited the greatest change in slope around beaver dams, crossings, and tributary confluences. Generally, the areas with relatively lower gradients tended to precede beaver dams, most likely due to the deposition caused by backwatering and slower flows, as observed in the field assessments summarized in Section 3.

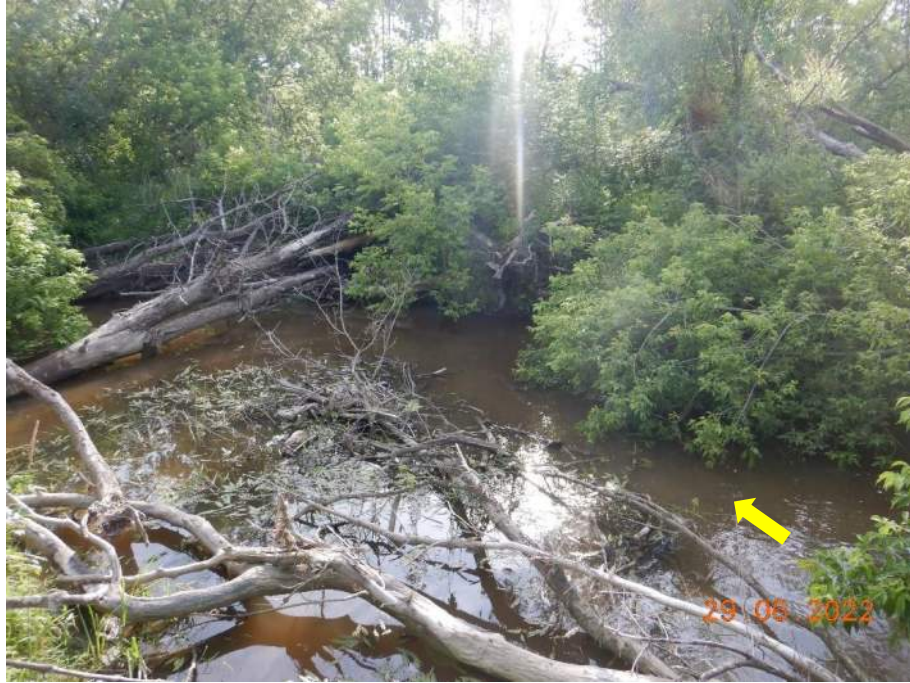
Photo 1
Bear Brook: BB1

The feature was well defined with multiple large woody debris jams and fallen trees in the channel, most likely due to a recent storm. Riparian vegetation composed of mature hardwoods and shrubs.

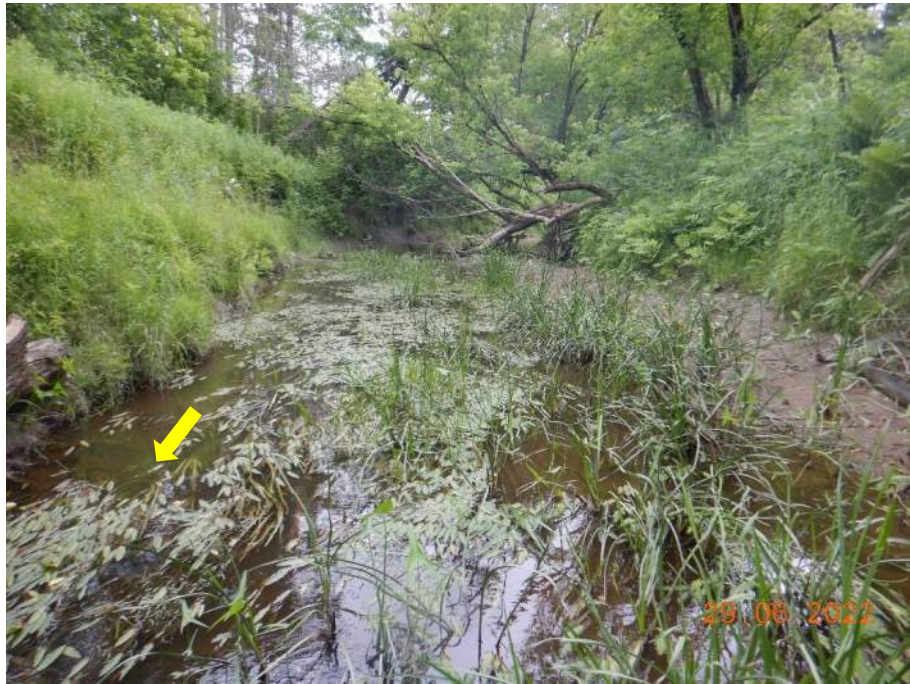
Photo 2
Bear Brook: BB2

The feature was well defined with riparian vegetation consisting of ferns, grasses, and mature hardwoods. Instream vegetation was common.

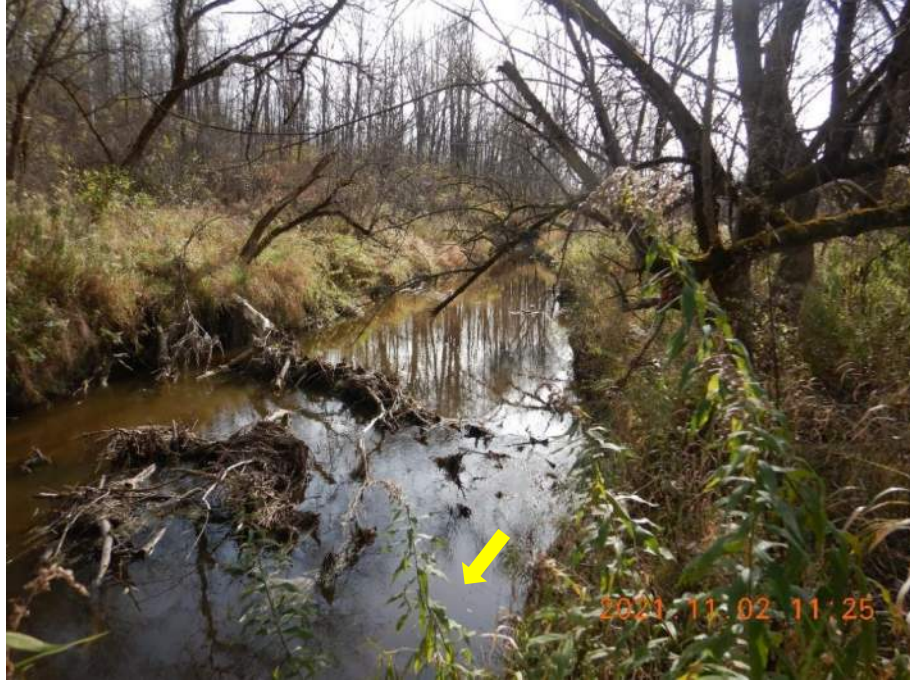
Photo 3
Bear Brook: BB3

The feature channel contained several debris jams associated with old beaver dams. Riparian vegetation consisted of mature trees.

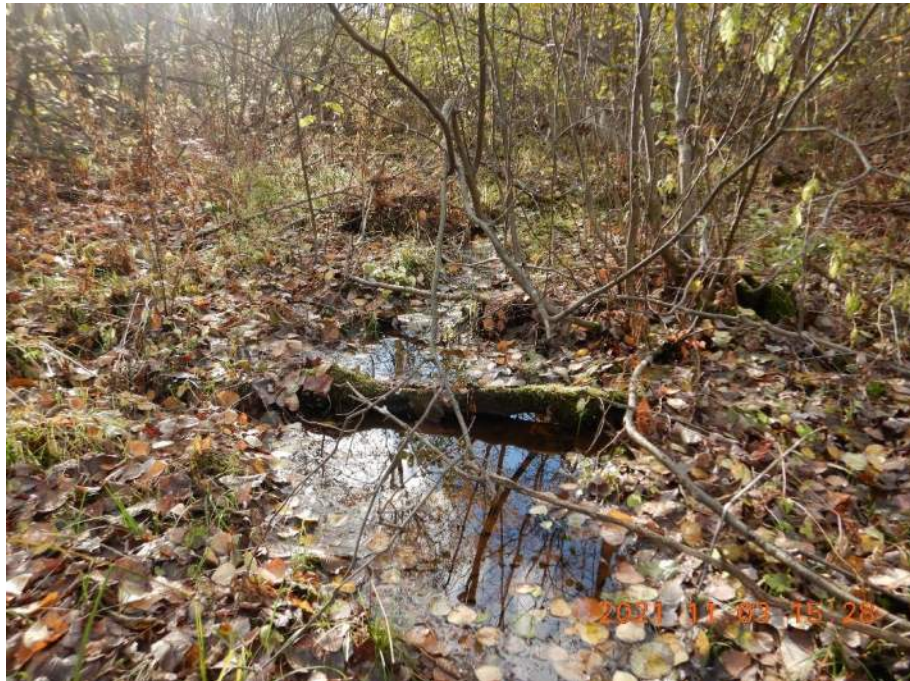
Photo 4
Bear Brook: BB3 1

The feature was defined with multiple culverts throughout the reach. Riparian vegetation consisted of grasses and small hardwoods.

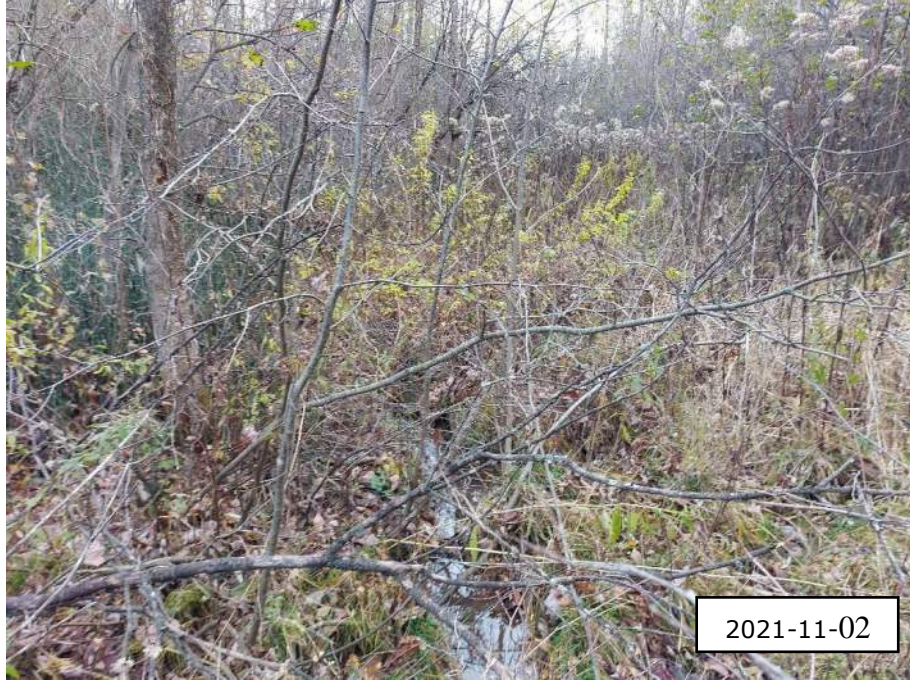
Photo 5
Bear Brook: BB3 2

Feature lacked definition and was dry in some areas. Riparian vegetation consisted of grasses and hardwoods.

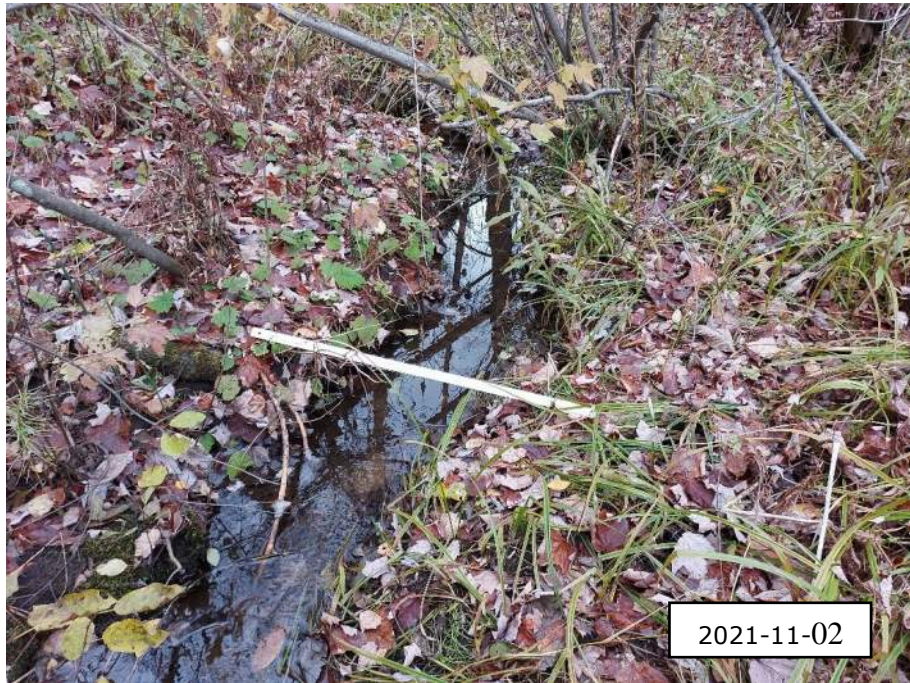
Photo 6
Bear Brook: BB3 3

Feature was narrow and defined with riparian vegetation consisting of grasses and immature hardwoods.

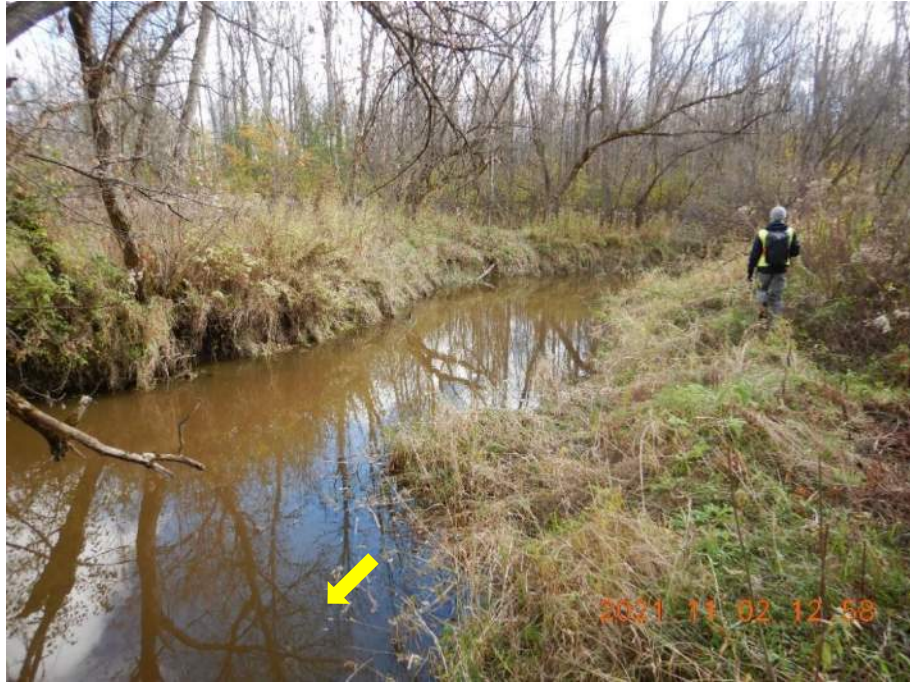
Photo 7
Bear Brook: BB4

Riparian vegetation consisted of grasses and hardwoods; several debris jams associated with beaver dam.

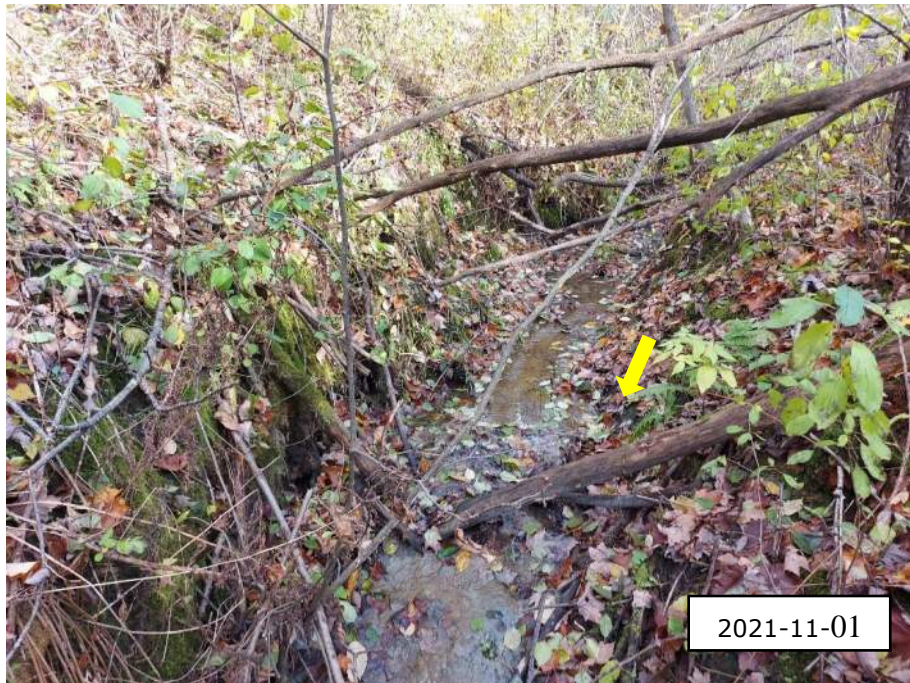
Photo 8
Bear Brook: BB4 2

Channel was well defined. Undercutting was common and riparian vegetation consisted of grasses and hardwoods.

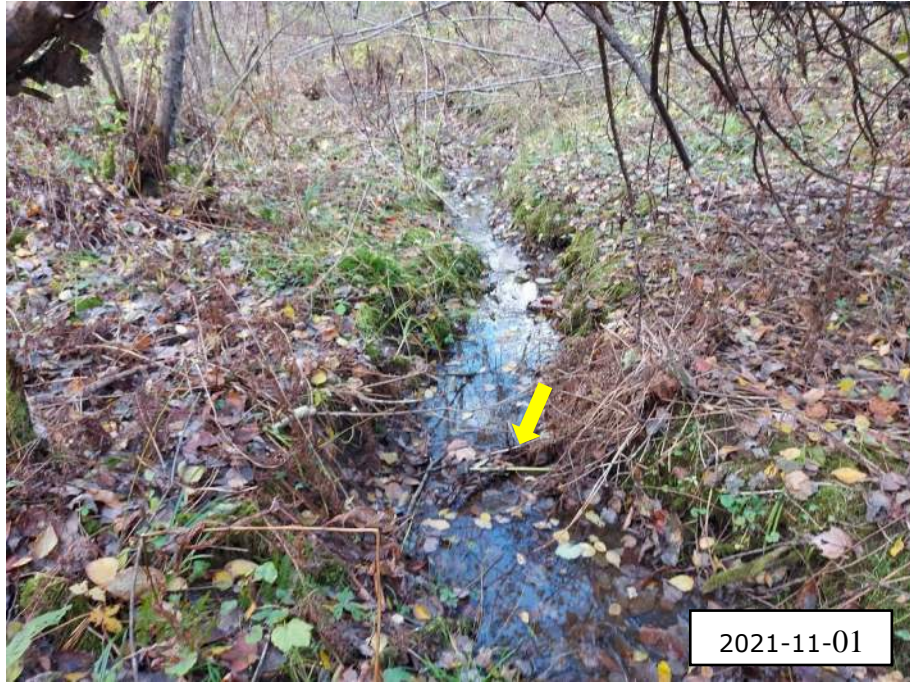
Photo 9
Bear Brook: BB4 2A

Channel flows through unconfined valley. Riparian vegetation consisted primarily of mature hardwoods and immature grasses.

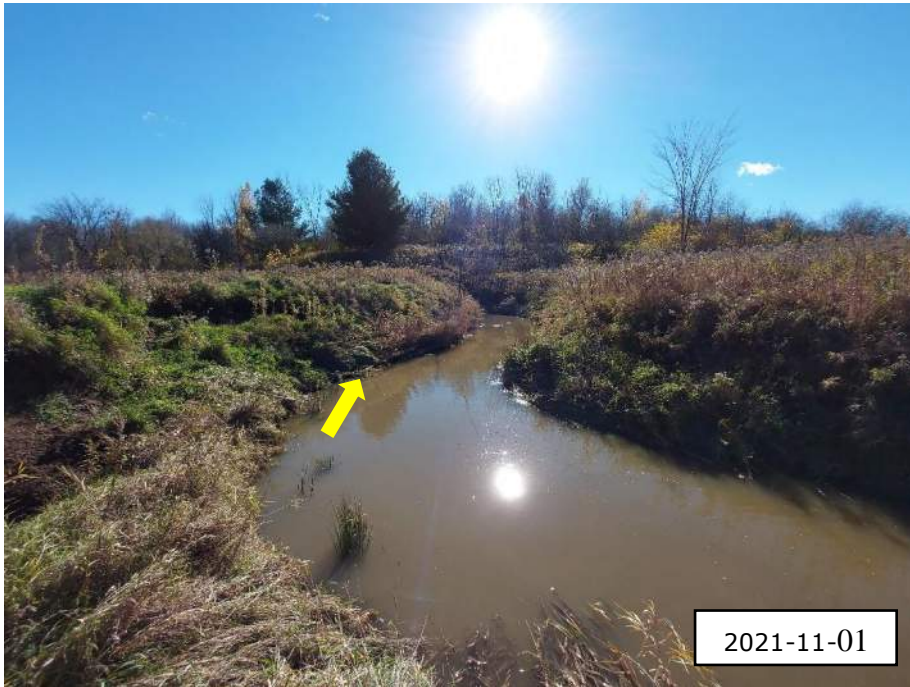
Photo 10
Bear Brook: BB5

The feature was well defined, and several debris jams were present. Undercutting and slumping was common.

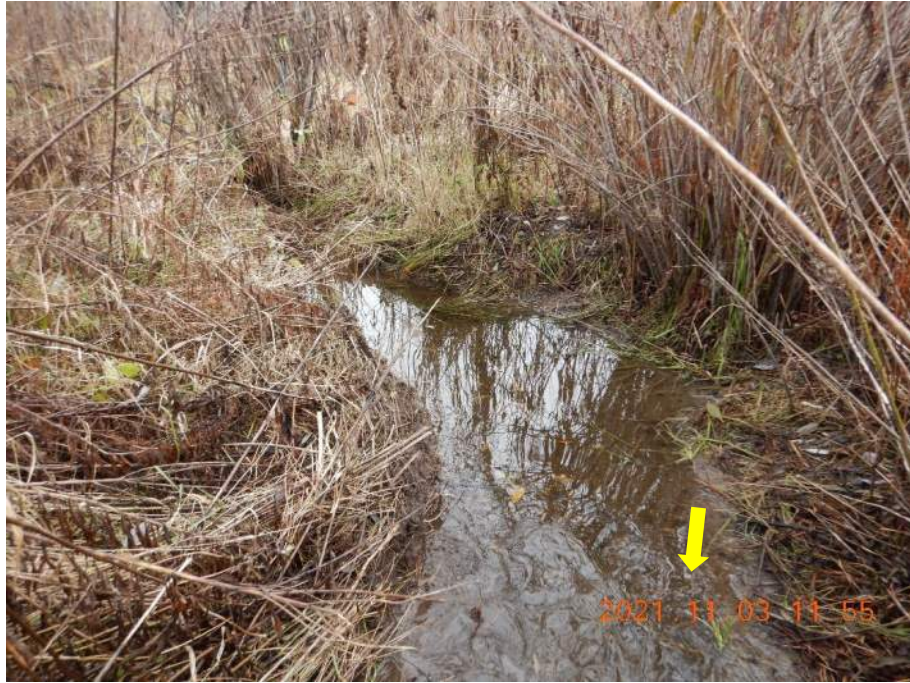
Photo 11
Bear Brook: BB5 1

Feature was poorly defined with riparian vegetation consisting of grasses and shrubs.

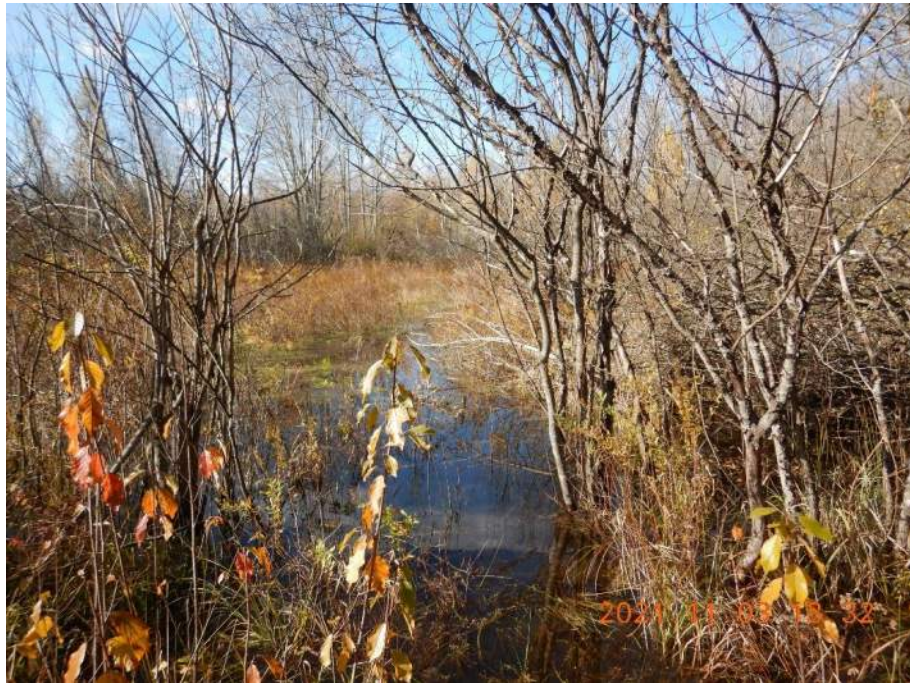
Photo 12
Bear Brook: BB5 1 1

Channel was poorly defined, riparian vegetation primarily mature shrubs and immature grasses.

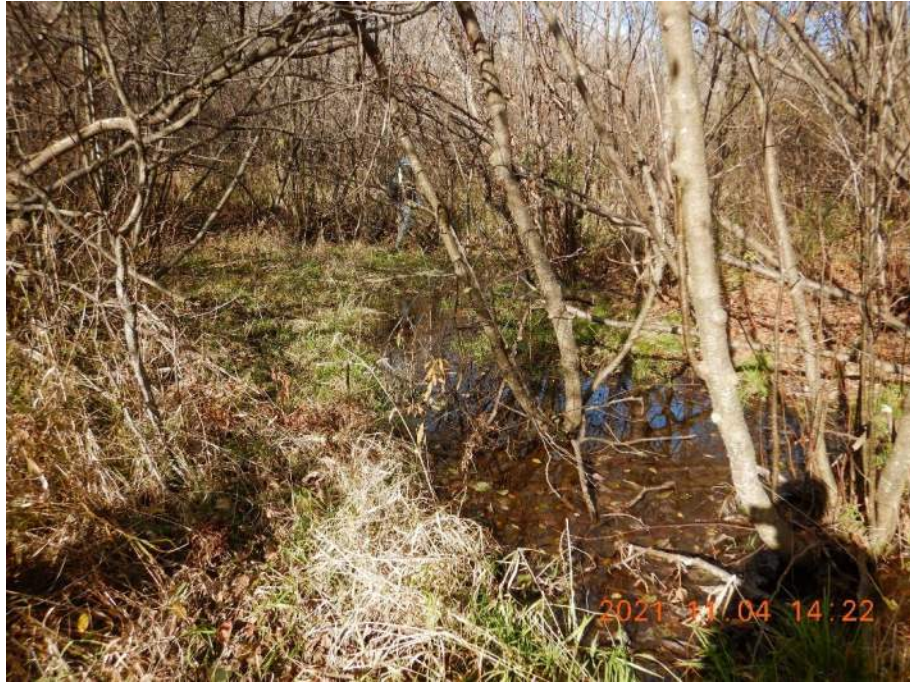
Photo 15
Bear Brook: BB5 3

Channel had poor definition and several beaver dams were present. Cattails and grasses were present in the channel adjacent to beaver dams.

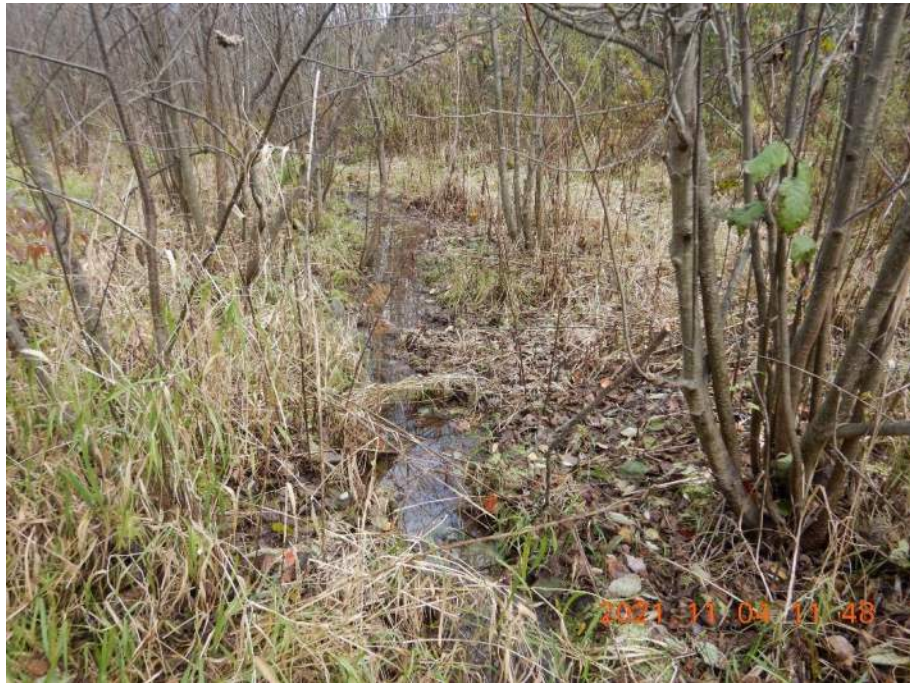
Photo 16
Bear Brook: BB5 4

Channel was a poorly defined swale, with mature trees and immature grasses in the riparian zone.

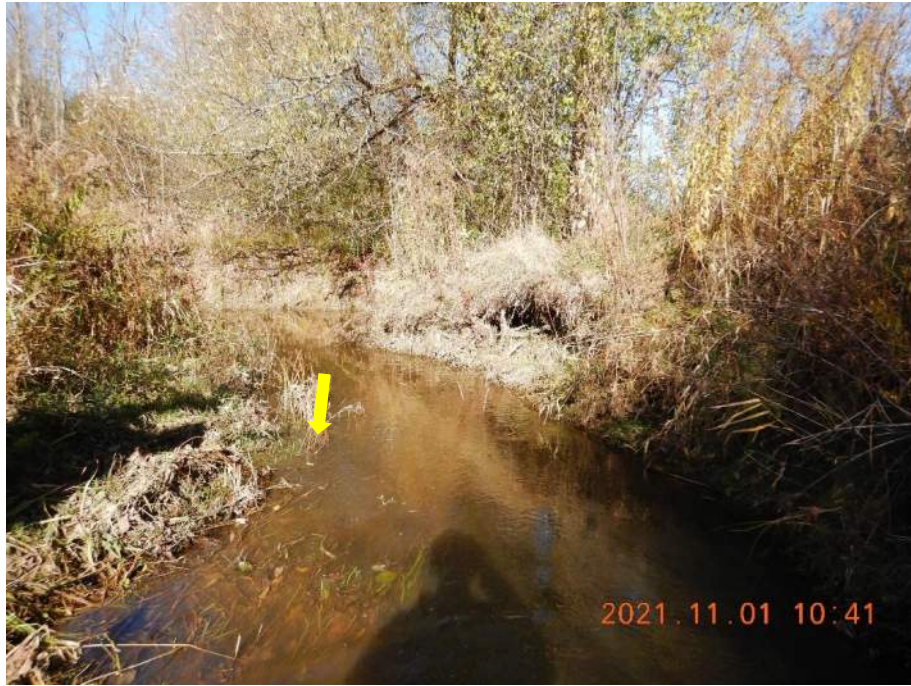
Photo 17
Bear Brook: BB5 5

The featured conveyed flows through a woodlot, riparian vegetation consisted of mature trees. Slumping, undercutting and scour common.

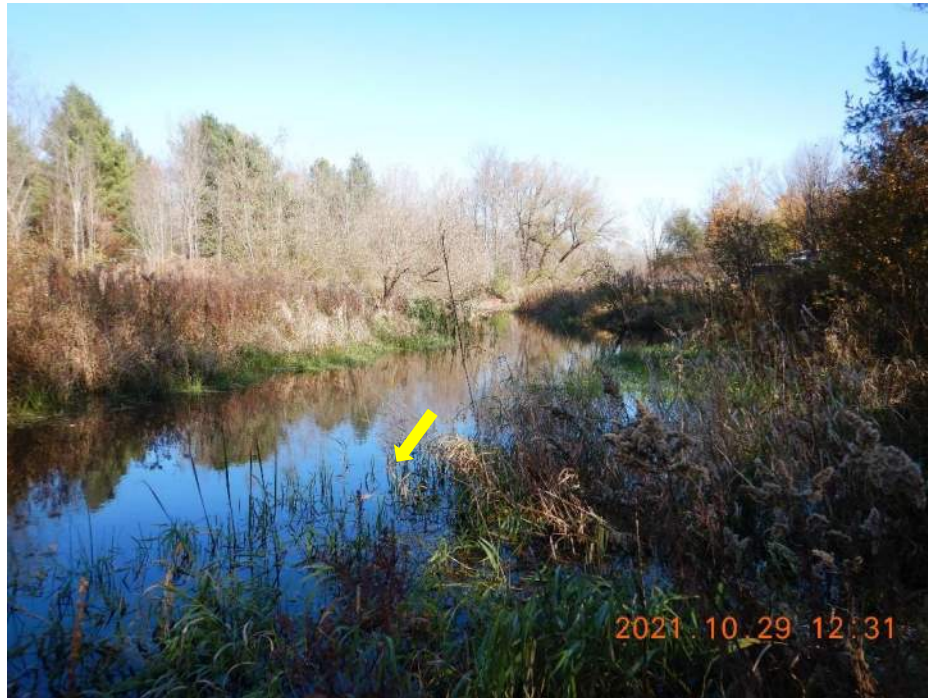
Photo: 18
Bear Brook: BB5 5A

The featured lacked definition due to backwater from an upstream beaver dam. Riparian vegetation consisted of mature trees.

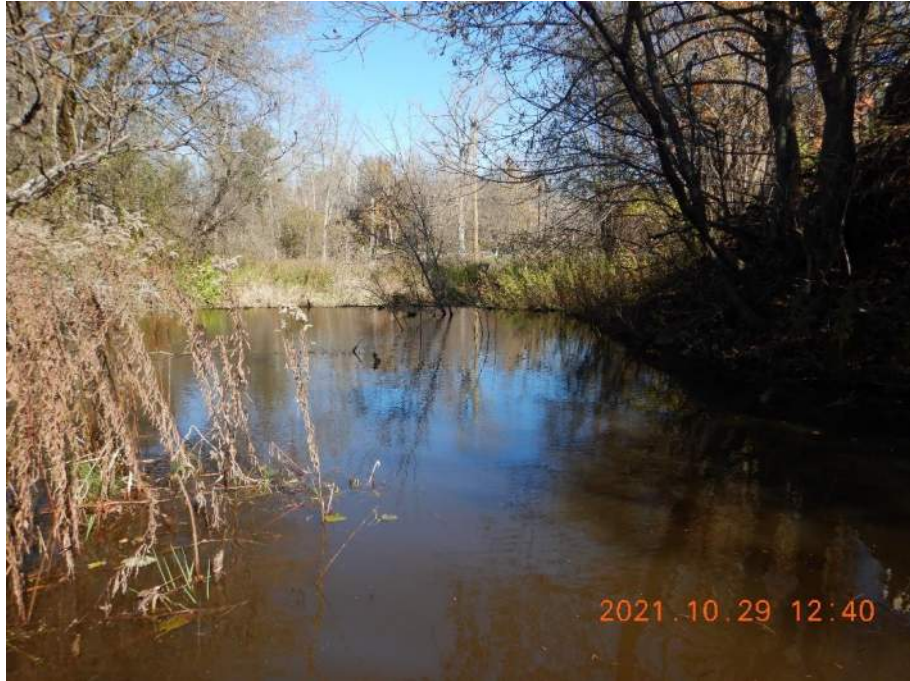
Photo: 19
Bear Brook: BB5 5A 2

Woody debris jams present, bank angle 5-30% through mid to upstream extent, erosion predominant at downstream extent

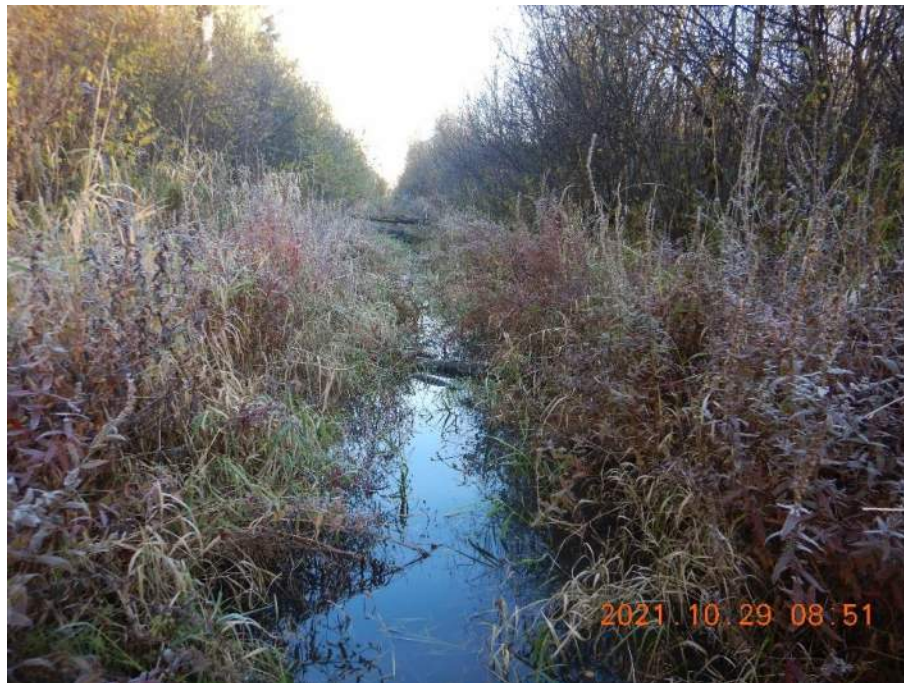
Photo: 21
Bear Brook: BB5 5A 3 1A

Riparian vegetation consisting of grasses and shrubs, low entrenchment identified.

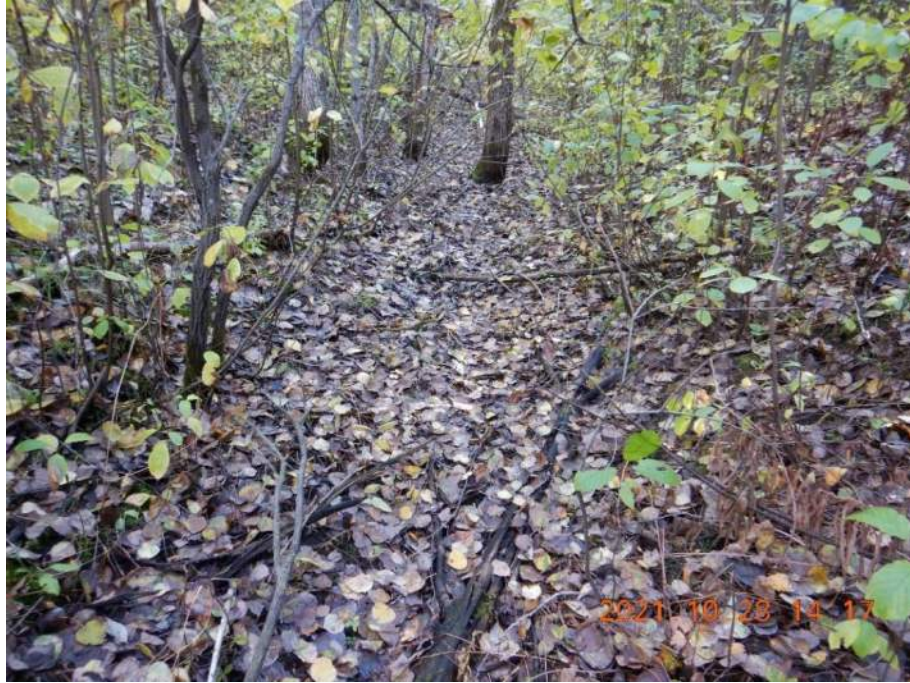
Photo: 24
Bear Brook: BB5 5A 3B 1

The feature was primarily dry during visit, and channel lacked definition. Flows conveyed through a woodlot.

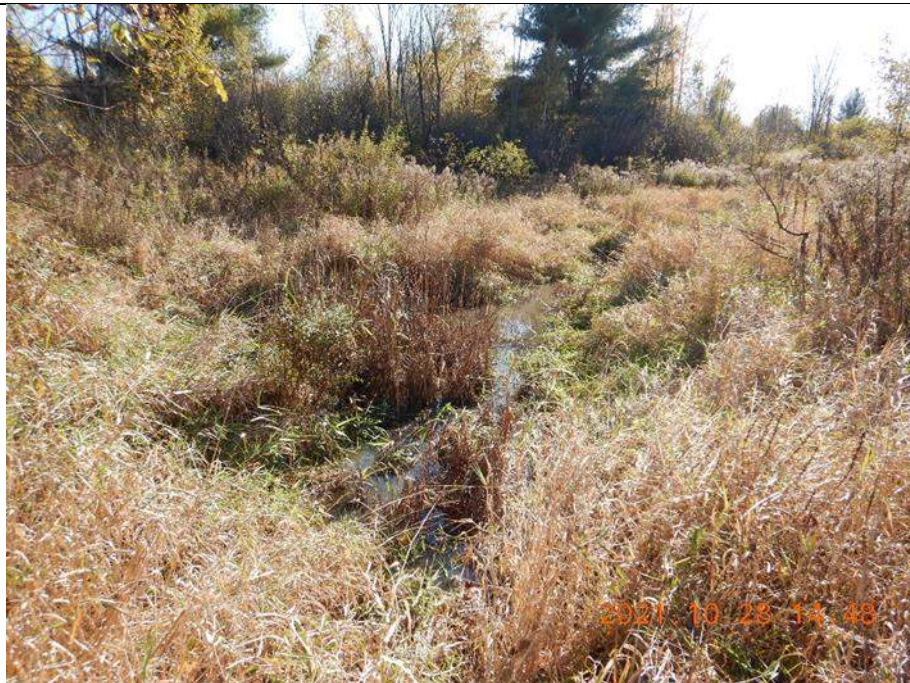
Photo 25
Bear Brook: BB5 5A 3B 2

The feature conveyed flows through an online wetland and lacked bank definition.

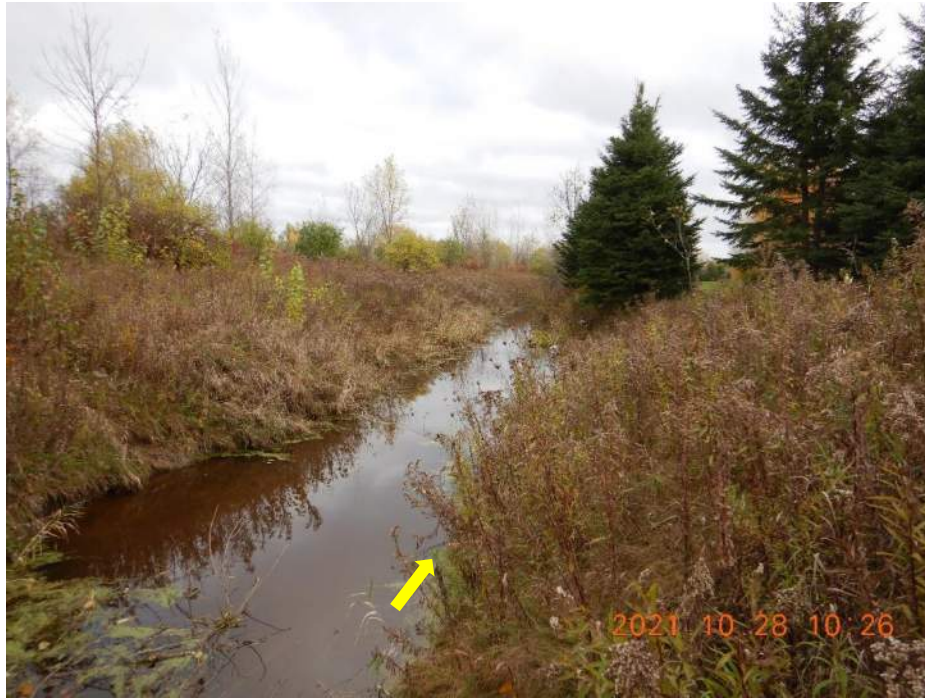
Photo 26
Bear Brook: BB5 5A 3C

Evidence of enlarging, erosion and minor adjustment may be related to beaver activity

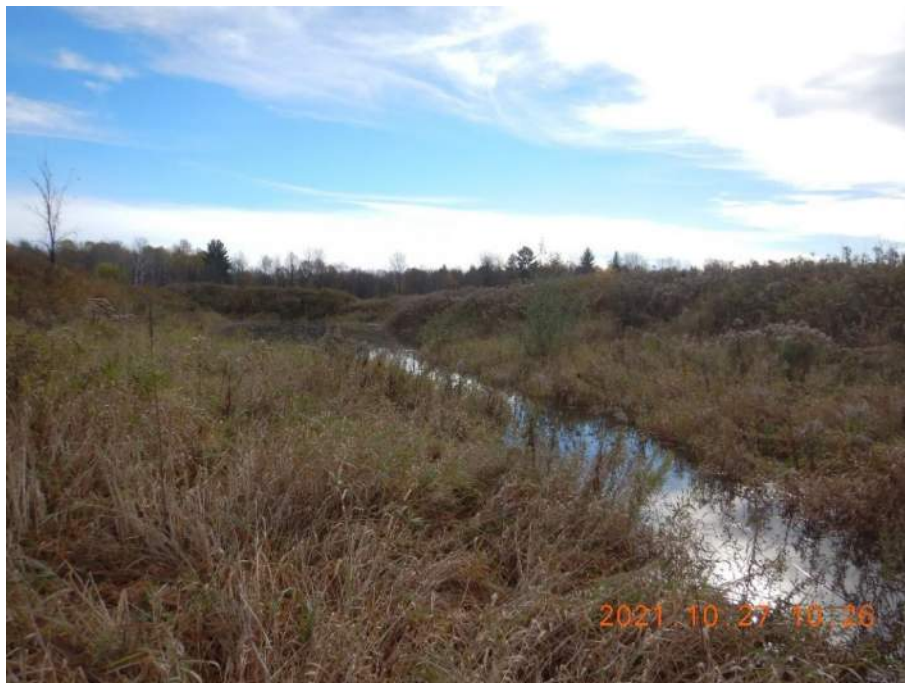
Photo 29
Bear Brook: BB5 5C

Feature was characteristics of a large agricultural swale with multiple flow paths along the reach.

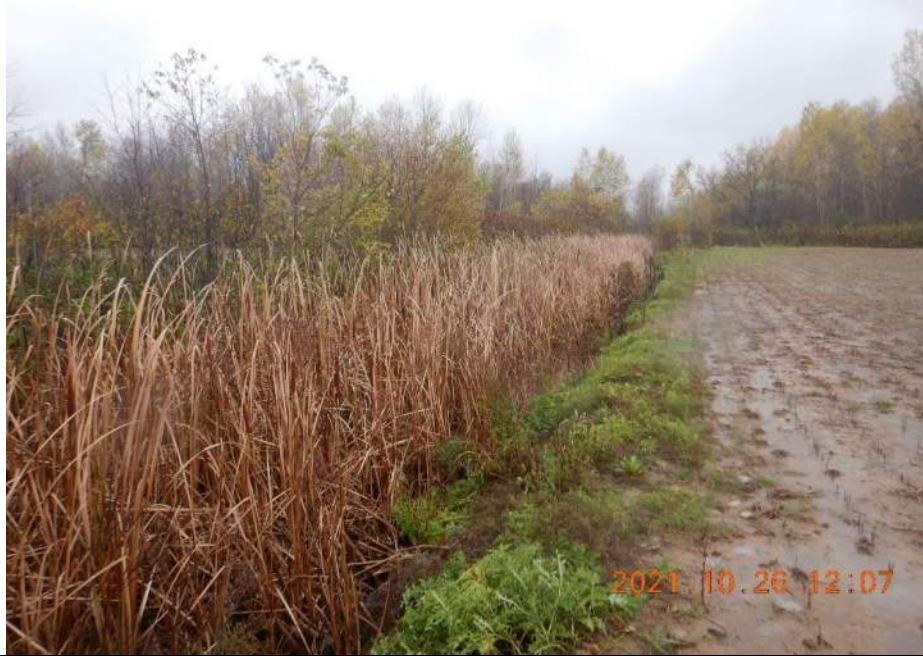
Photo 30
Bear Brook: BB5 5C 1

Feature was characteristic of a large agricultural swale along the reach and was modified due to agricultural activities. Lacked defined banks and flow paths along the reach.

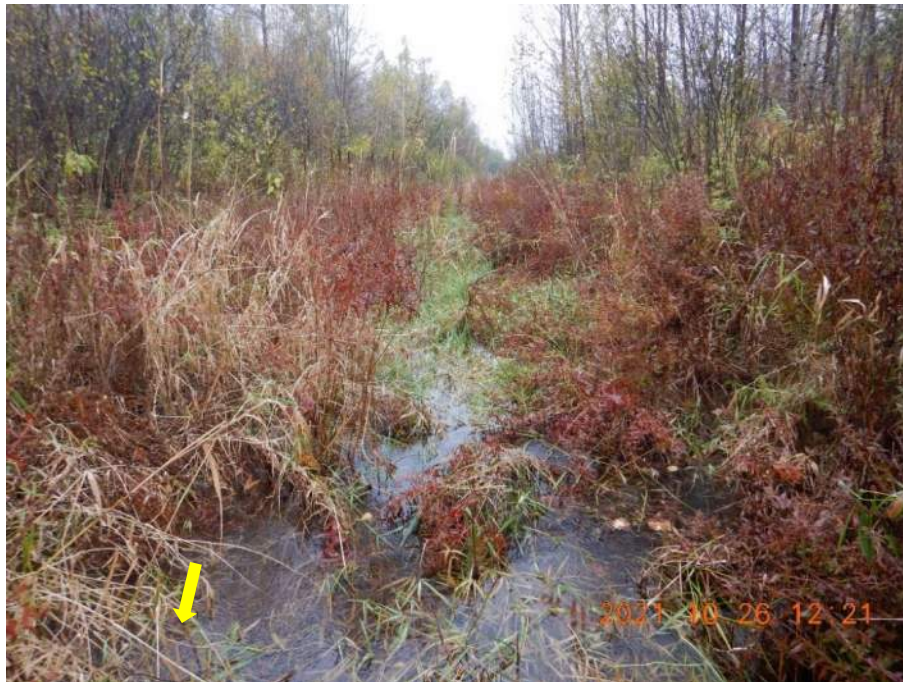
Photo 31
Bear Brook: BB5 5C 1A

The reach was characteristic of a large swale, with accumulation of organics in the channel. Riparian vegetation consisted of grasses and shrubs.

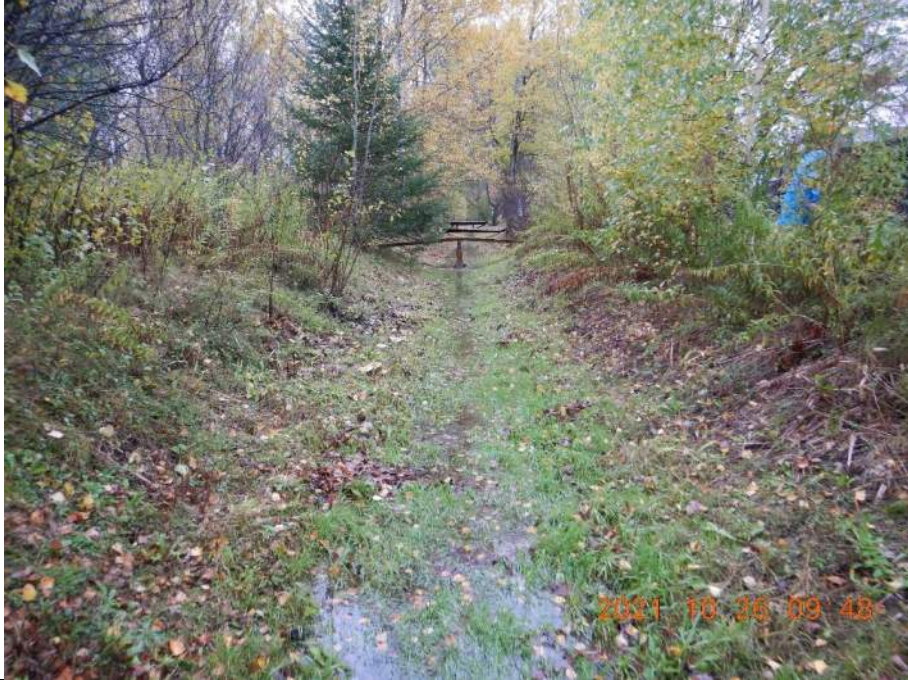
Photo 32
Bear Brook: BB5 5C 1A 1

The feature was ditch-like with many foot bridge crossings. The channel appeared to be straightened and received flows from several storm drains/culverts connected to residential homes

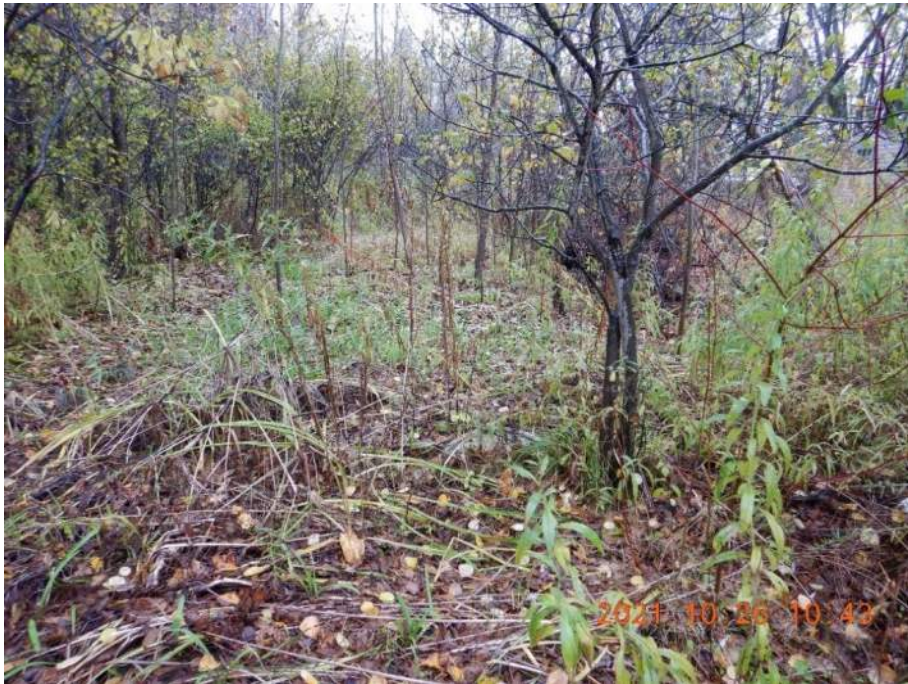
Photo 33
Bear Brook: BB5 5C 1A 2

100% runs, agricultural swale. Poorly defined with little geomorphic activity

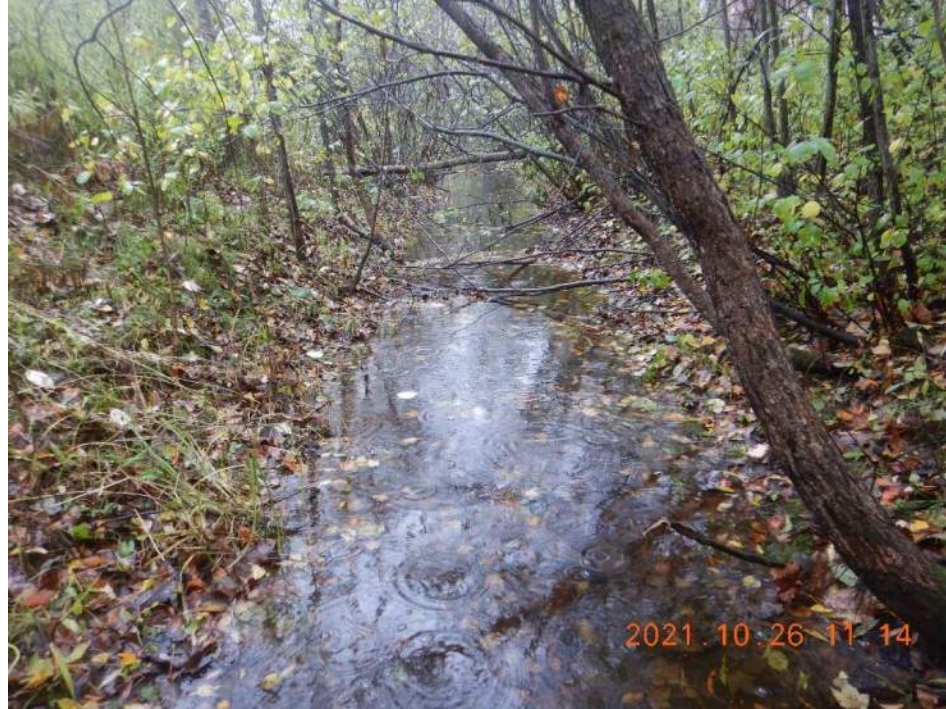
Photo 34
Bear Brook: BB5 5D

The feature showed signs of perennial flows, riparian vegetation consisted of trees and shrubs.

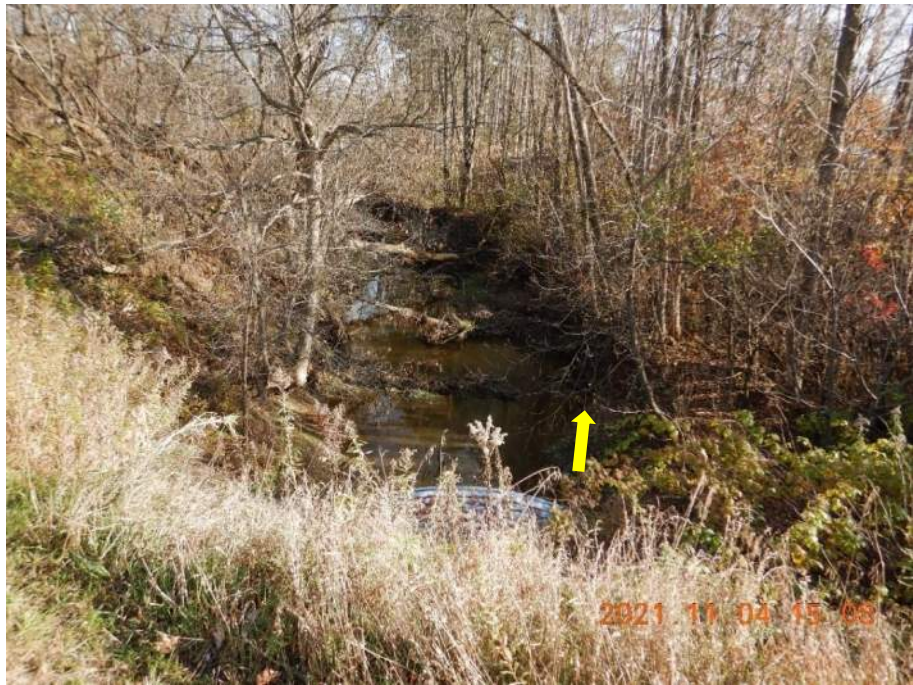
Photo 37
Bear Brook: BB7

Limited channel access. Reach appeared to have some undercutting and riparian vegetation consisted primarily of hardwoods.

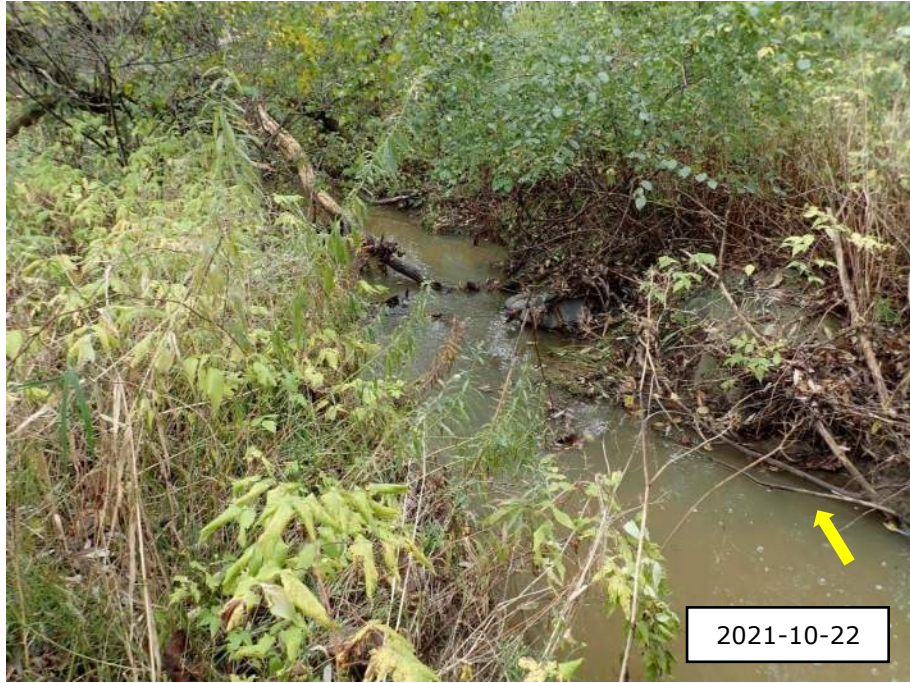
Photo 38
Bear Brook: BB8 1

Channel travels through partially confined valley. Leaning trees and erosion was common throughout the reach.

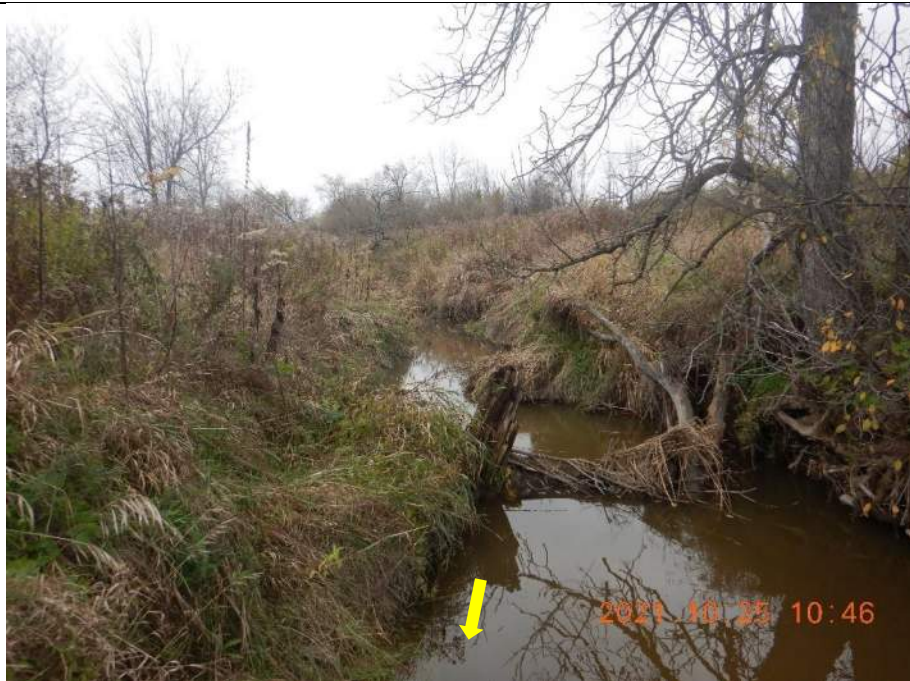
Photo 41
Bear Brook: BB9

The feature was backwatered due to an upstream beaver dam. Riparian vegetation was composed of grasses. The feature runs parallel to agricultural fields.

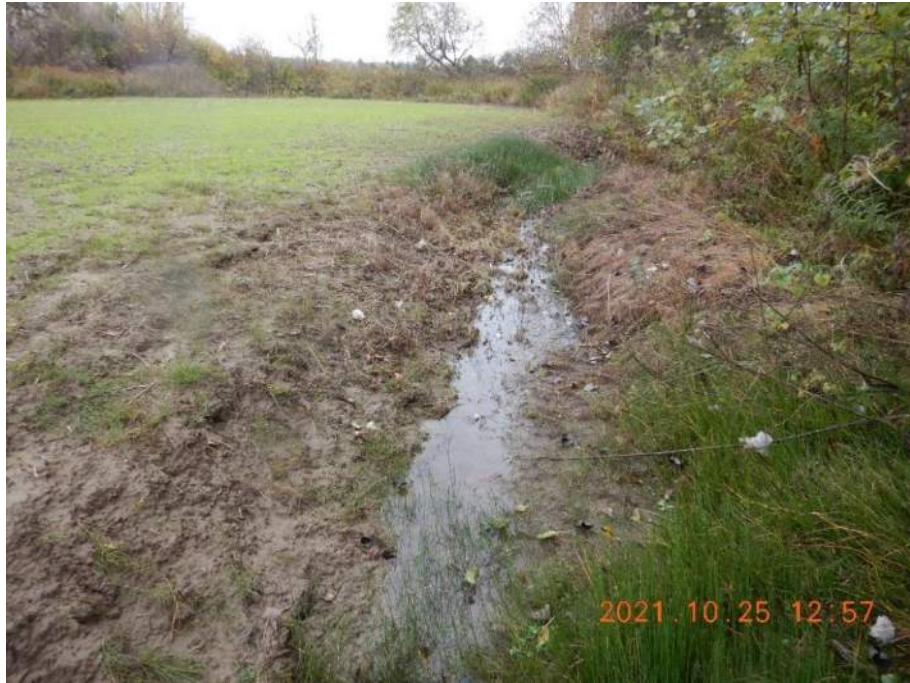
Photo 42
Bear Brook: BB9 1

The feature was poorly defined and lacking banks. Feature runs through an agricultural field.

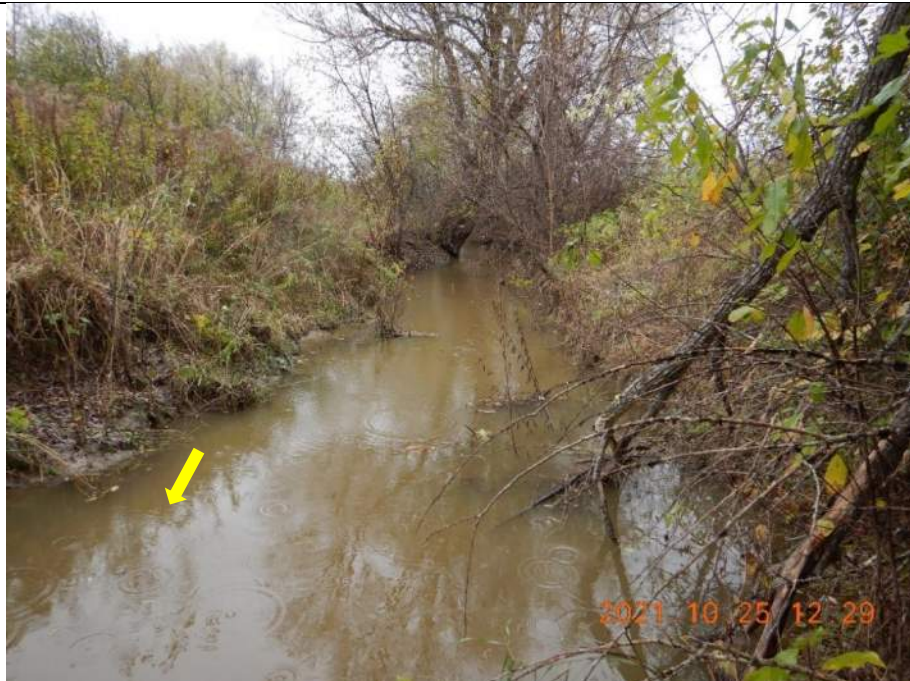
Photo 43
Bear Brook: BB10

The feature was located downstream from a golf course. Channel was well defined and entrenched.

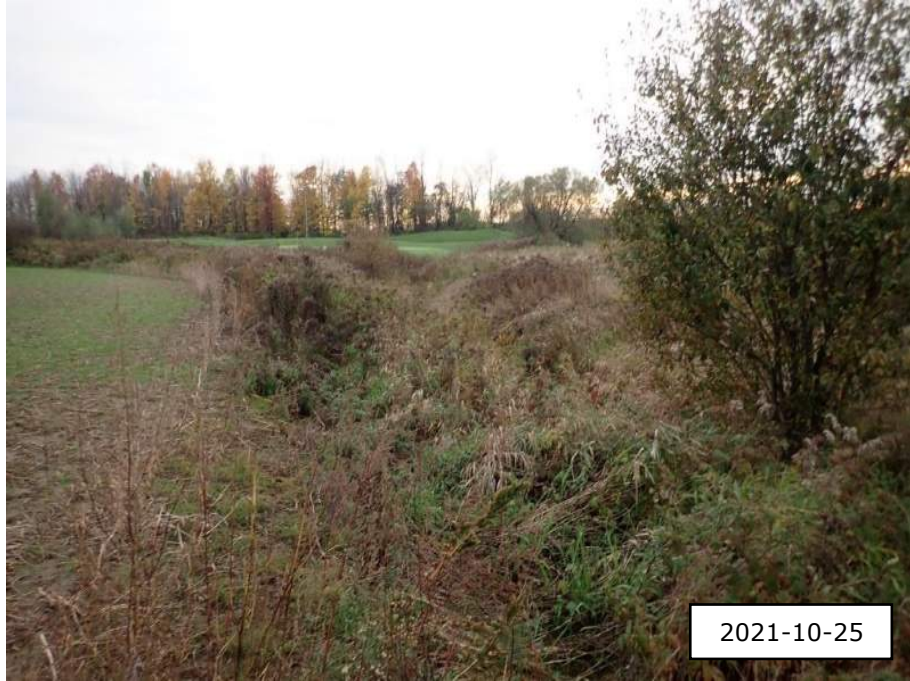
Photo 44
Bear Brook: BB10 1

The feature was well defined, and conveyed flows through an agricultural field and the southeastern corner of a golf course.
