Bear Brook and Ramsay Creek Watersheds Fluvial Geomorphological Study

Existing Conditions Summary Report
Tewin Lands

December 12, 2024

GEO Morphix Project No. 21063

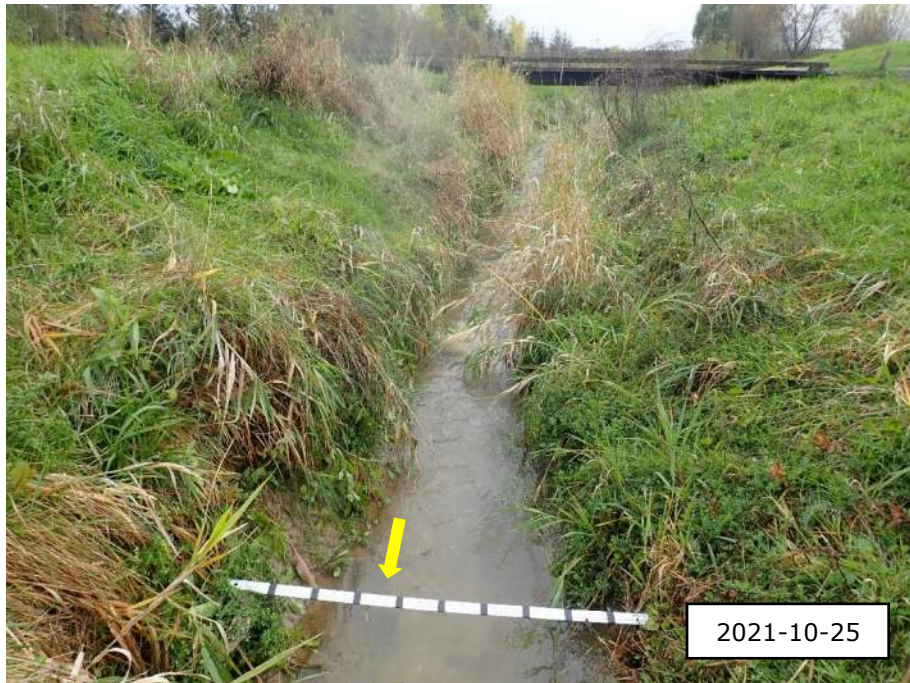
Photo 45
Bear Brook: BB10 1A

Narrow channel conveying flows through an active golf course. Riparian vegetation primarily landscaped grass.

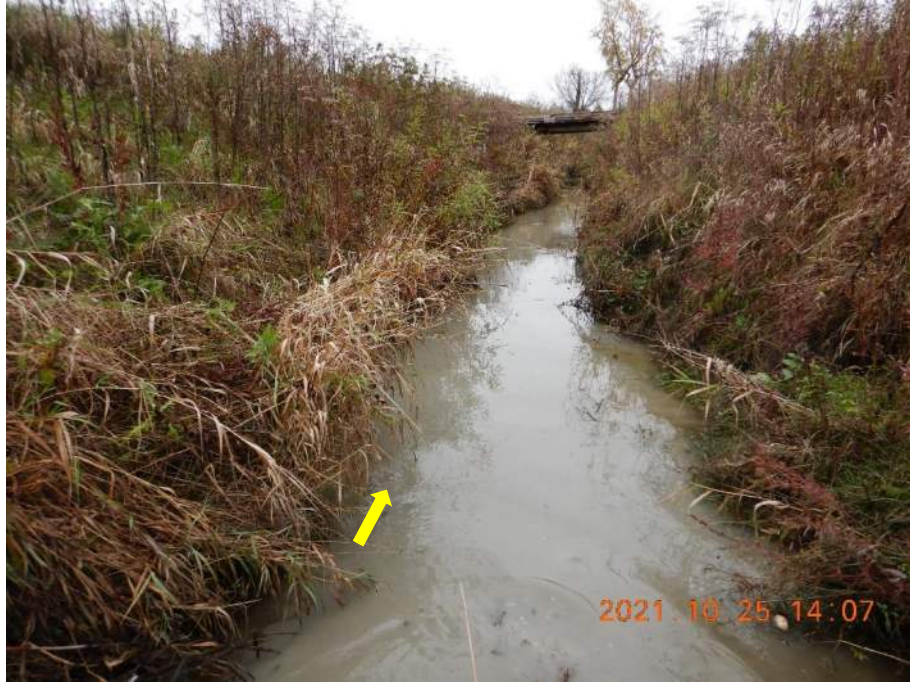
Photo 48
Bear Brook: BB12

Conveyed flows tranverse through grassland. Channel was defined and riparian vegetation consisted of grasses.

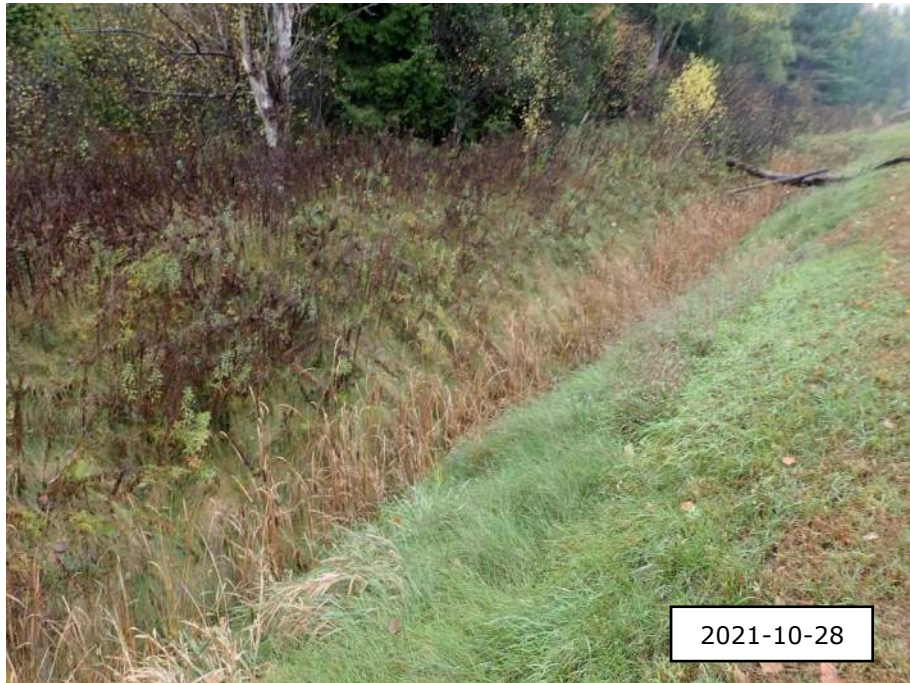
Photo 49
Bear Brook: BB12 1

Channel identified as a roadside ditch with near uniform channel geometry. Riparian vegetation consisted of grasses and hardwoods.

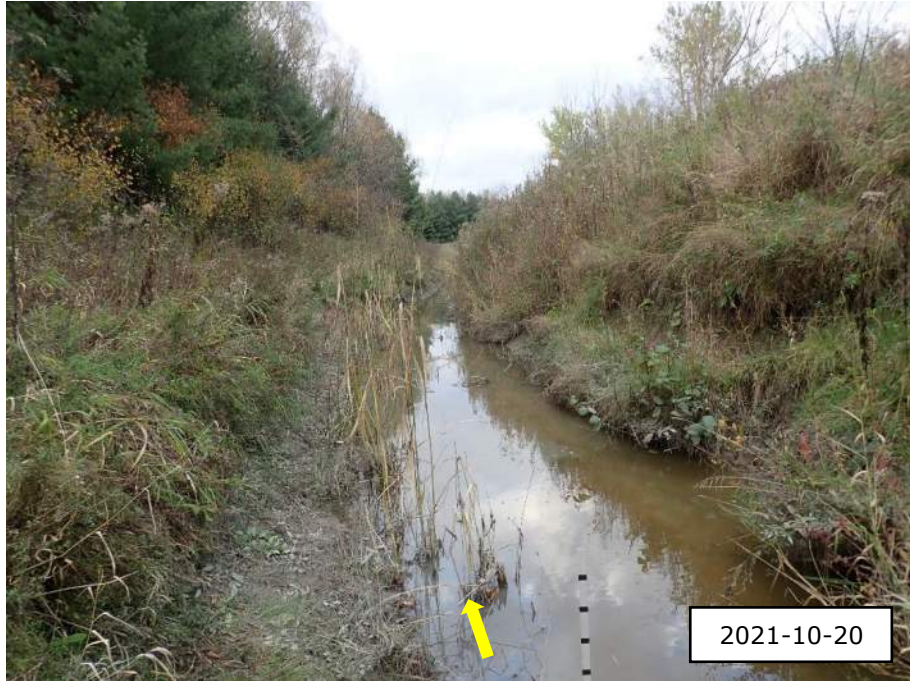
Photo 50
Bear Brook: BB13

Partially straightened throughout the reach. Slumping and vegetated islands common along the reach. Riparian vegetation was primarily grasses.

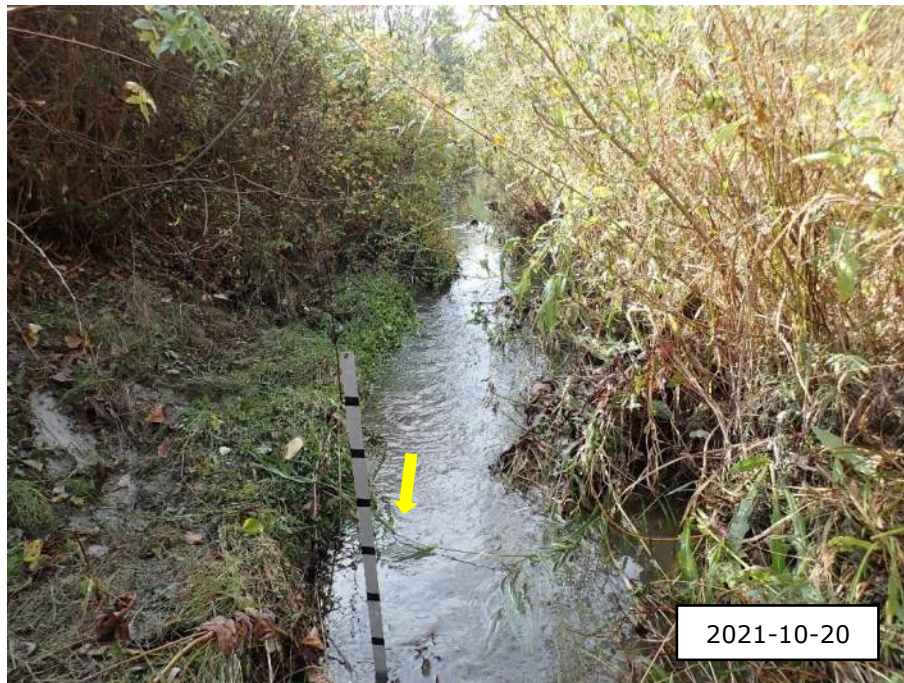
Photo 53
Bear Brook:BB16

Straight ditched channel with mostly runs. Riparian vegetation was primarily grasses.

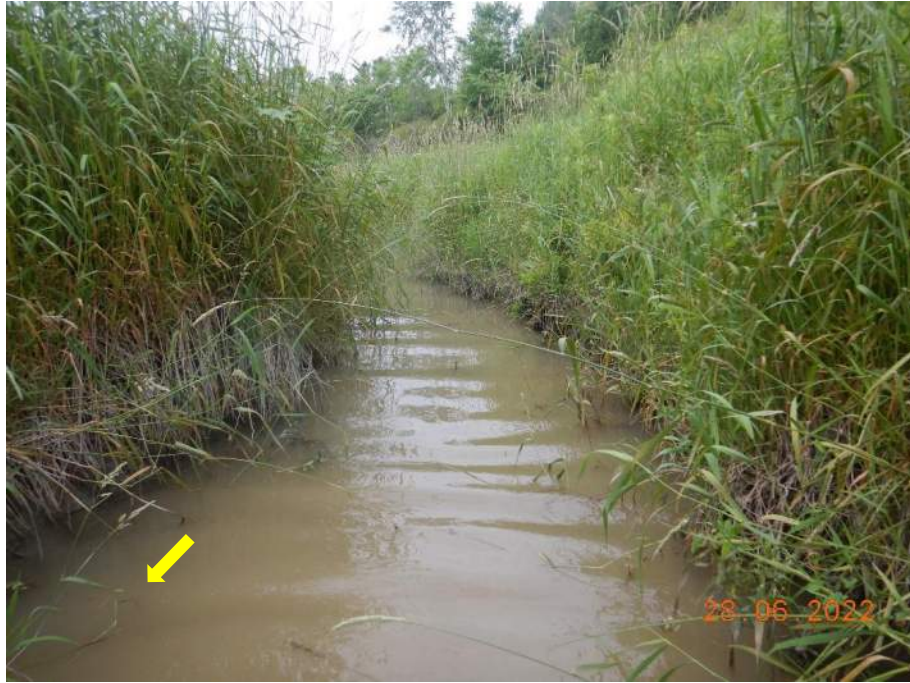
Photo 54
Ramsay Creek: RC1

| 2022-06-28 | RC1 | Clay, silt, sand, gravel, cobble | Clay, silt, sand | Undercutting, banks slumping | Unconfined | 0.28 | In Transition | WI | 16 | Fair | Riparian habitat conditions, channel stability | 2.17 | 2.08 | 60-90 | 60-100% | Grasses | Rooted floating | Entrenched channel, high banks with tall grasses |

Conveyed flows through large grassland. Channel entrenchment and bank slumping were evident. The yellow arrow indicates the direction of flow where possible

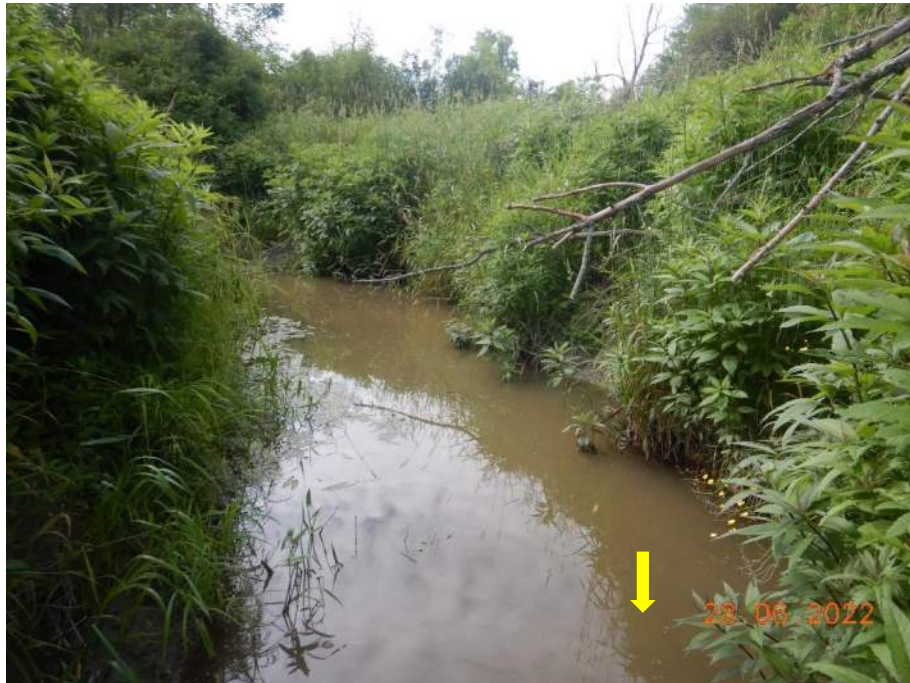
Photo 55
Ramsay Creek: RC2

| 2022-06-28 | RC2 | Clay, silt, sand, gravel, cobble | Clay, silt, sand | Undercutting, slab failure, rotational slip and slump | Unconfined | 0.38 | In Transition | WI | 15 | Fair | Riparian habitat conditions, channel stability | 7.09 | 1.45 | 60-90 | 60-100% | Grasses | Rooted floating | Heavy vegetation encroachment |

Channel was entrenched. Riparian zone consisted primarily of tall grasses. Bank slumping was evident.

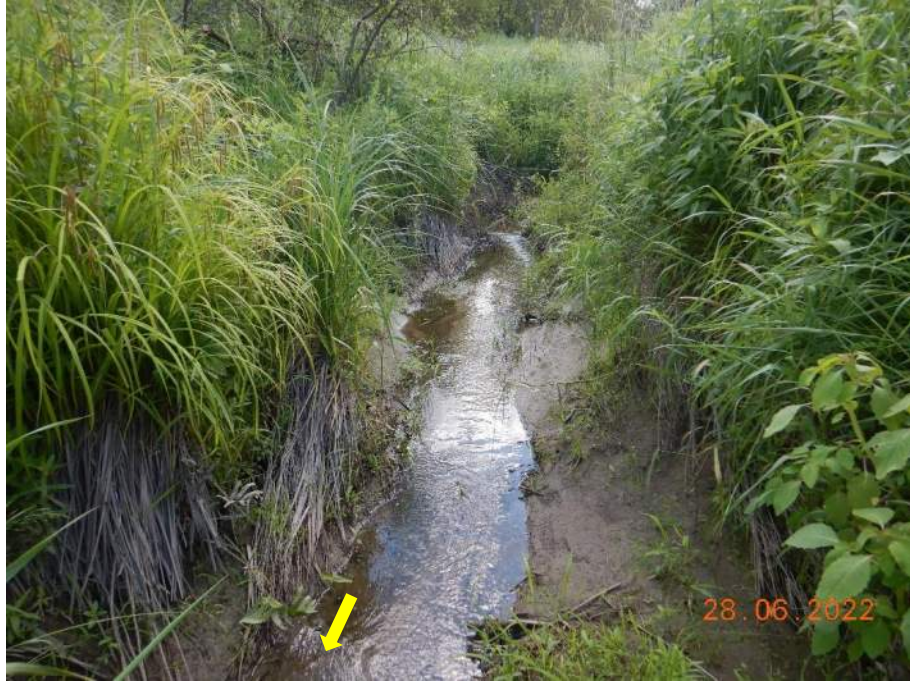
Photo 56
Ramsay Creek: RC3

Conveyed flows through entrenched channel. Many downed trees due to recent storm.

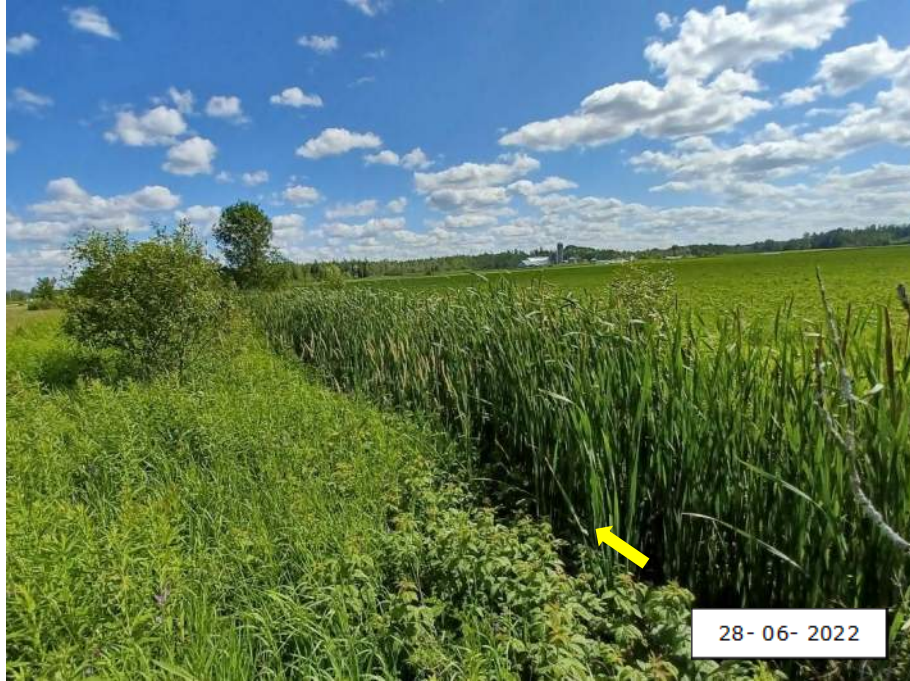
Photo 58
Ramsay Creek: RC4 1 1

Conveyed flows through a straightened channel, travelling through active agricultural fields.

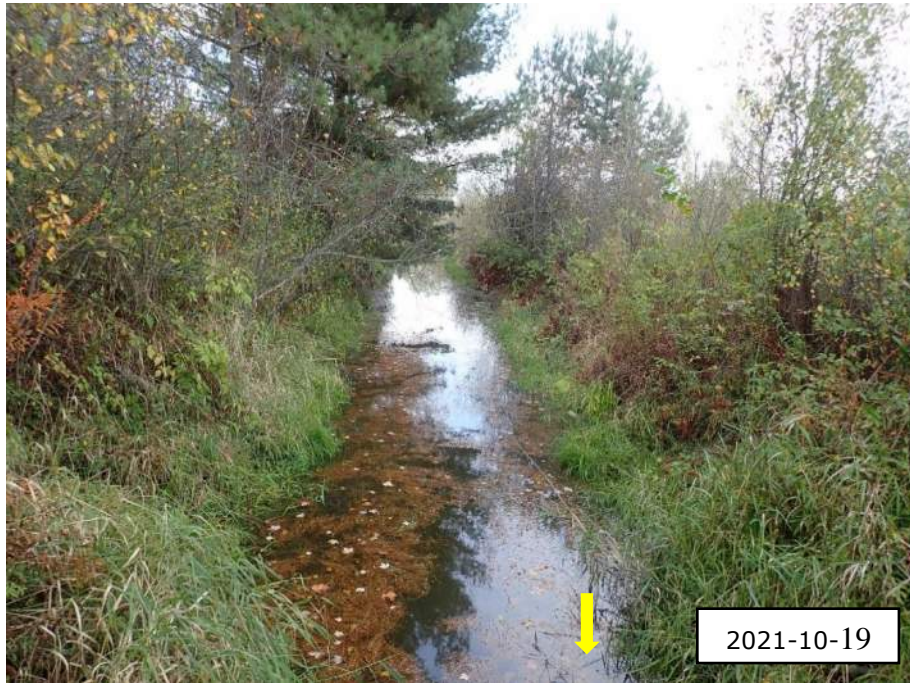
Photo 59
Ramsay Creek: RC4 1 1A

Straight agricultural ditch, riparian zone consisting of grasses. Situated between agricultural fields

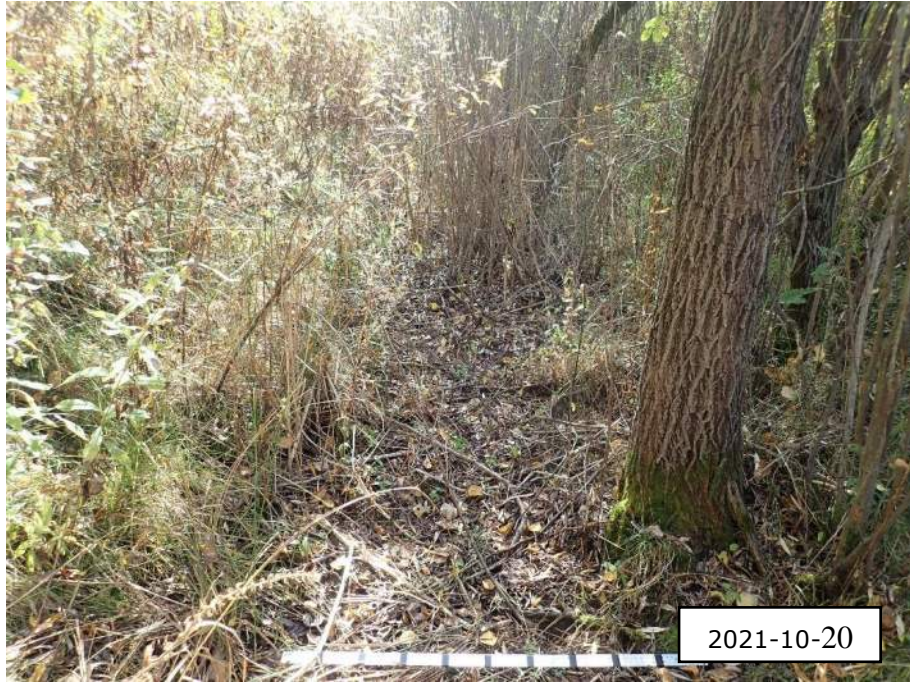
Photo 60
Ramsay Creek: RC4 1 1A 1

The above feature was a defined, straight channel with beaver dams retaining water along the reach. Runs parallel to woodlot.

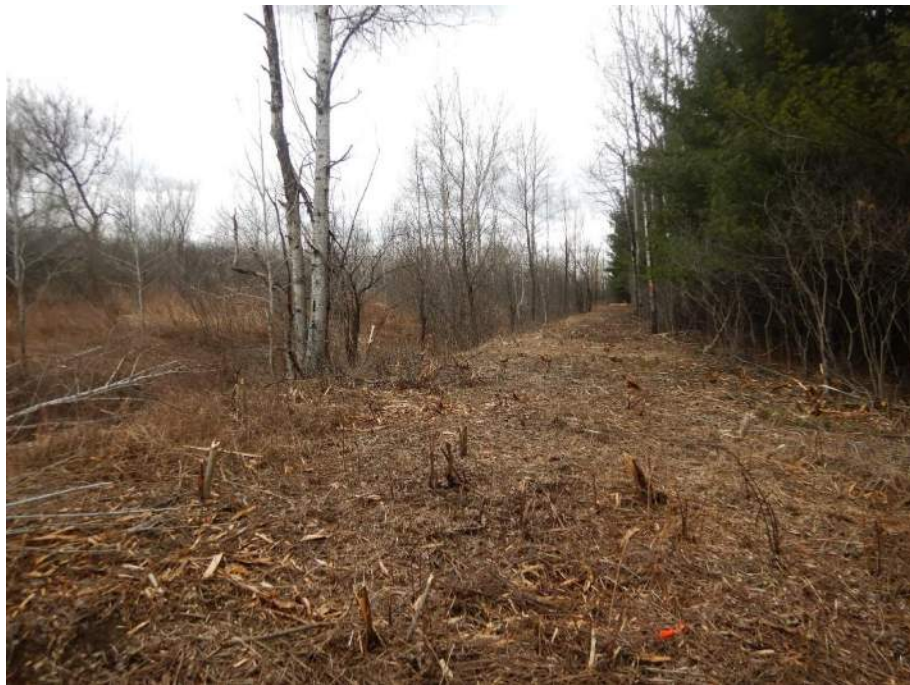
Photo 61
Ramsay Creek: RC4 1 1A 1A

Former agricultural ditch with no flows at the time of visit.

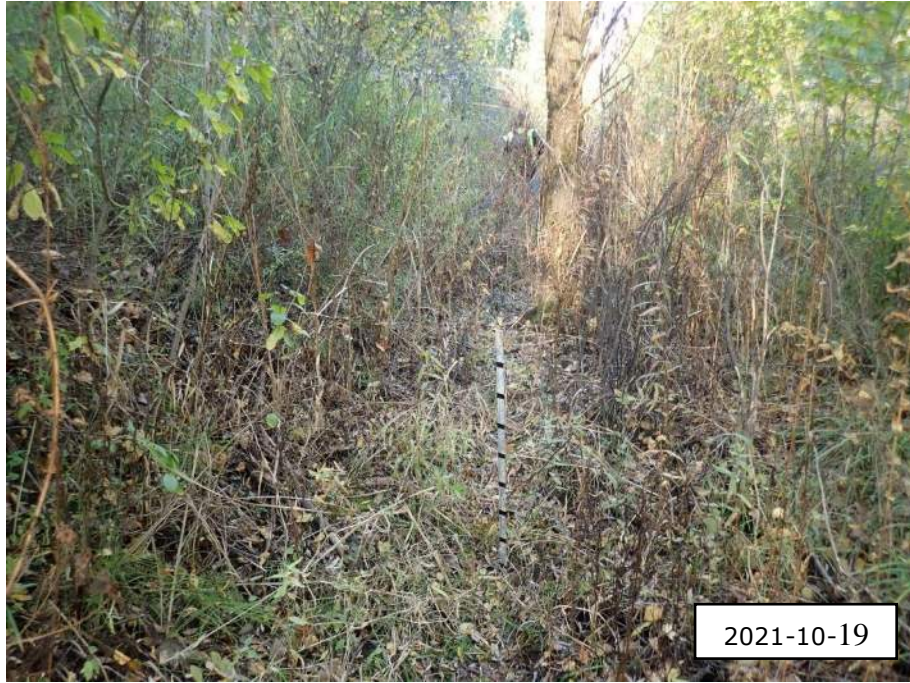
Photo 62
Ramsay Creek: Rc4 1 1A 2

Small poorly defined feature. Photo taken during spring 2022 HDFA assessments.

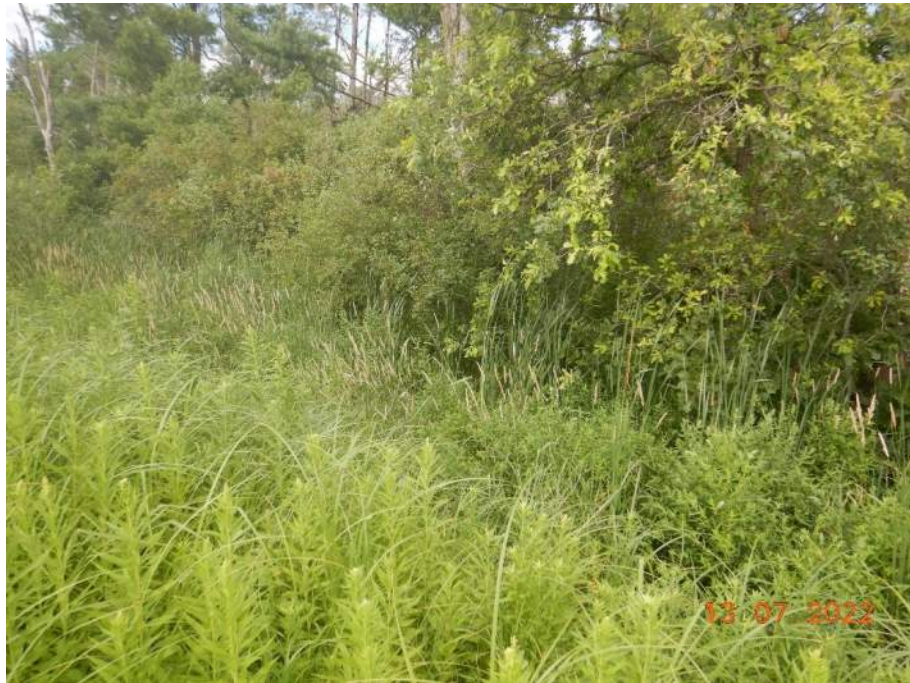
Photo 65
Ramsay Creek: RC5 1

Channel lacked defined banks; water was shallow/absent during visit.

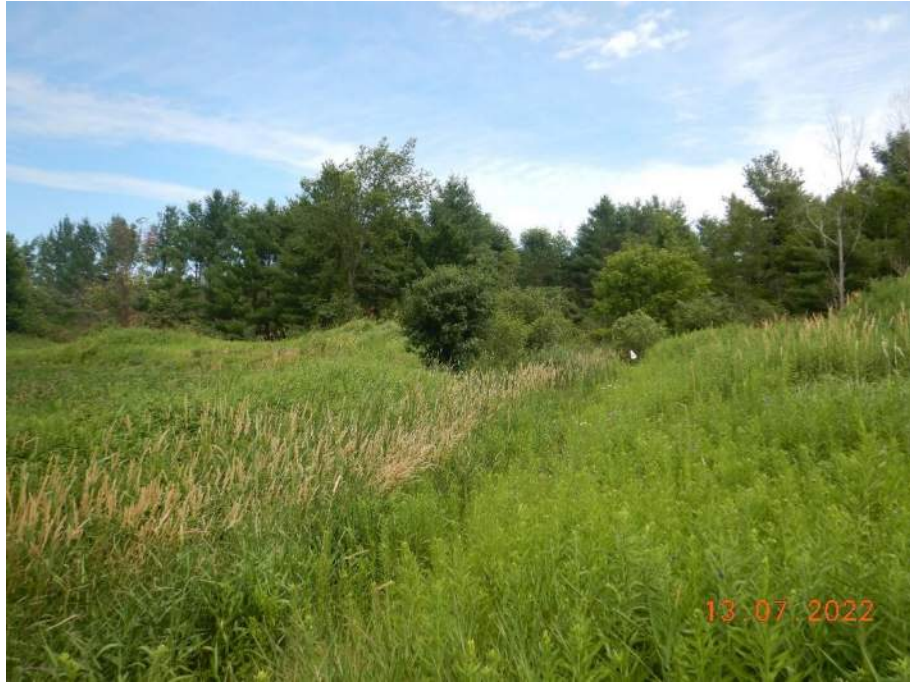
Photo 66
Ramsay Creek: RC5 1 1

Agricultural swale, vegetation encroachment was heavy. Channel was dry.

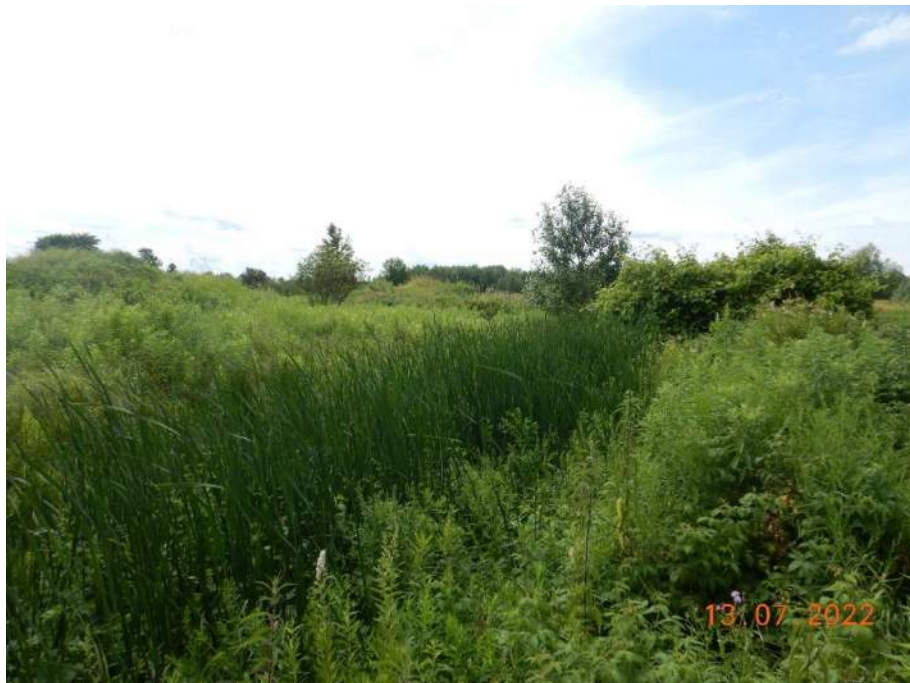
Photo 67
Ramsay Creek: RC5 1 2

Agricultural ditch, some water present. Riparian vegetation primarily grasses.

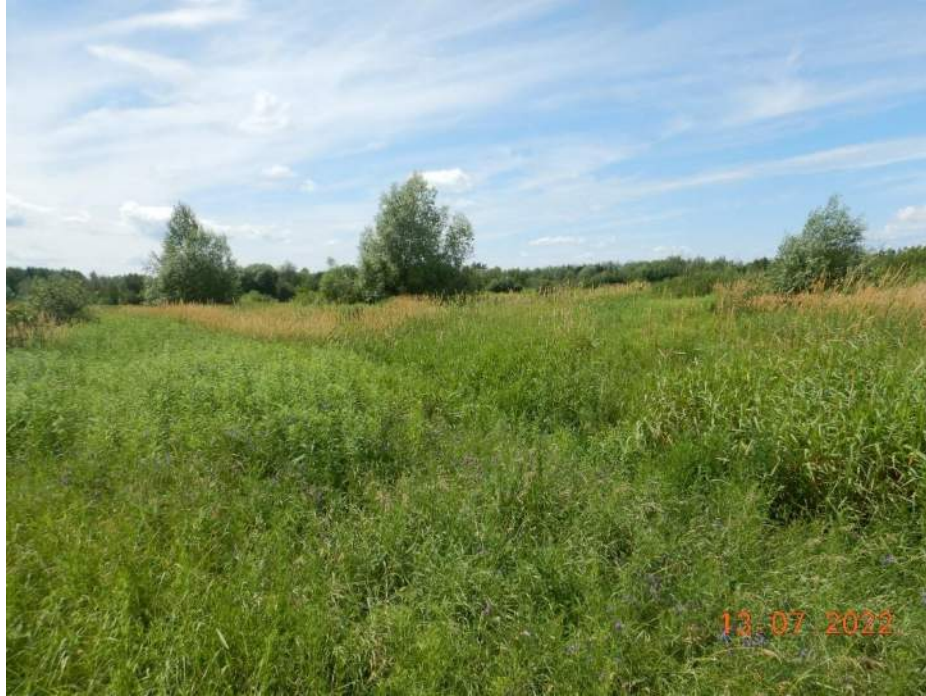
Photo 68
Ramsay Creek: RC5 1 3

Agricultural ditch, some water present. Riparian vegetation primarily grasses.

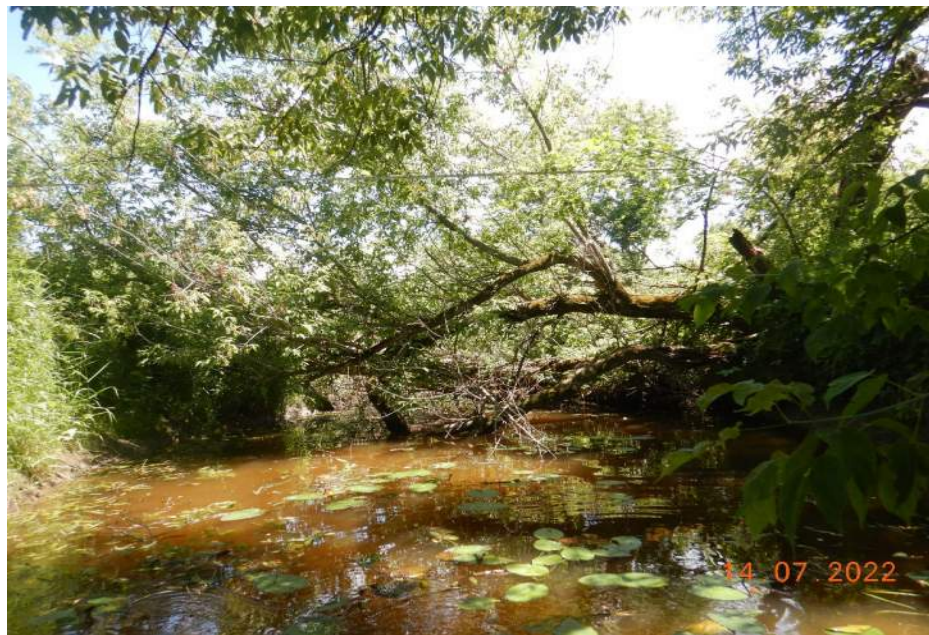
Cross Section 4 - Facing Downstream

Reach BB1 is a low gradient channel that passes through an unconfined valley. Riparian vegetation was characterized by grasses and some mature trees. Rooted submergent and emergent vegetation was common along the reach, however vegetation encroachment was minimal. Substrate consisted of clay to sand in both the pools and the riffles. Average bankfull width and depth were 9.63 m and 1.22 m, respectively. Some undercutting was observed, up to 0.35 m and bank slumping was present.

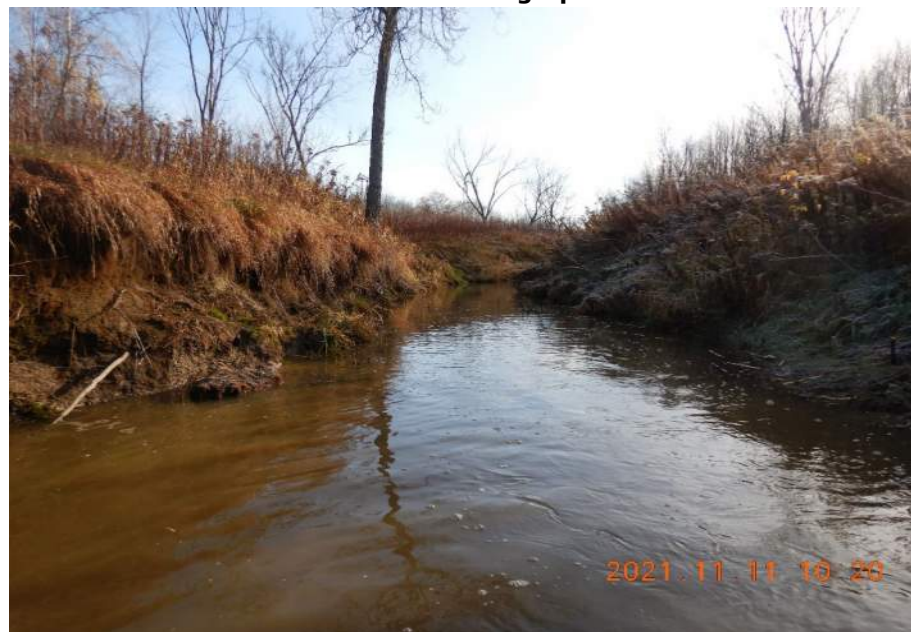
Cross Section 3 - Facing Upstream

Reach BB5 was a low gradient, meandering channel that passed through a partially confined valley. Riparian vegetation was characterized by grasses in the floodplain and on the valley slopes. There was minimal encroachment of vegetation to the channel and some reeds were found in the channel. Substrate consisted of clay to Sand in riffles and pools. Average bankfull width and depth were 5.97 m and 0.82 m, respectively. Undercutting was minimal and was measured up to a maximum of 0.12 m.

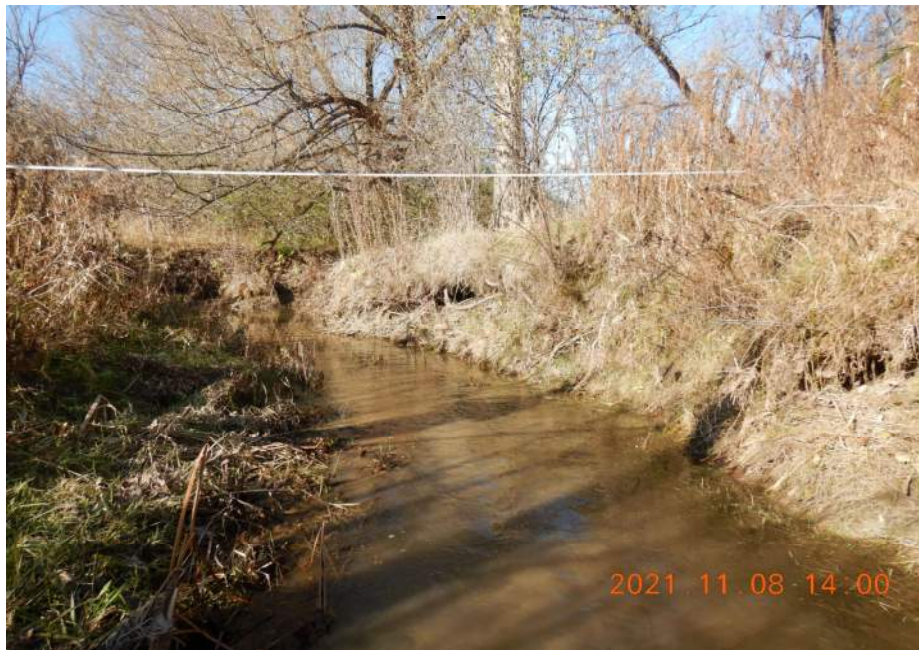
Reach BB5-5 was a minimal gradient, meandering channel that passed through a partially confined valley. Riparian vegetation was characterized by grasses in the floodplain and on the valley slopes. There was minimal encroachment of vegetation to the channel and some reeds were found in the channel. Substrate consisted of clay to sand in riffles and pools. Average bankfull width and depth were 4.34m and 0.59 m, respectively. Undercutting frequency was minimal and was measured up to a maximum of 0.45 m.

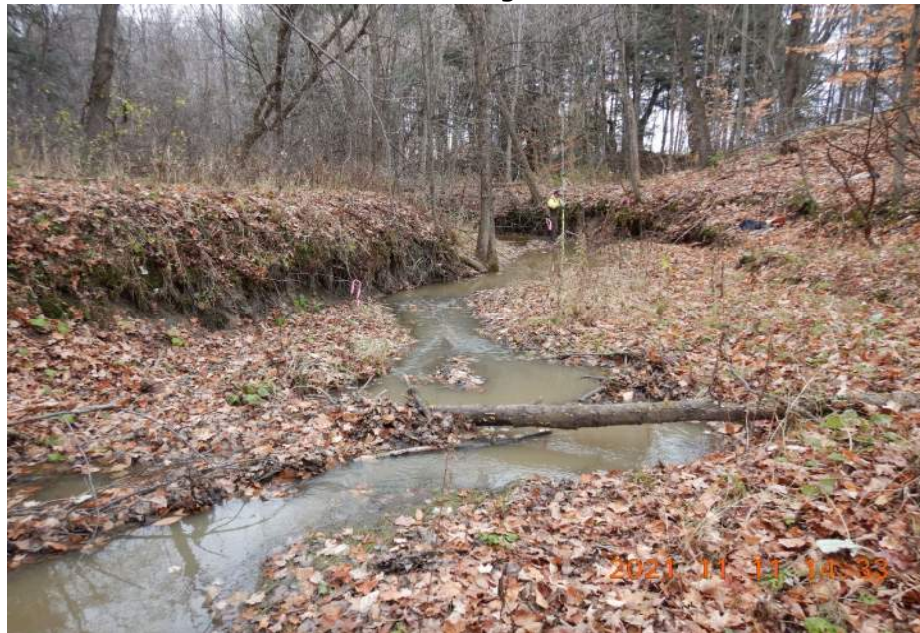
Cross Section 6 - Facing Downstream

Reach BB5-5A-3 was a moderate gradient, meandering channel that passed through a partially confined valley. Riparian vegetation was characterized by grasses in the floodplain and trees on the valley slopes. Substrate consisted of clay to cobbles in riffles and pools. Average bankfull width and depth were 6.31 m and 0.39 m, respectively. Undercutting was fairly common and was measured up to a maximum of 0.93 m.

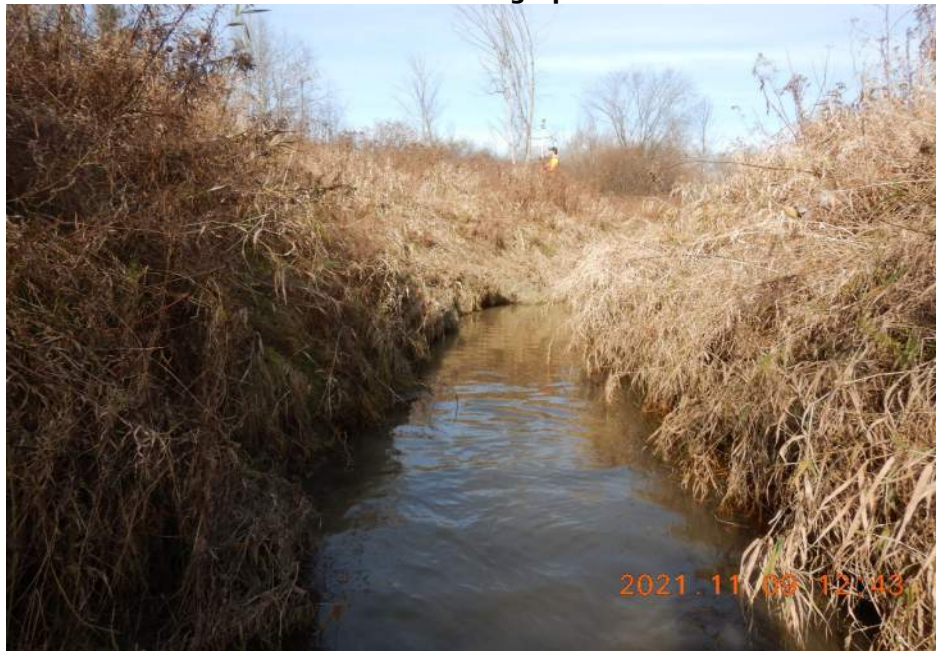
Cross Section 9 - Facing Upstream

Reach BB6 was a minimal gradient, meandering channel that passed through a partially confined valley. Riparian vegetation was characterized by grasses in the floodplain and on the valley slopes. There was minimal encroachment of vegetation to the channel and some reeds were found in the channel. Substrate consisted of Clay to Sand in riffles and pools. Average bankfull width and depth were 4.73 m and 0.94 m, respectively. Undercutting frequency was minimal and was measured up to a maximum of 0.45 m.

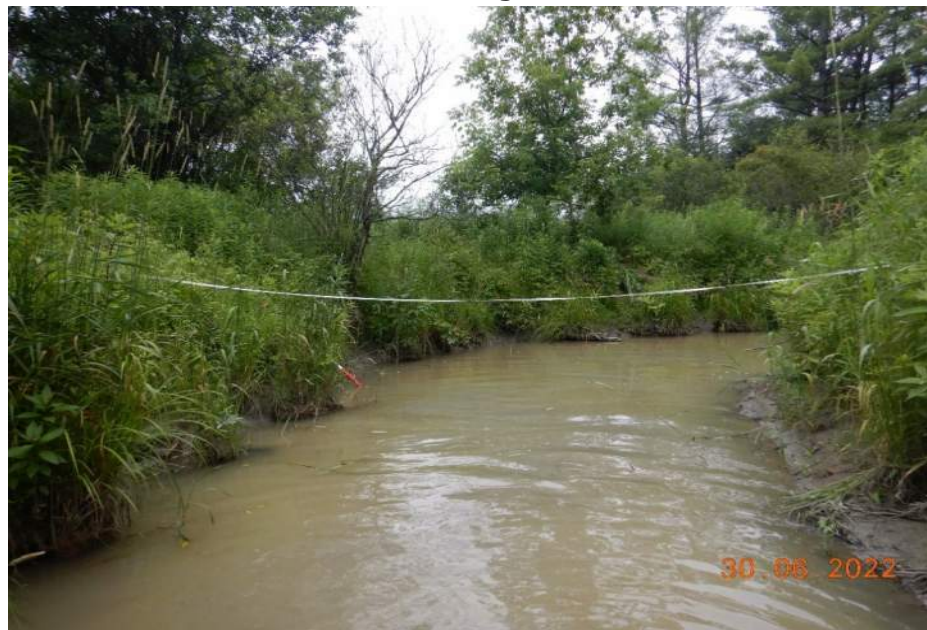
Cross Section 6 - Facing Downstream

Reach RC1 was a low gradient meandering channel that flowed through an unconfined valley. Riparian vegetation was predominantly characterized by grasses and small shrubs. There was minor encroachment of emergent-type vegetation into the channel. Channel substrates consisted mainly of clays and sands. Although, some gravel and cobbles were found in riffles. Average bankfull width and depth were 6.30 m and 0.79 m, respectively. Bank undercutting was observed up to a maximum of 0.30 m. In addition, bank slumping was common throughout the reach.

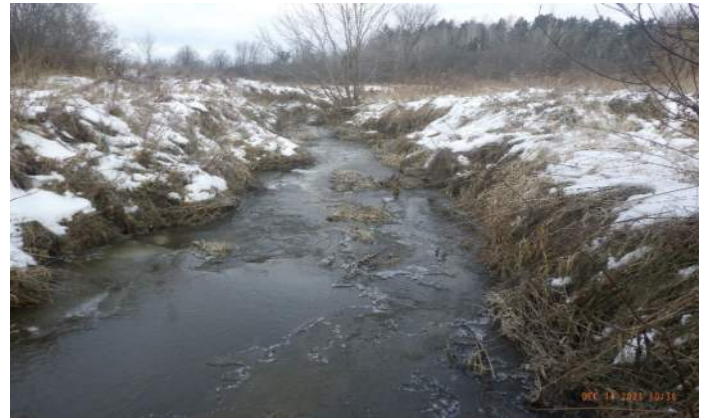
Representative Cross-Section #1

Photograph at cross section 1 (looking downstream)

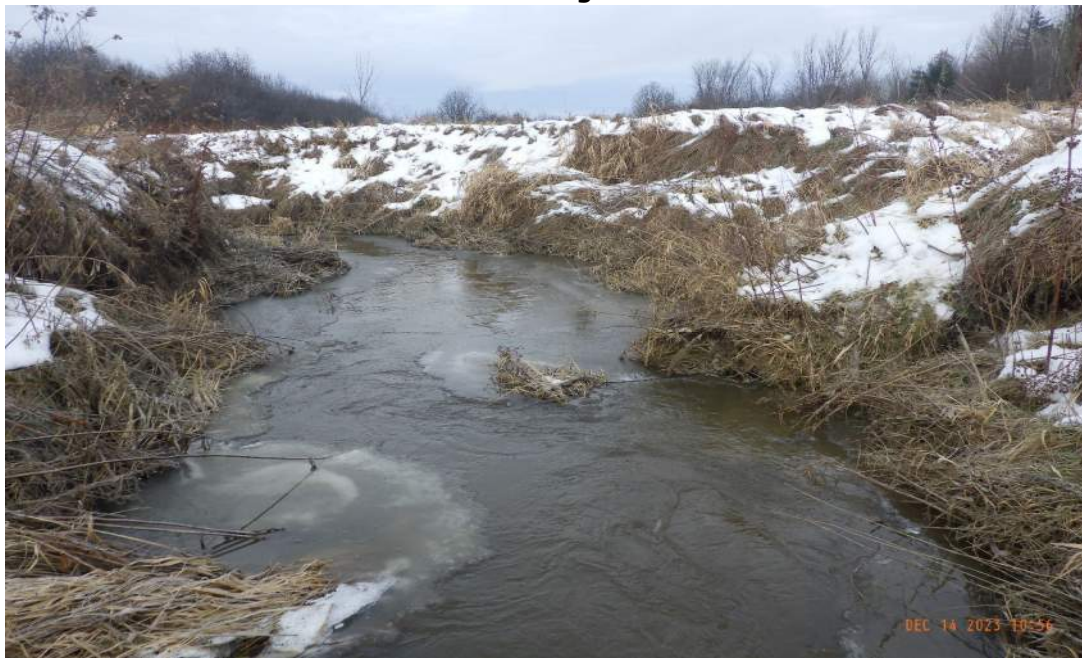
Cross Section 3 - Facing Downstream

Reach RCB meanders through active agriculture with a grassy buffer between the channel and the cultivated lands. There was no riffle formations, and was mostly composed of runs and pools. The riparian vegetation encroaches the channel and instream rooted emergent vegetation was well established. Channel slumps, fracture lines and undercutting was observed throughout the reach. The channel bed was composed of soft silt and sand over a compact clay-till subpavement. Some sections of the reach exhibited exposed compact clay-till on the bed. During the time of the assessment, the channel was iced over, however the average bankfull width and depth was 5.85 m and 0.80 m respectively, and wetted with and depth at 2.73 m and 0.31 m , respectively.

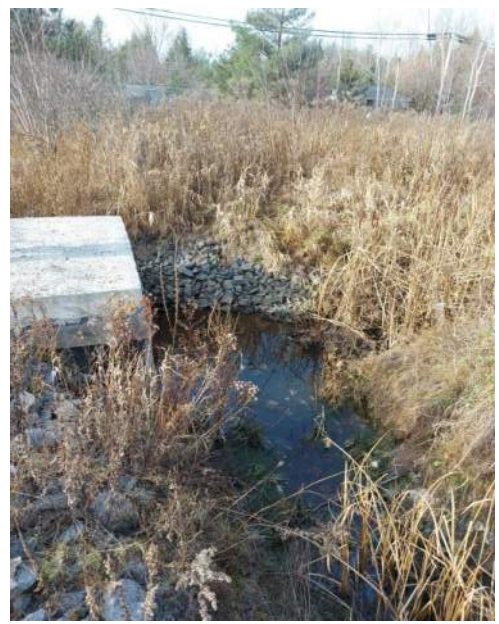
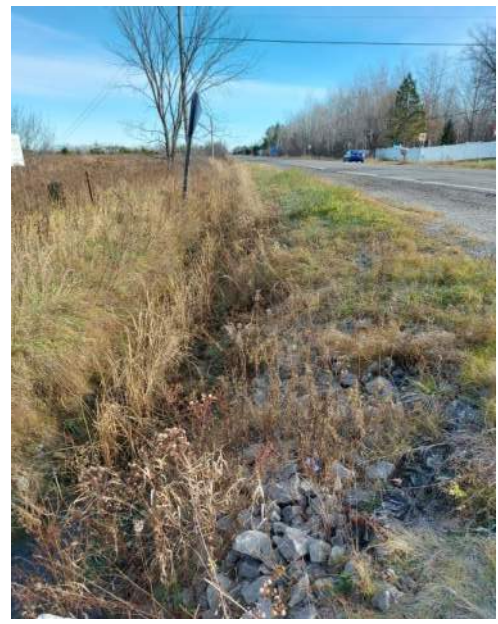
Figure 1

Existing conditions at **Crossing 1** on the north side of Piperville Road. Left photo is facing southwest at the box culvert; right photo is facing northeast at the roadside ditch.

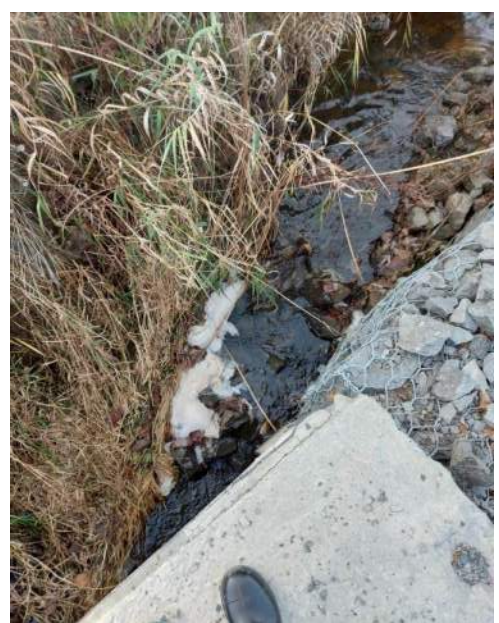
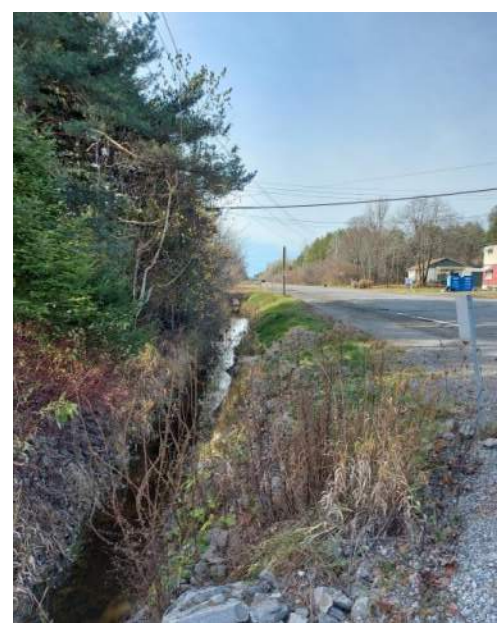
Figure 2

Existing conditions at **Crossing 1** on the south side of Piperville Road. Left photo is facing down at the box culvert opening; right photo is facing southwest at the roadside ditch.

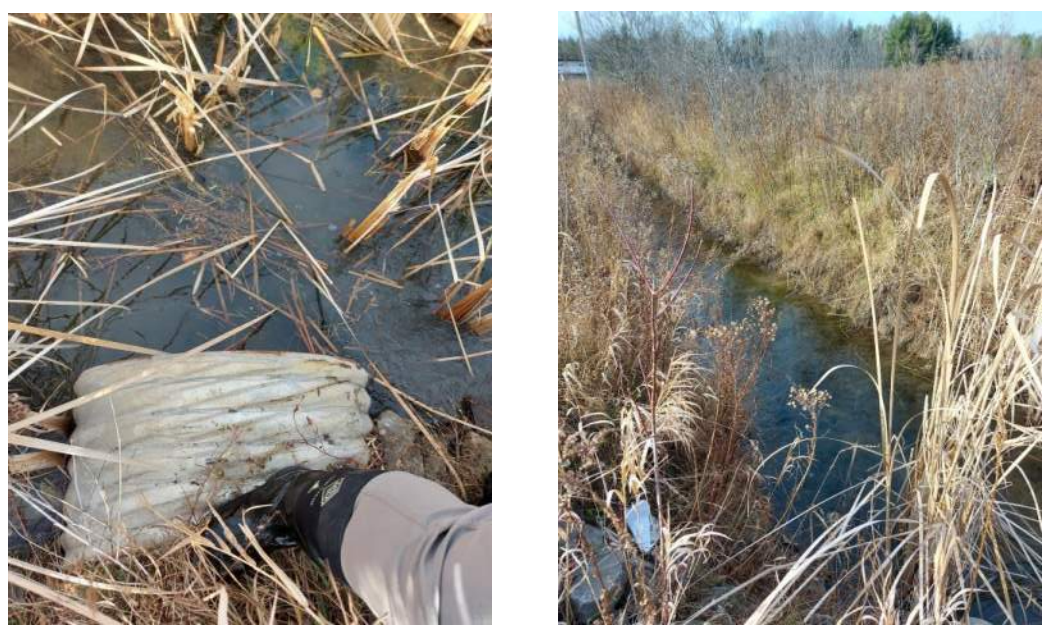
Figure 3

Existing conditions at **Crossing 2** on the north side of Piperville Road. Left photo is facing down at the culvert opening; right photo is facing southwest at the roadside ditch towards Crossing 1.

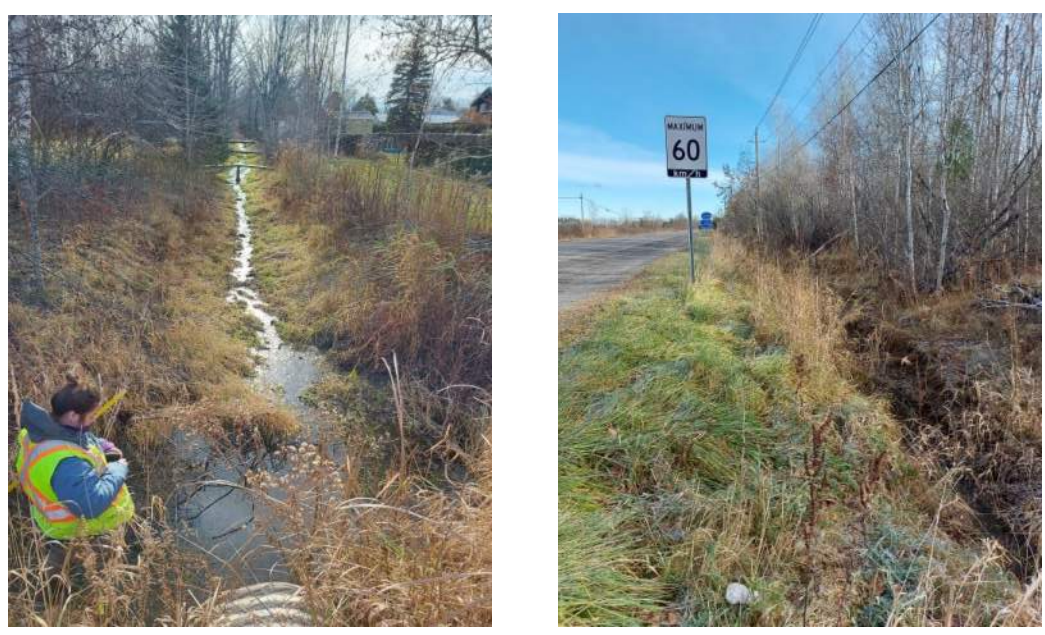
Figure 4

Existing conditions at **Crossing 2** on the south side of Piperville Road. Left photo is facing southeast at a drainage ditch flowing into the culvert from properties south of Piperville Road; right photo is facing northeast at the roadside ditch.

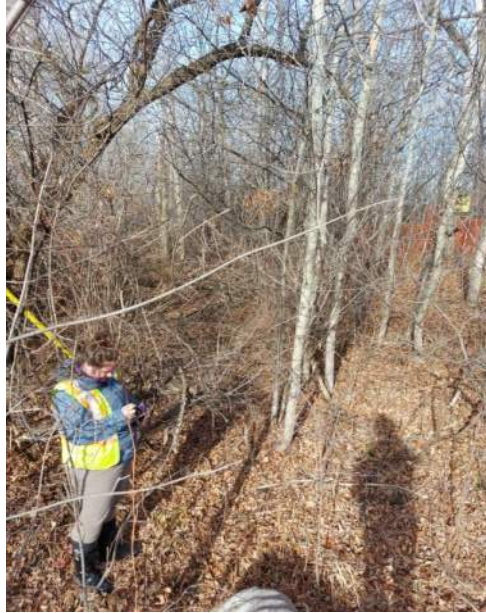
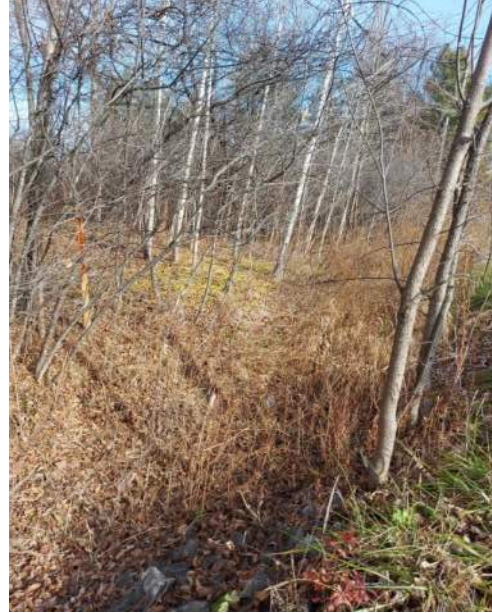
Figure 5

Existing conditions at **Crossing 3** on the north side of Piperville Road. Left photo is facing north from the culvert opening; right photo is facing northeast at the roadside ditch.

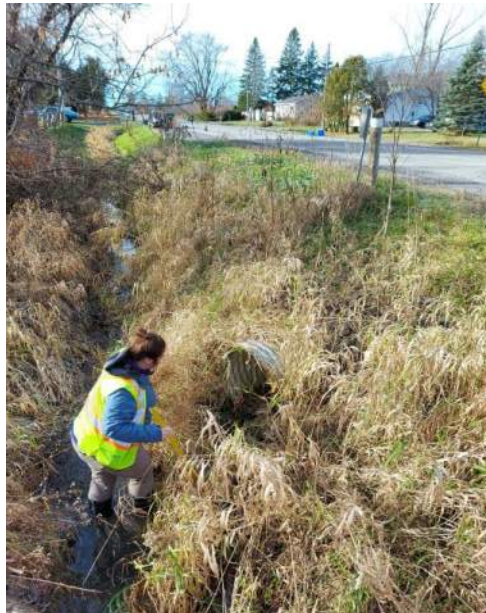
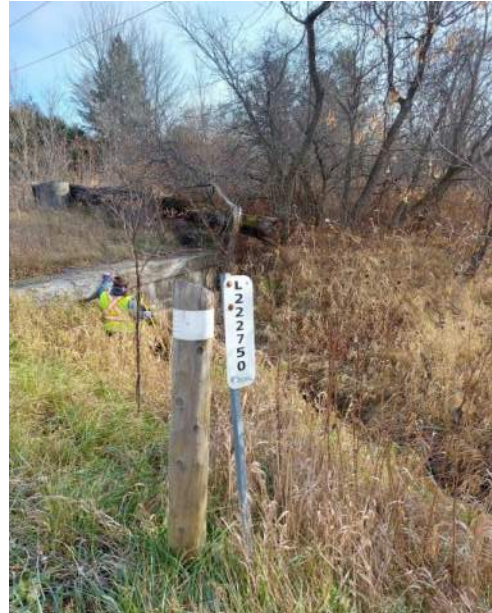
Figure 6

Existing conditions at **Crossing 3** on the south side of Piperville Road. Left photo is facing southeast at the culvert opening; right photo is facing southeast at a concrete structure situated immediately east of the culvert outlet.

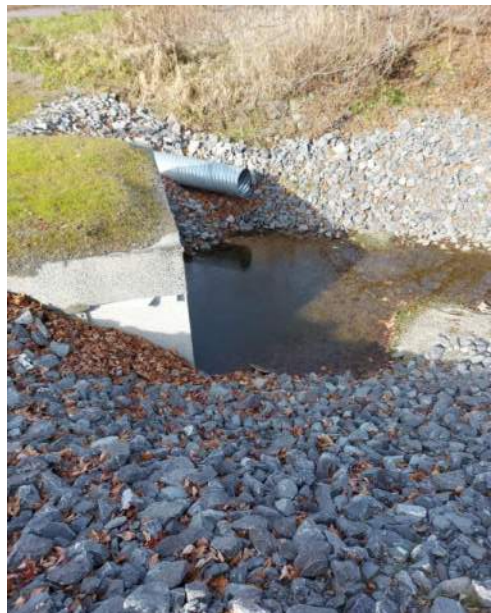
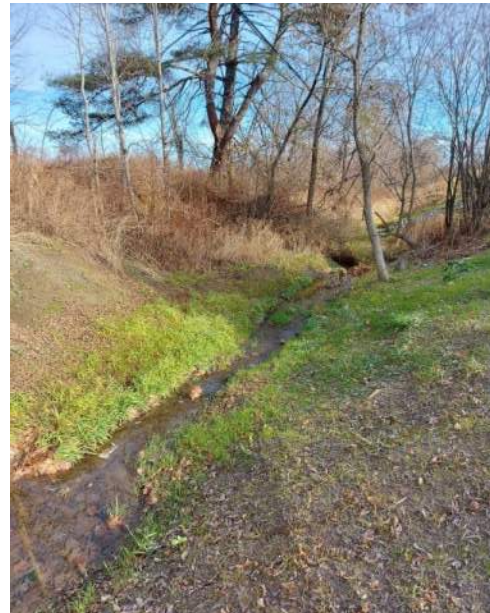
Figure 7

Existing conditions at **Crossing 4** on the north side of Piperville Road. Left photo is facing southeast at the box culvert; right photo is facing northeast at the roadside ditch.

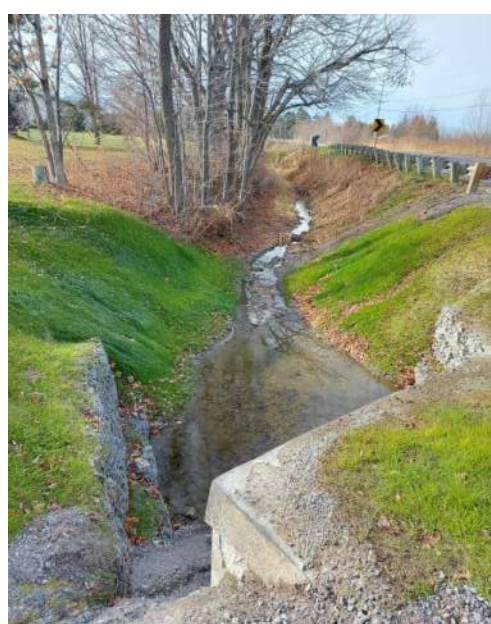
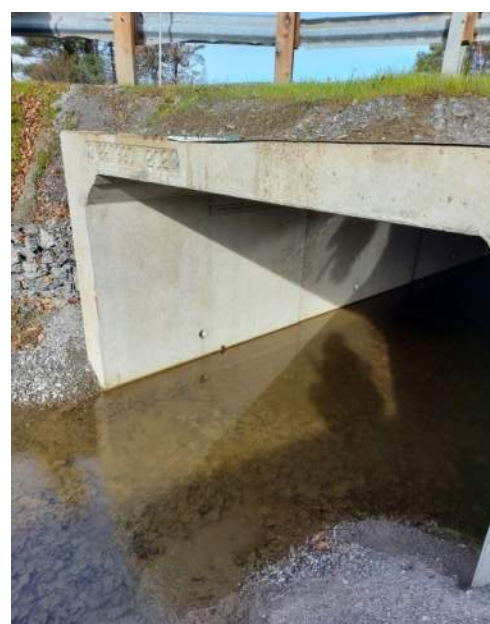
Figure 8

Existing conditions at **Crossing 4** on the south side of Piperville Road. Left photo is facing southeast from behind the culvert; right photo is facing north at the culvert opening.

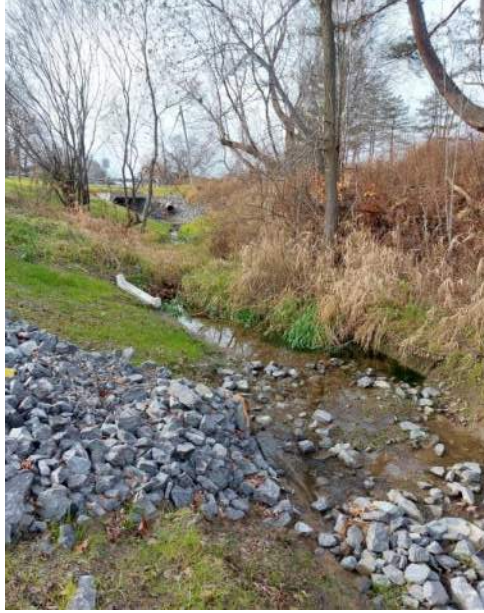
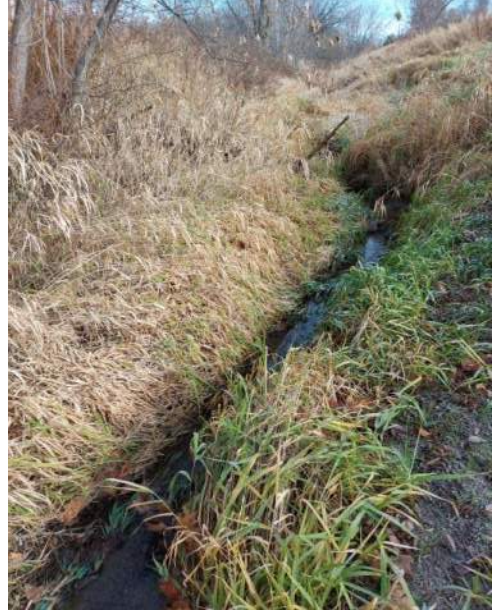
Figure 9

Existing conditions at **Crossing 5** on the north side of Piperville Road. Left photo is facing southeast towards Crossing 4; right photo is facing northeast at the roadside ditch draining from the culvert.
