Bear Brook and Ramsay Creek Watersheds Fluvial Geomorphological Study

Existing Conditions Summary Report
Tewin Lands

December 12, 2024

GEO Morphix Project No. 21063

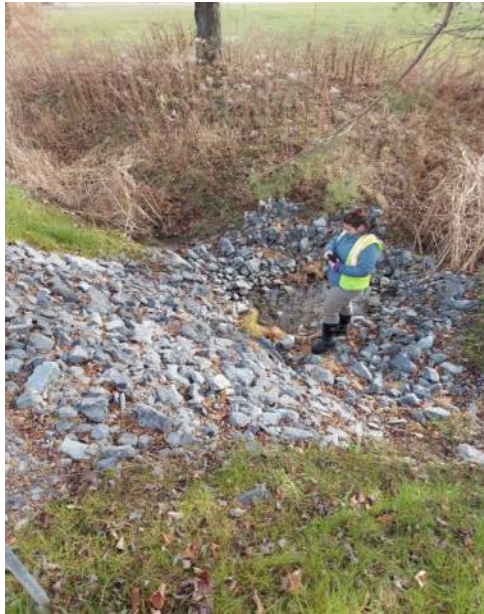
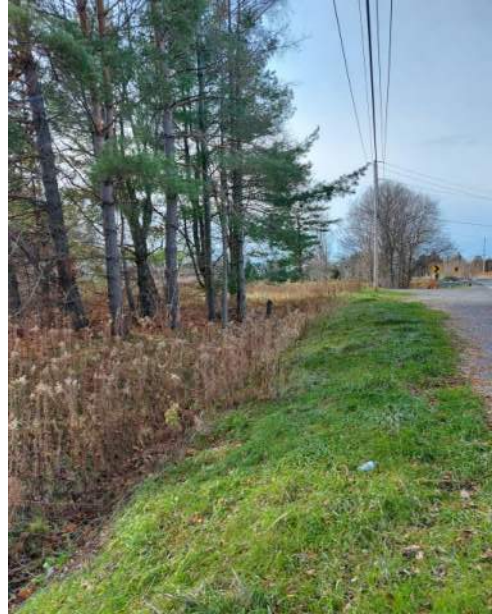
Figure 10

Existing conditions at **Crossing 5** on the south side of Piperville Road. Left photo is facing southeast; right photo is facing northwest at the roadside ditch.

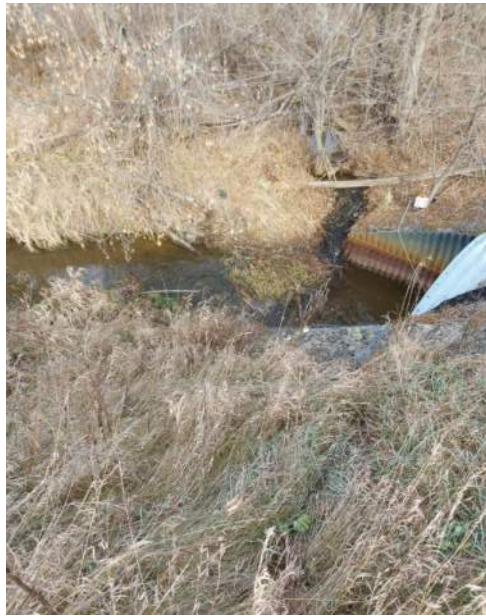
Figure 11

Existing conditions at **Crossing 6** on the north side of Piperville Road. Left photo is facing northeast from the road; right photo is facing northwest. Some slumping was observed along the banks.

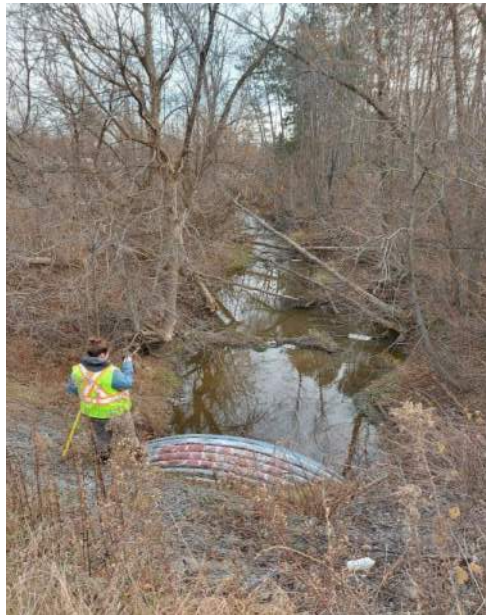
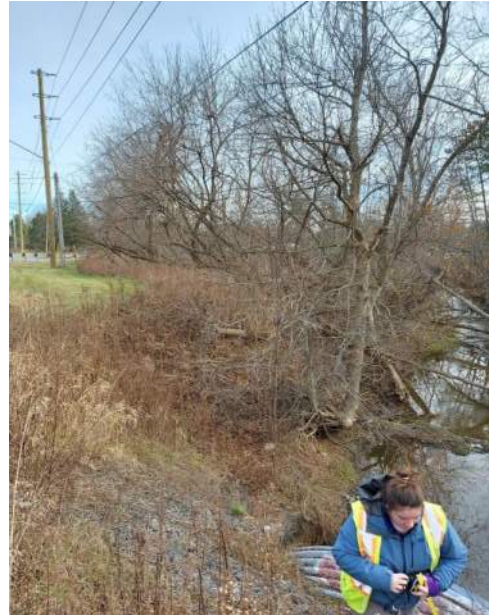
Figure 12

Existing conditions at **Crossing 6** on the south side of Piperville Road. Left photo is facing southeast; right photo is facing east along Piperville Road. Some erosion scars and fallen trees were observed.

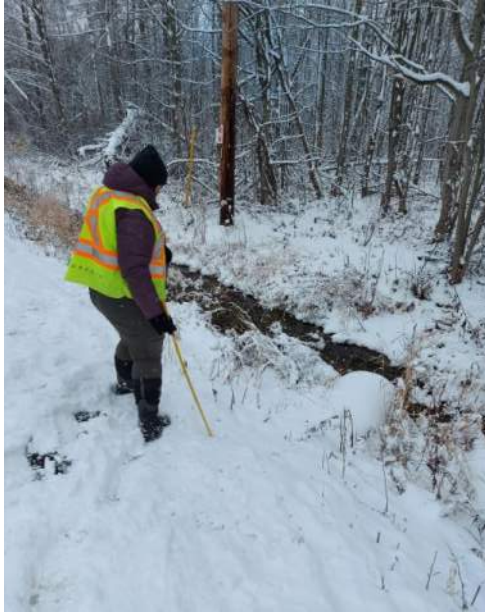
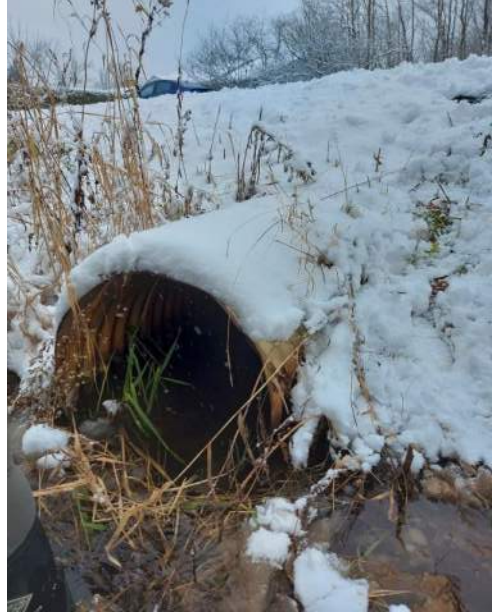
Figure 13

Existing conditions at **Crossing 7** on the west side of Farmer's Way. Left photograph is taken facing northwest along the roadside ditch; right photograph is taken facing east at the mouth of the culvert.

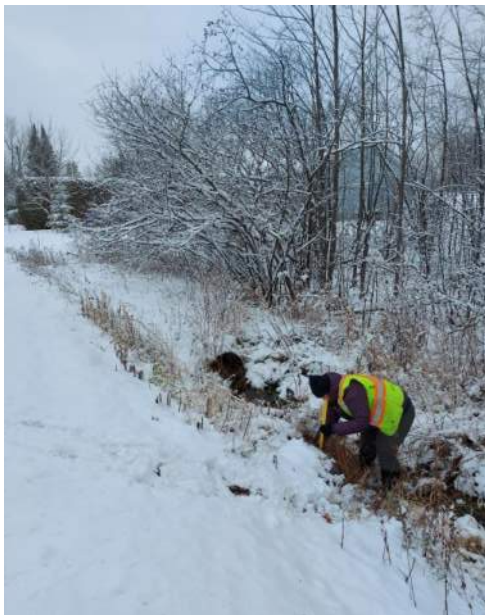
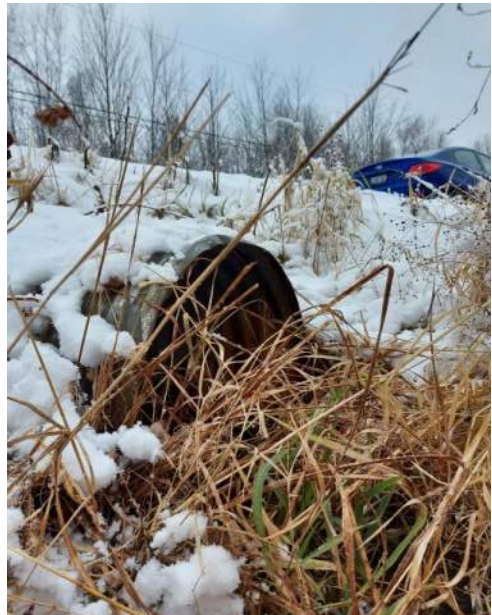
Figure 14

Existing conditions at **Crossing 7** on the east side of Farmer's Way. Left photograph is taken facing northeast along the roadside ditch; right photograph is taken facing west at the mouth of the culvert.

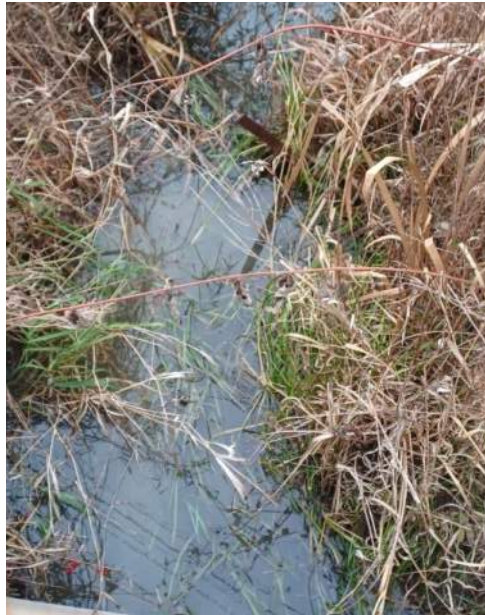
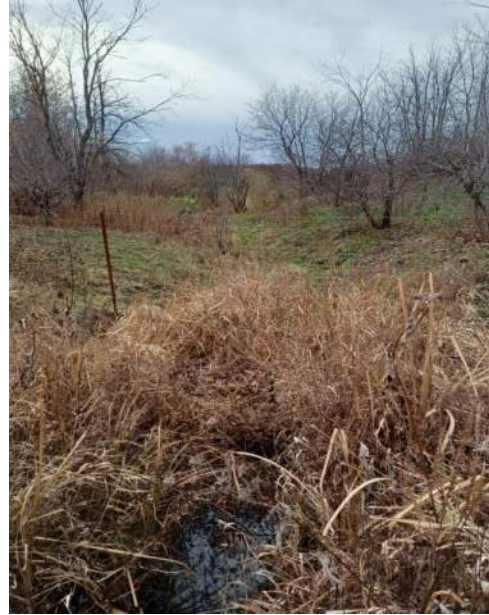
Figure 15

Existing conditions at **Crossing 8** on the west side of Ramsayville Road. Left photo is facing down at the mouth of the culvert; right photo is facing west.

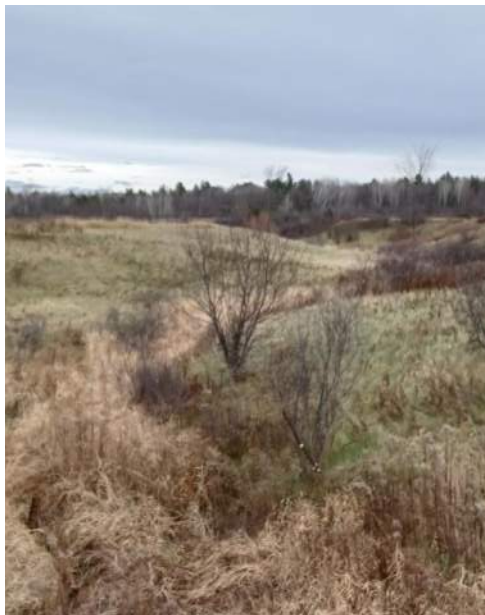
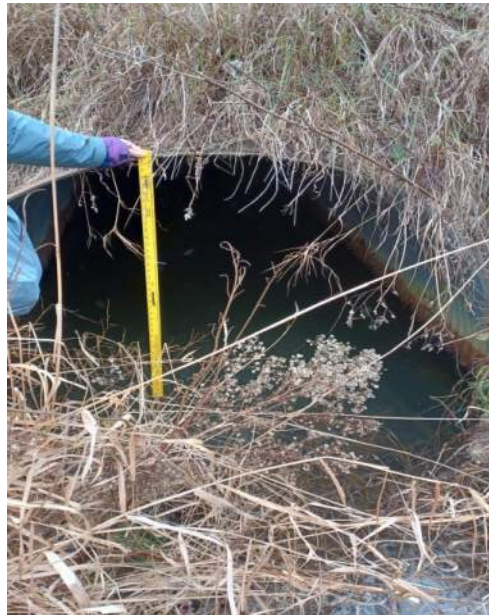
Figure 16

Existing conditions at **Crossing 8** on the east side of Ramsayville Road. Left photo is facing east; right photo is facing west into the mouth of the culvert.

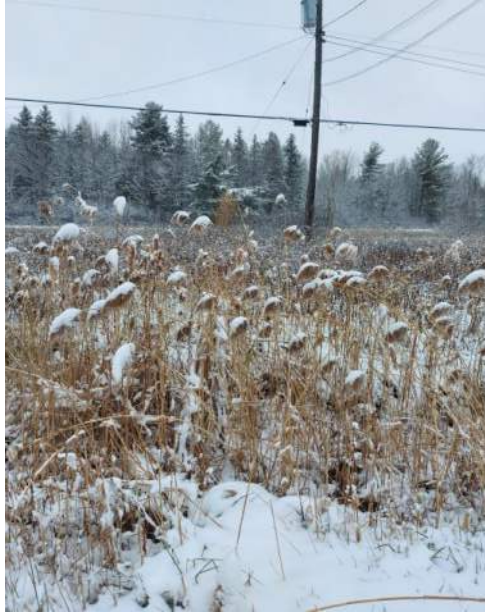
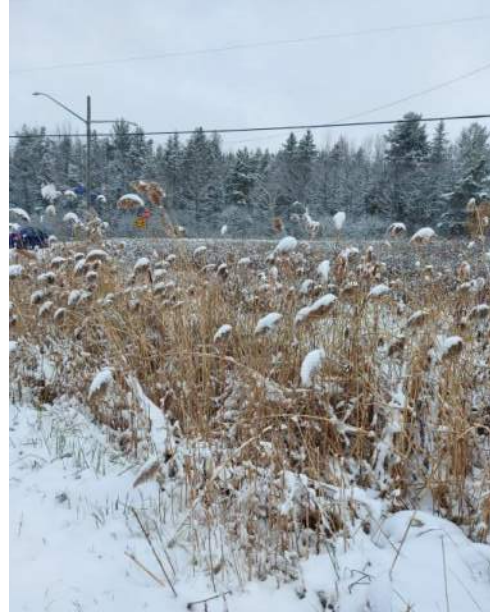
Figure 17

Existing conditions at **Crossing 9** on the north side of Farmer's Way. Left photo is facing north; right photo is taken facing northeast; no defined channel was observed.

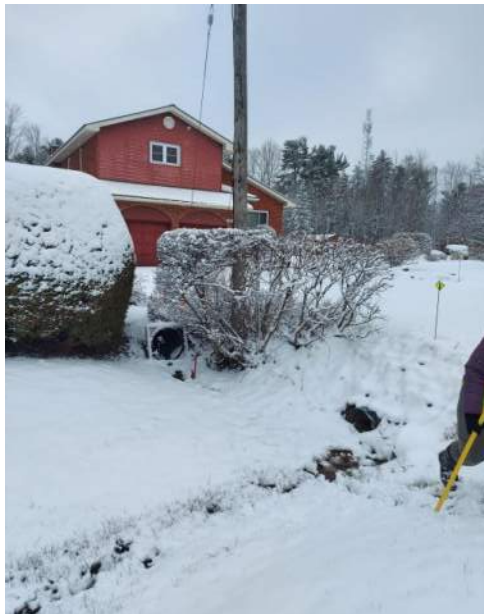
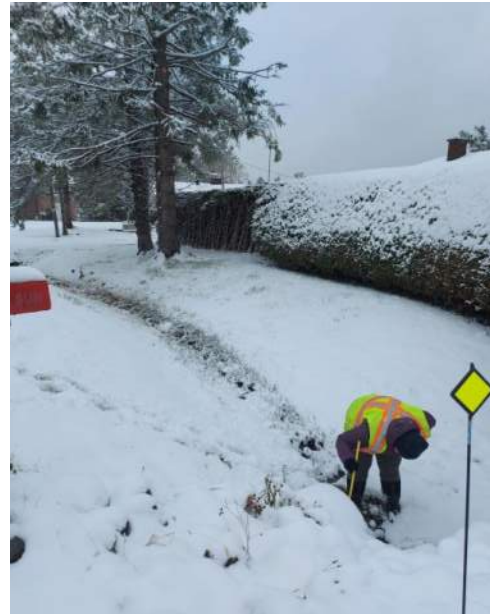
Figure 18

Existing conditions of **Crossing 9** on the south side of Farmer's Way. Left photograph is taken facing southwest towards the output of the roadside ditch; right photograph is taken facing southeast.

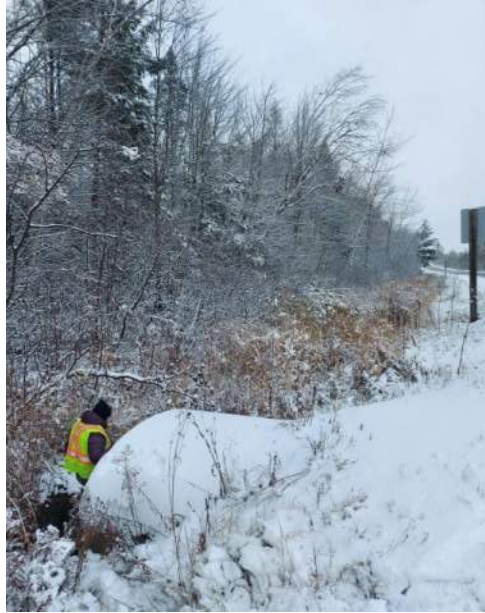
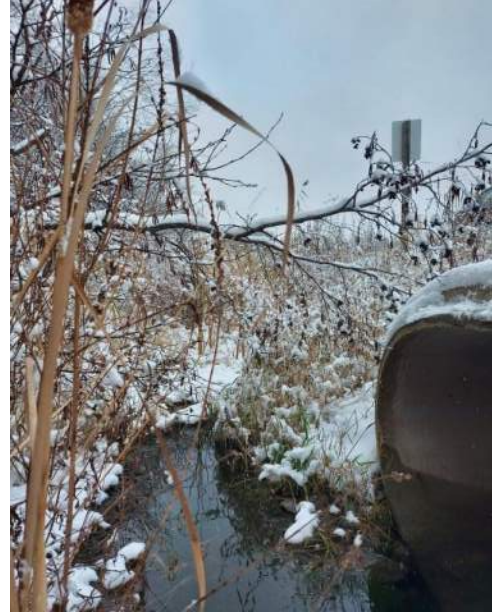
Figure 19

Existing conditions at **Crossing 10** on the north side of Leitrim Road. Left photograph is facing northeast along the roadside ditch; right photograph is facing southeast towards the culvert.

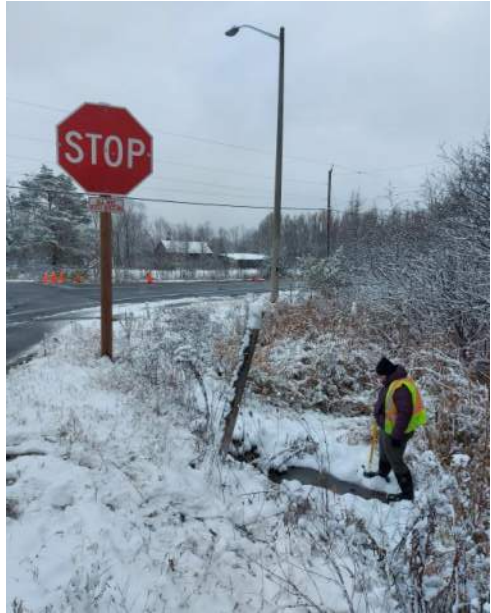
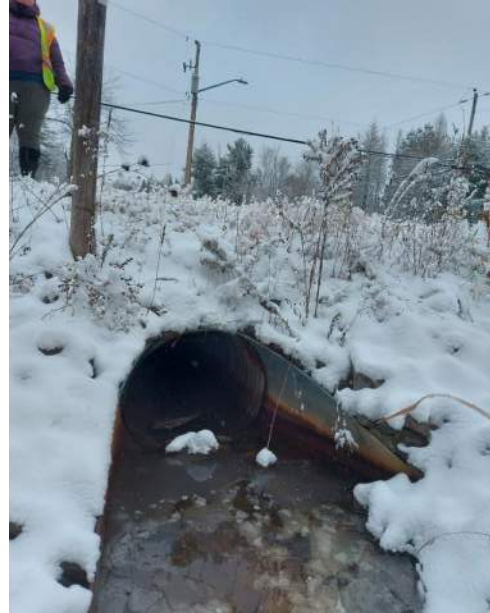
Figure 21

Existing conditions at **Crossing 10** on the south side of Leitrim Road. Left photograph is facing southwest along the roadside ditch; right photograph is facing southeast.

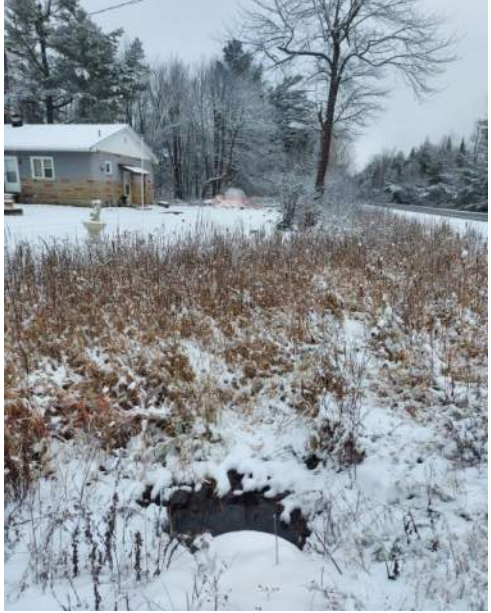
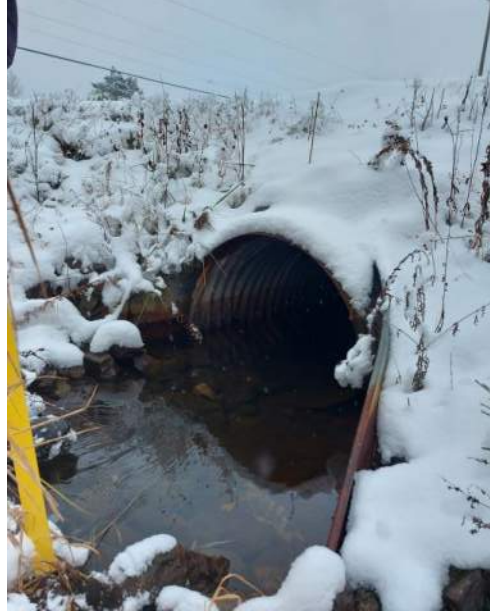
Figure 22

Existing conditions at **Crossing 11** on the north side of Leitrim Road. Left photo is taken facing northwest; right photograph is taken facing south at the mouth of the culvert.

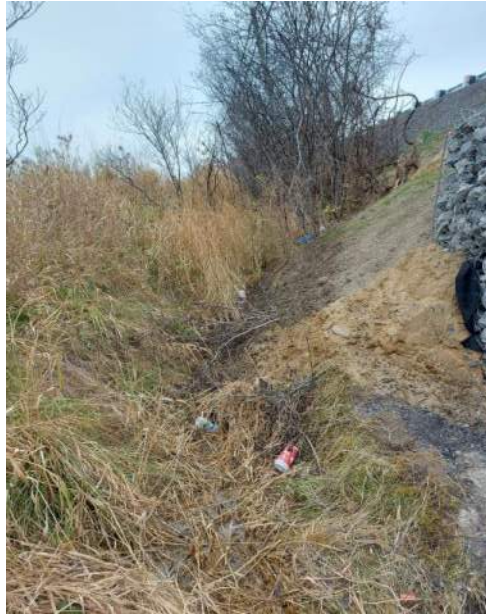
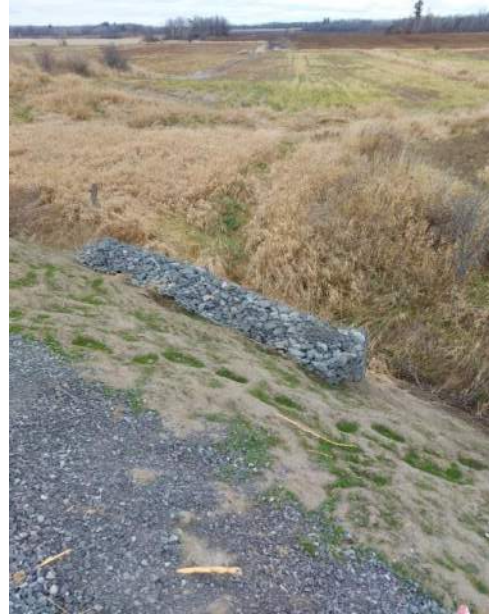
Figure 23

Existing conditions at **Crossing 11** on the south side of Leitrim Road. Left photograph is facing south, downstream; right photograph is taken facing southwest towards the mouth of the culvert.

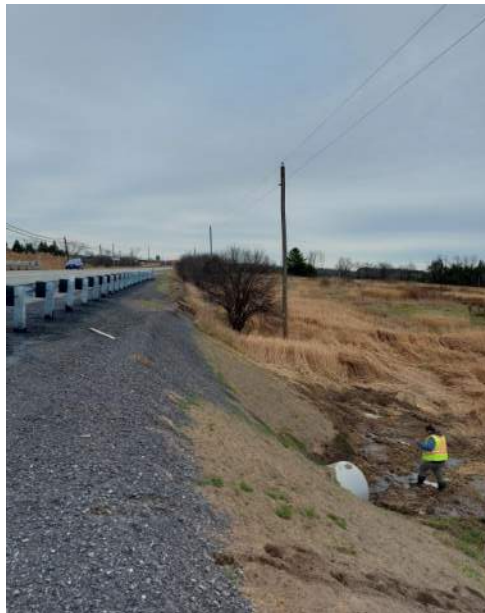
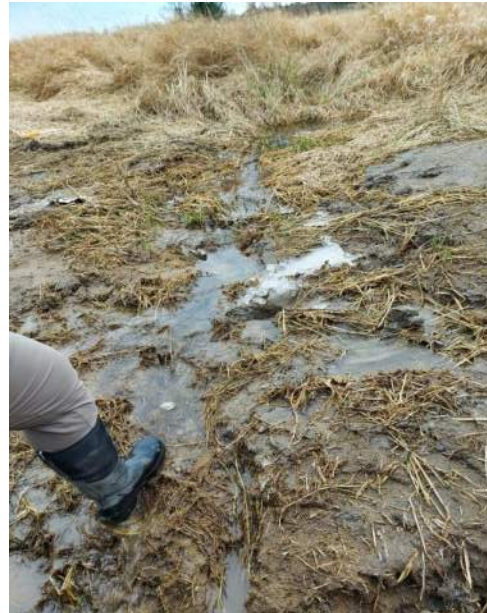
Figure 24

Existing conditions at **Crossing 12** on the north side of Russell Road. Left photo is facing northeast parallel to Russell Road; right photo is facing north.

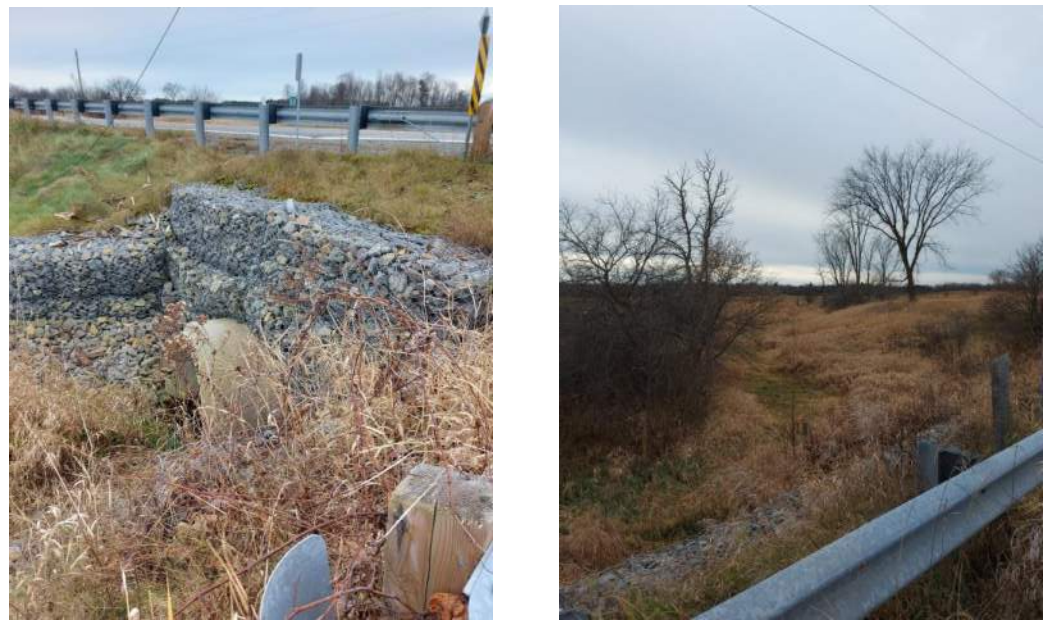
Figure 25

Existing conditions at **Crossing 12** on the south side of Russell Road. Left photo is facing west down Russell Road; right photo is facing south.

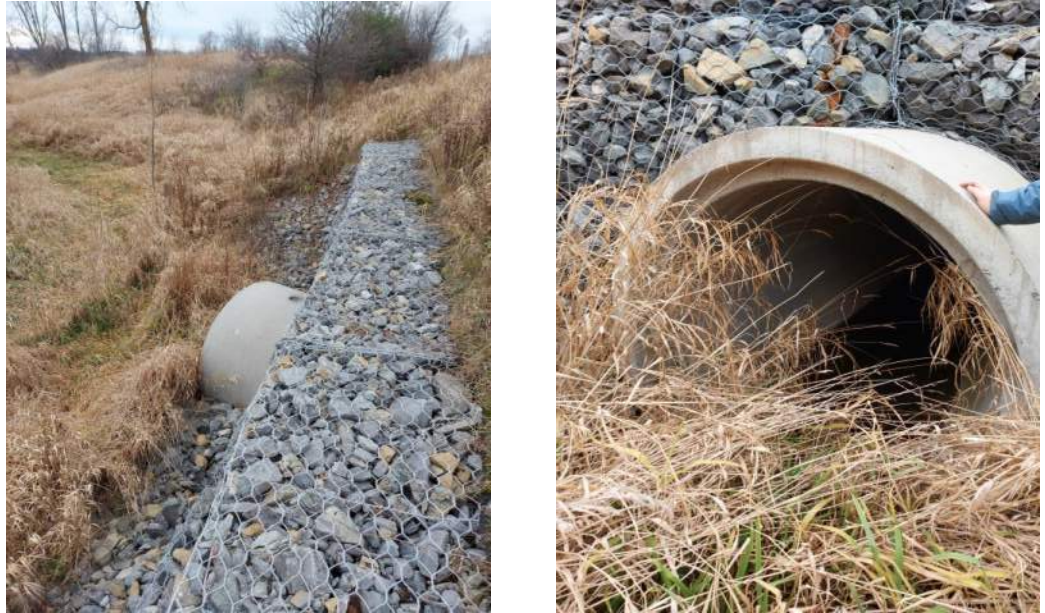
Figure 26

Existing conditions at **Crossing 13** on the north side of Russell Road. Left photograph is facing east; the right photograph is facing northeast, downstream.

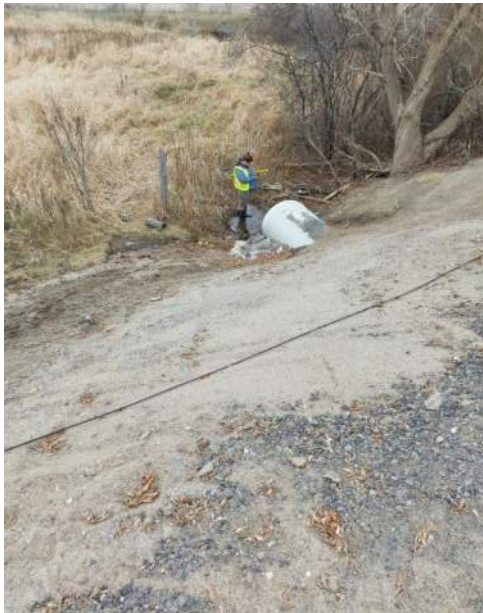
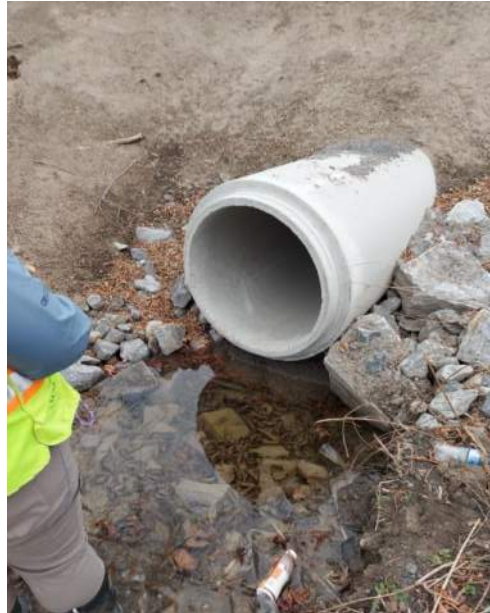
Figure 27

Existing conditions at **Crossing 13** on the south side of Russell Road. Left photograph is facing northeast; right photograph is facing south towards the culvert.

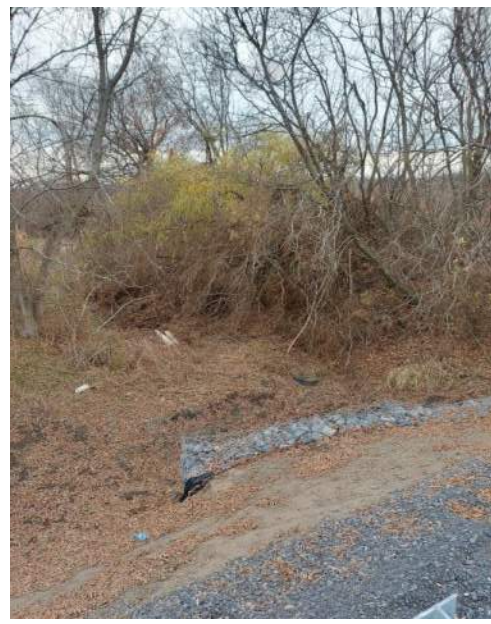
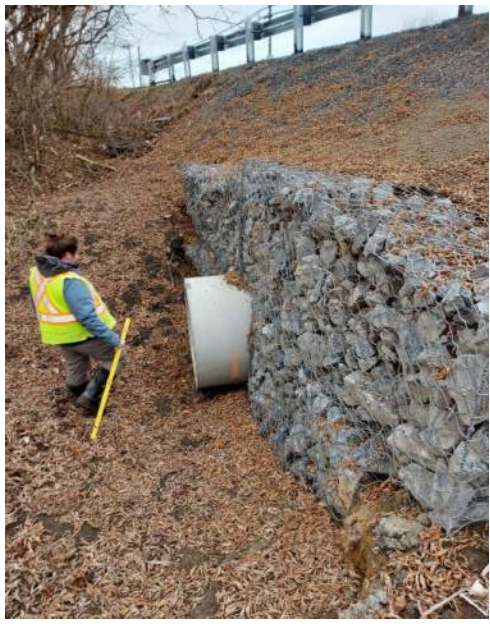
Figure 28

Existing Conditions at **Crossing 14** on the north side of Russell Road. Left photograph is facing northeast; right photograph is facing south towards the mouth of the culvert.

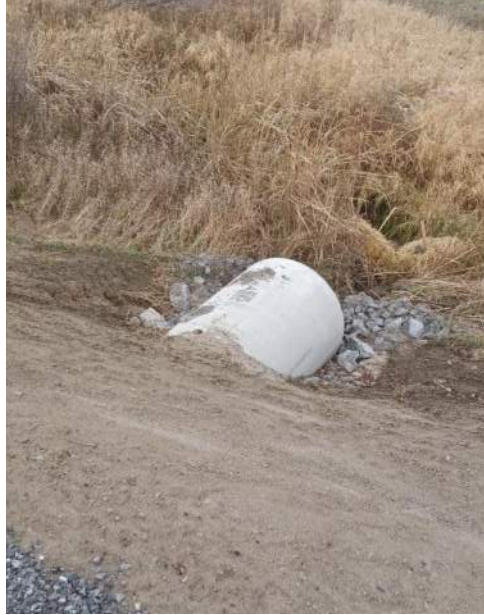
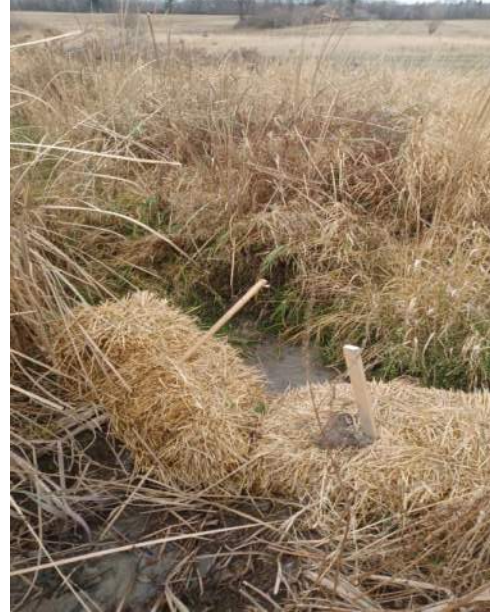
Figure 29

Existing conditions at **Crossing 14** on the south side of Russell Road. Left photo is facing south, upstream; right photograph is facing southwest, channel was dry.

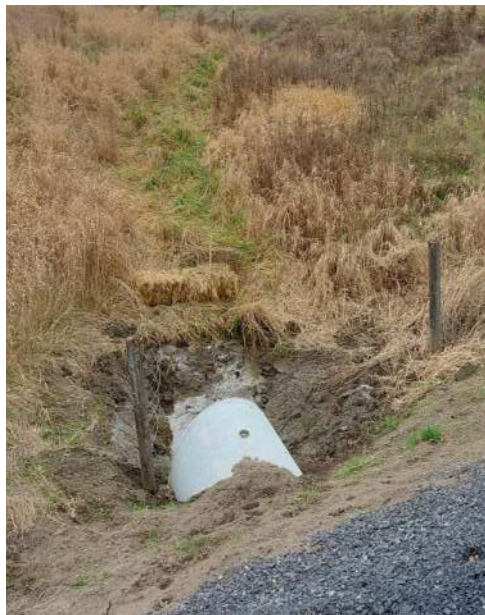
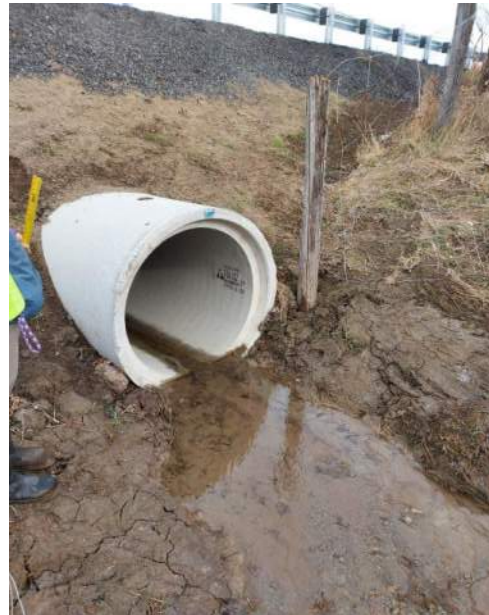
Figure 30

Existing conditions at **Crossing 15** on the north side of Russell Road. Left photograph is facing northwest; right photograph is facing north..

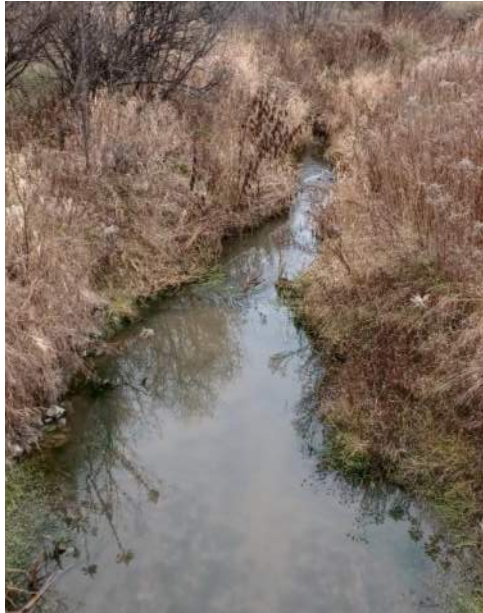
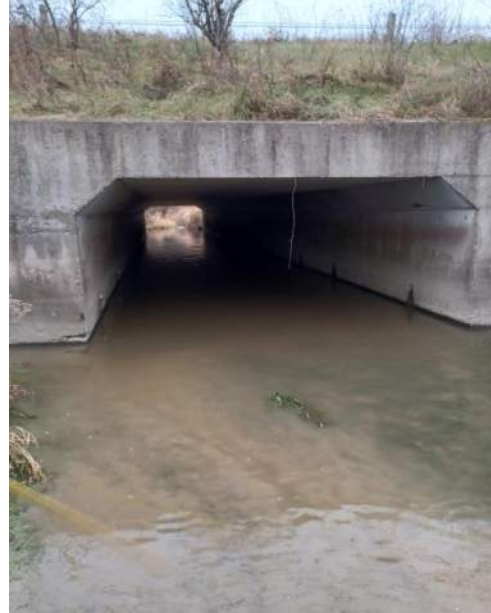
Figure 31

Existing conditions at **Crossing 15** on the south side of Russell Road. Left photograph is facing south along the channel; right photograph is facing north towards the mouth of the culvert.

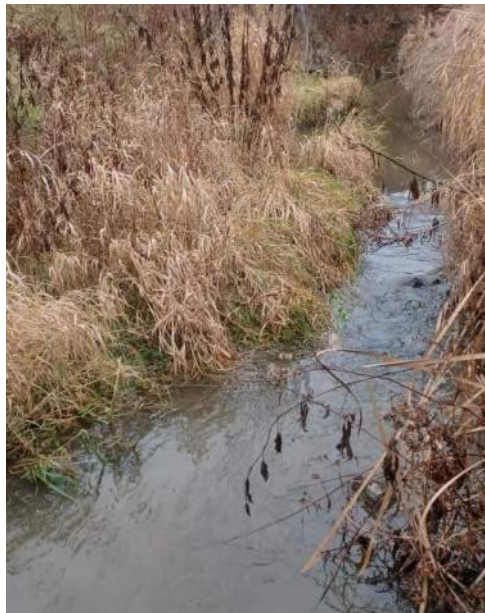
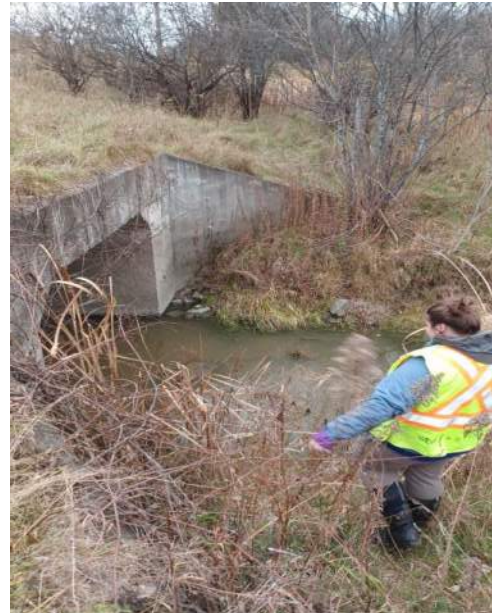
Figure 32

Existing conditions at **Crossing 16** on the north side of Russell Road. Left photograph is facing north, downstream; right photograph is facing south, into the culvert. Some slumping was observed.

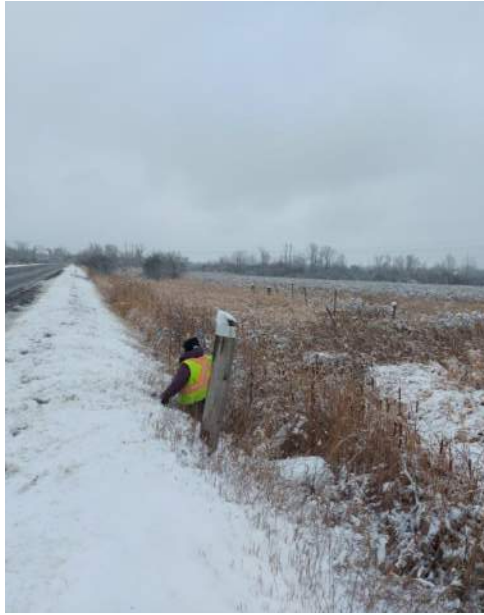
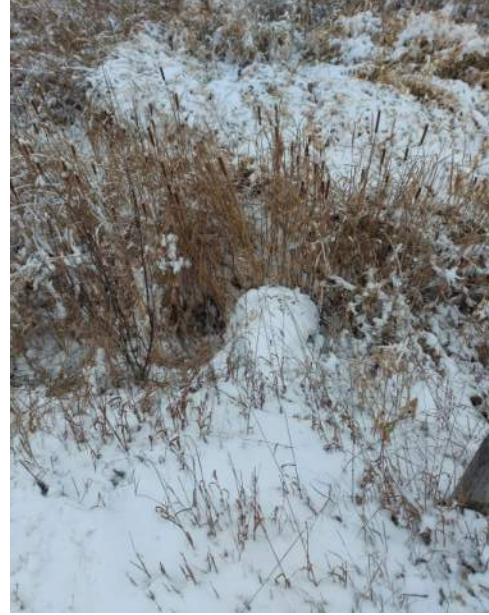
Figure 33

Existing conditions at **Crossing 16** on the south side of Russell Road. Left photo is facing south, upstream; right photo is facing southeast. Some slumping was observed..

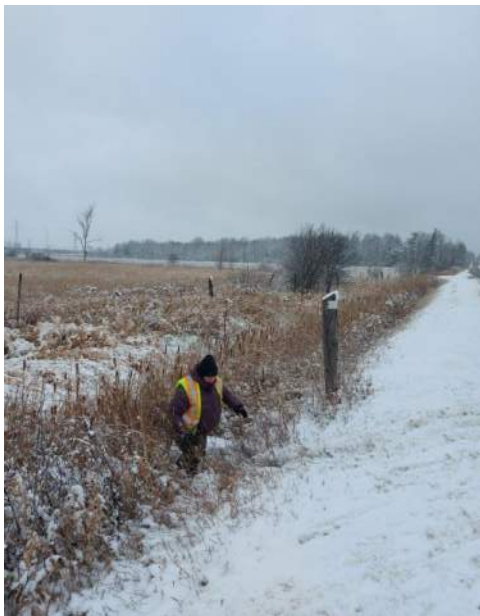
Figure 34

Existing conditions at **Crossing 17** on the west side of Ramsayville Road. Left photo is facing southwest along the roadside ditch; right photo is facing down at the culvert.

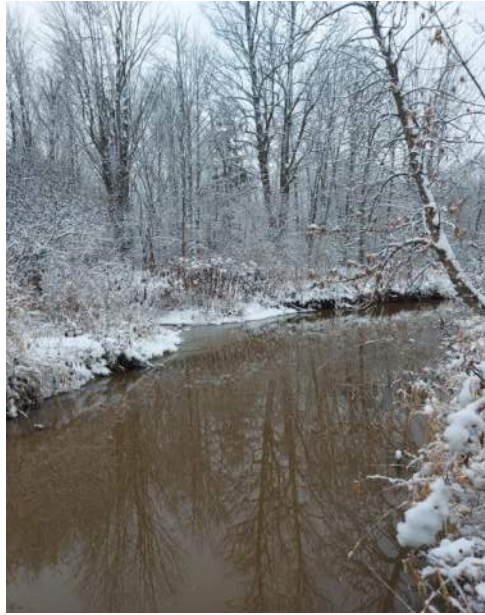
Figure 35

Existing conditions at **Crossing 17** on the east side of Ramsayville Road. Photo is facing southeast along the roadside ditch.

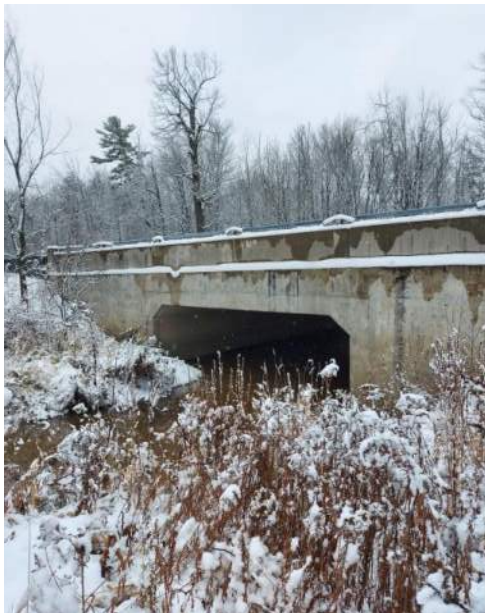
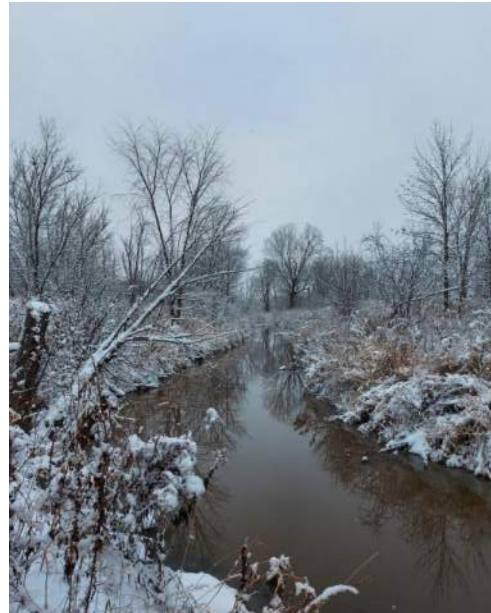
Figure 36

Existing conditions at **Crossing 18** on the west side of Ramsayville Road. Left photo is facing west, upstream; right photo is facing south. Some slumping and undercutting was observed.

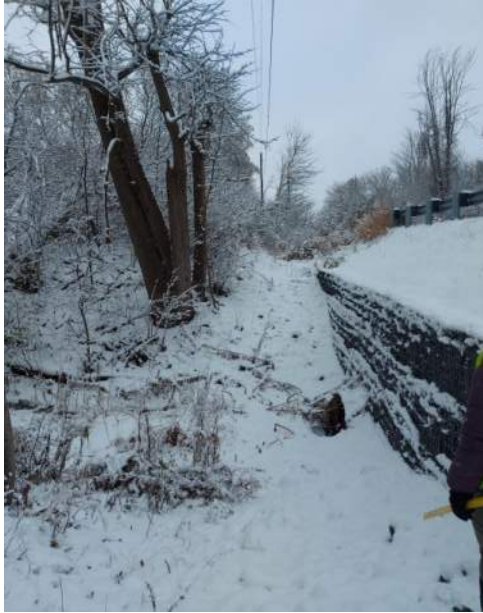
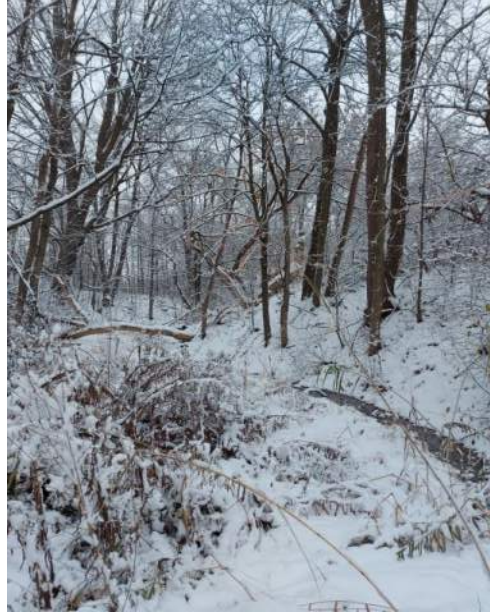
Figure 37

Existing conditions at **Crossing 18** on the east side of Ramsayville Road. Left photo is facing northwest towards the crossing structure; right photo is facing east, downstream. Some undercutting and slumping was observed.

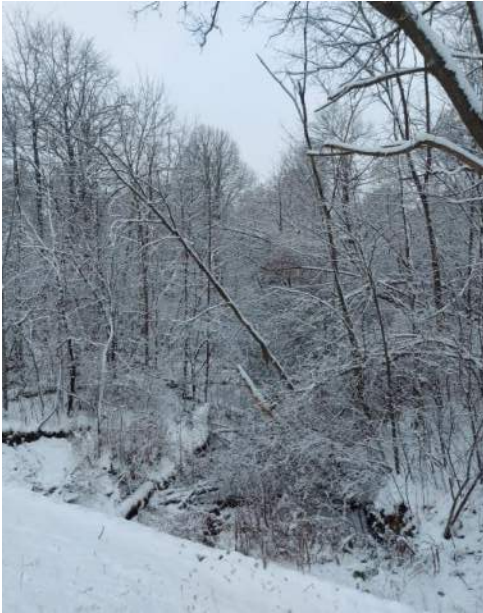
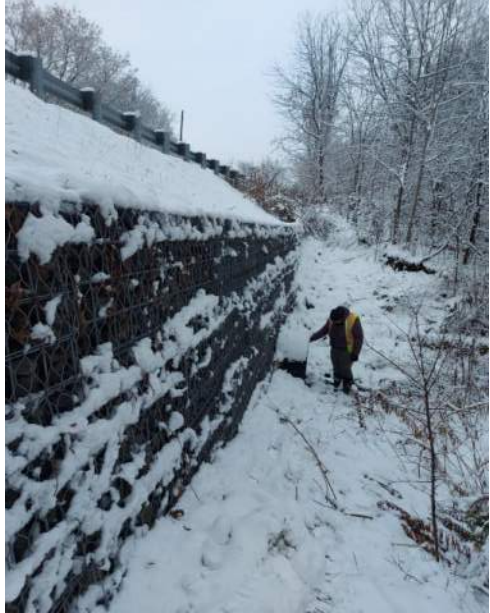
Figure 38

Existing conditions at **Crossing 19** on the west side of Ramsayville Road. Left photograph is facing north along Ramsayville Road; left photo is facing west, downstream.

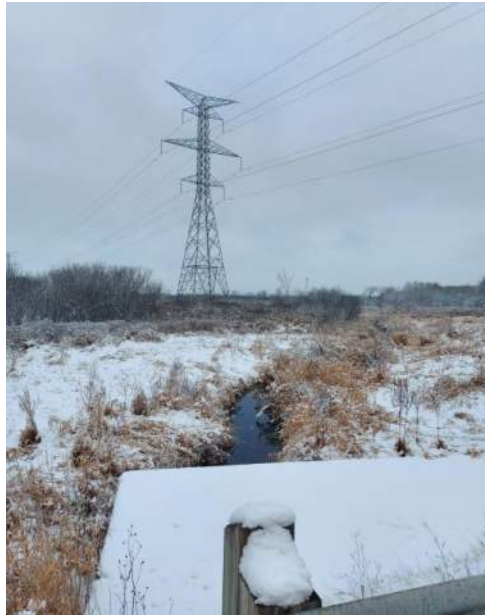
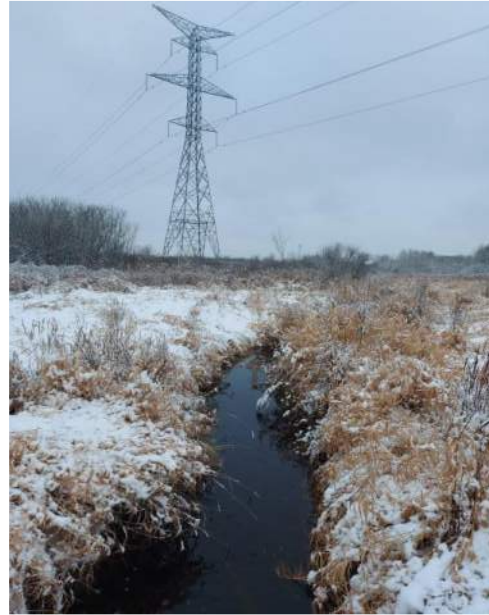
Figure 39

Existing conditions at **Crossing 19** on the east side of Ramsayville Road. Left photo is facing east; right phot is facing north along Ramsayville Road. Some minor erosion scars were observed.

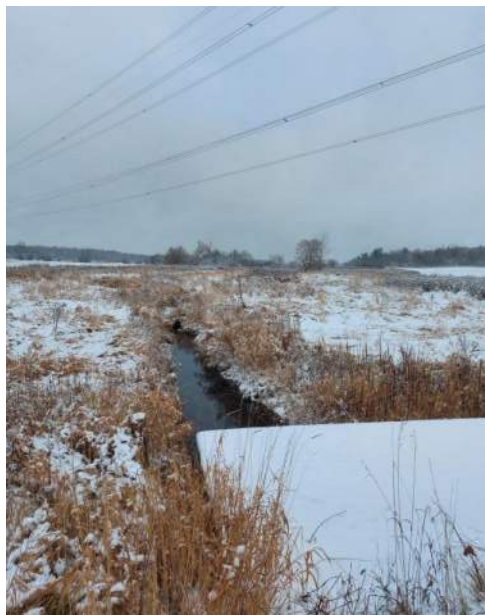
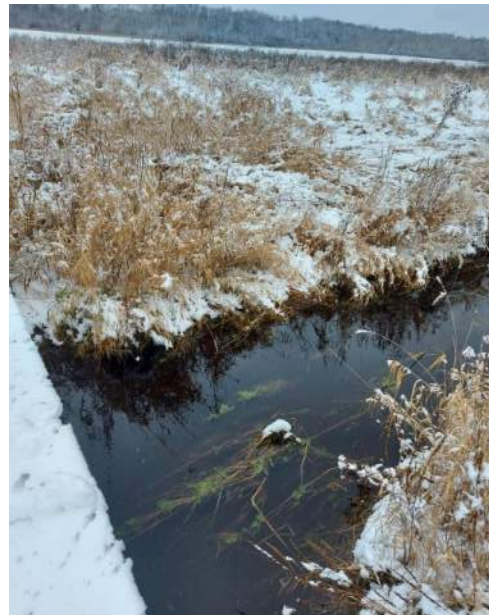
Figure 40

Existing conditions at **Crossing 20** on the west side of Ramsayville Road. Both photographs are facing west. Some minor slumping was observed.

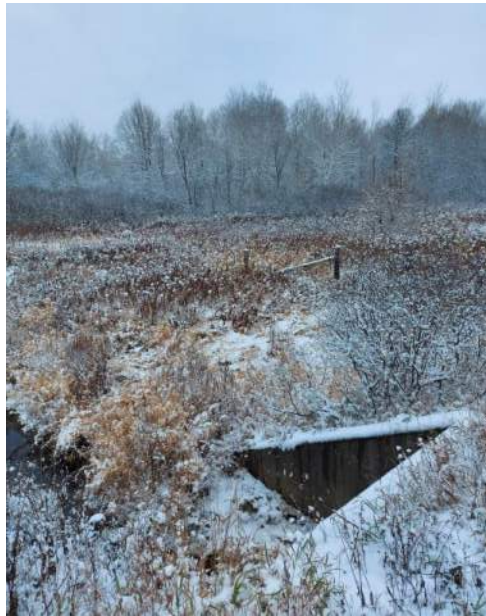
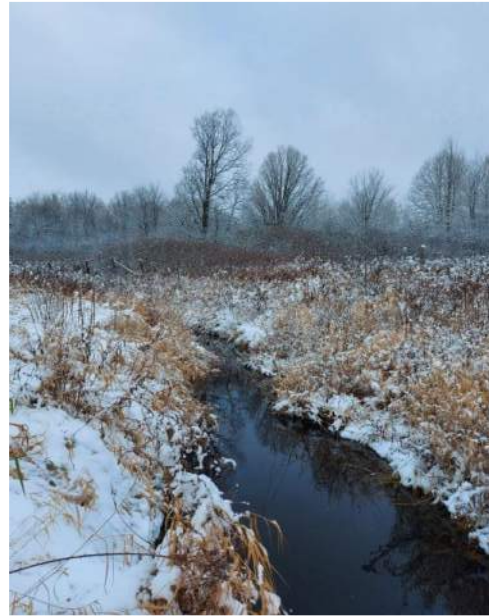
Figure 41

Existing conditions at **Crossing 20** on the east side of Ramsayville Road. Left phot is taken facing west; right photo is taken facing northeast. Some slumping was observed.

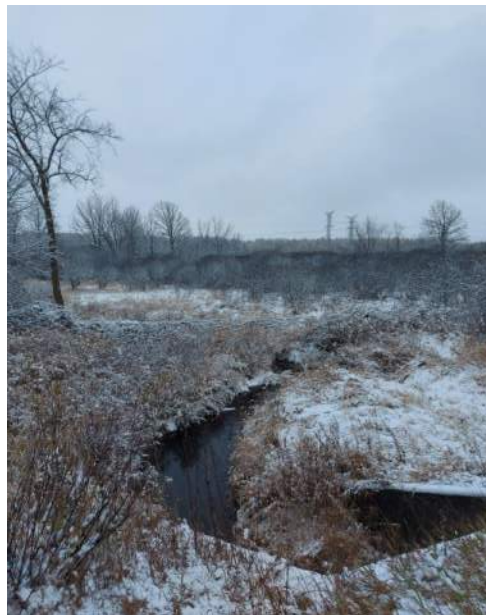
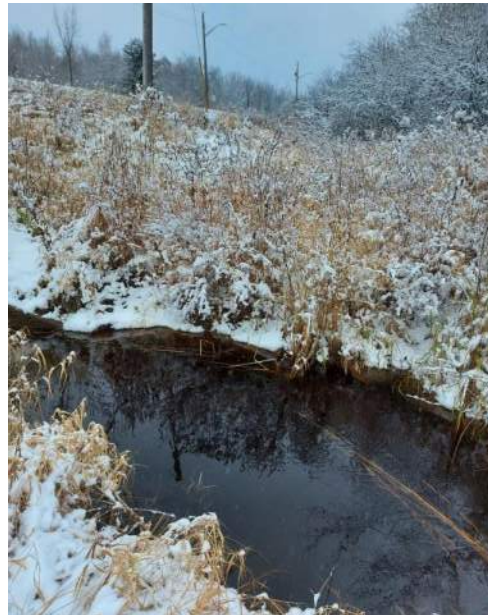
Figure 42

Existing conditions at **Crossing 21** on the north side of Walkley Road. Left photograph is taken facing northeast; right photograph is taken facing north. Some minor slumping was observed.

| Crossing ID | Culvert Type | Watercourse Type | Culvert Height | Water Depth | Culvert Depth | Bankfull Width | Bankfull Depth | Description |
|---|---|---|---|---|---|---|---|---|
| 021N | Concrete box, wings | Stream | 2.00 | 0.33 | 3.00 | 4.27 | 1.00 | No concerning channel erosion observed |

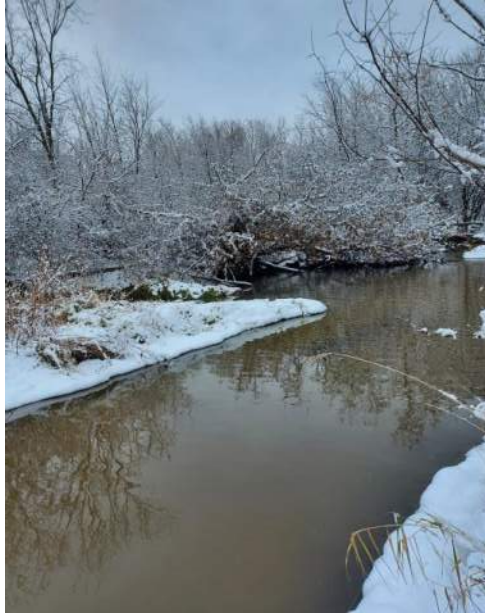
Figure 43

Existing conditions at **Crossing 21** on the south side of Walkley Road. Left photo is facing south; right photo is facing east. Some minor slumping was observed.

| Crossing ID | Culvert Type | Watercourse Type | Culvert Height | Water Depth | Culvert Depth | Bankfull Width | Bankfull Depth | Description |
|---|---|---|---|---|---|---|---|---|
| 021S | Concrete box, wings | Stream | 2.00 | 0.33 | 3.00 | 4.80 | 0.70 | No concerning channel erosion observed |

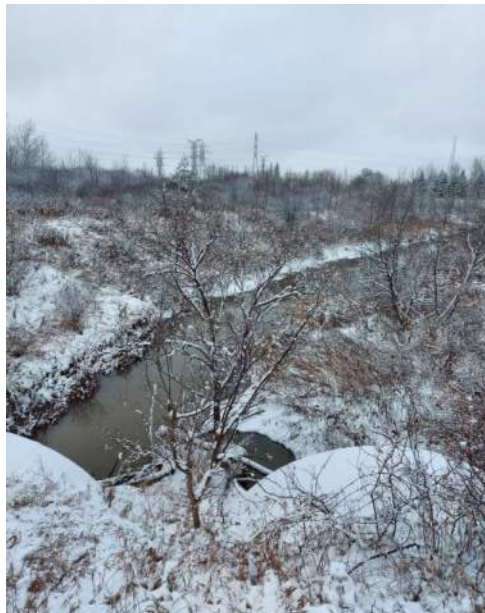
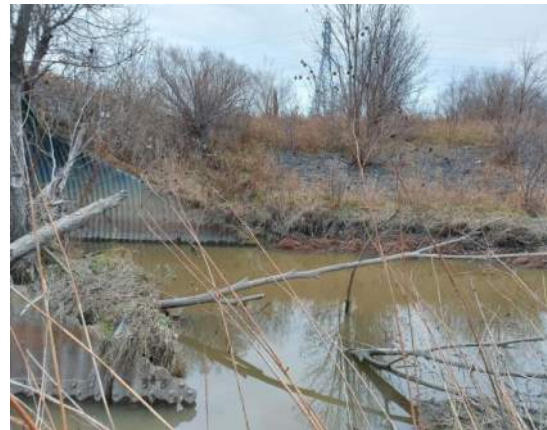
Figure 44

Existing conditions at **Crossing 22** on the north side of Walkley Road. Left photograph is facing northwest; left photograph is facing southwest at the dual culverts. Undercutting was observed.

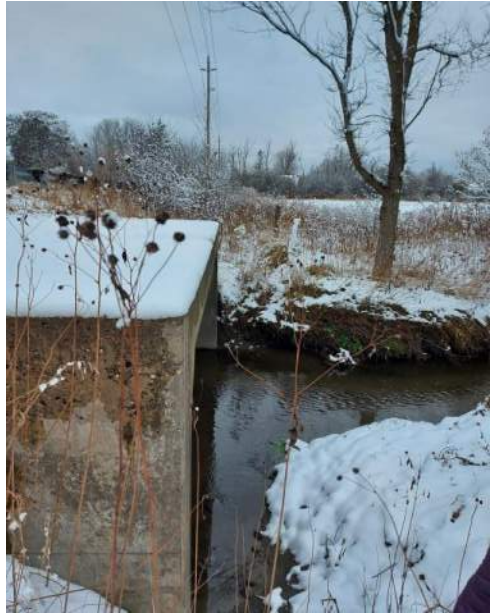
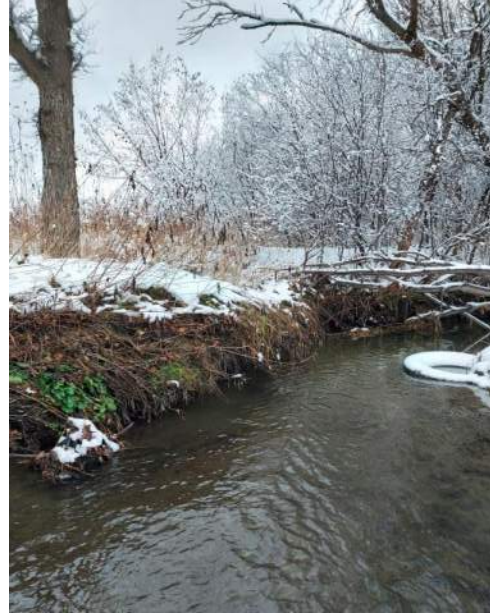
Figure 45

Existing conditions at **Crossing 22** on the south side of Walkley Road. The left photograph is facing south; the right photograph was taken during a second visit and is facing east. Slumping was observed.

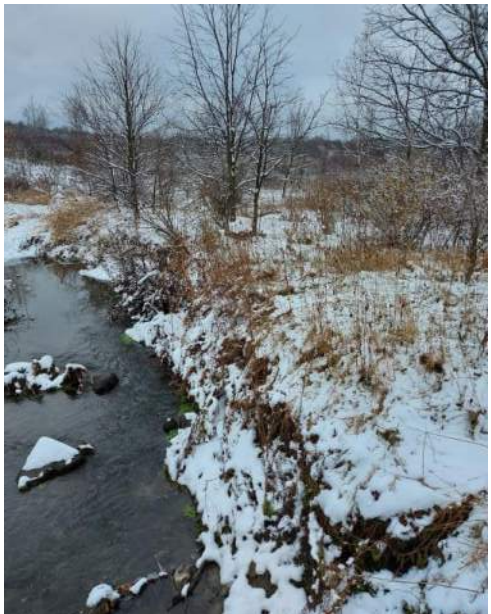
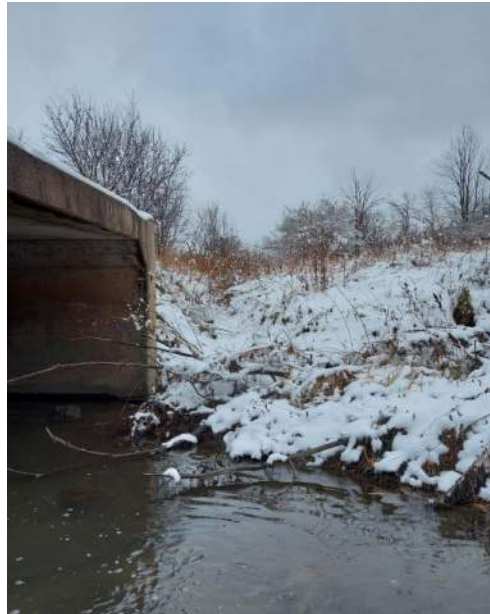
Figure 46

Existing conditions at **Crossing 24** on the north side of Russell Road. Left photograph is facing northwest along Russell Road; right photograph is facing north where undercutting and erosion scars were observed.

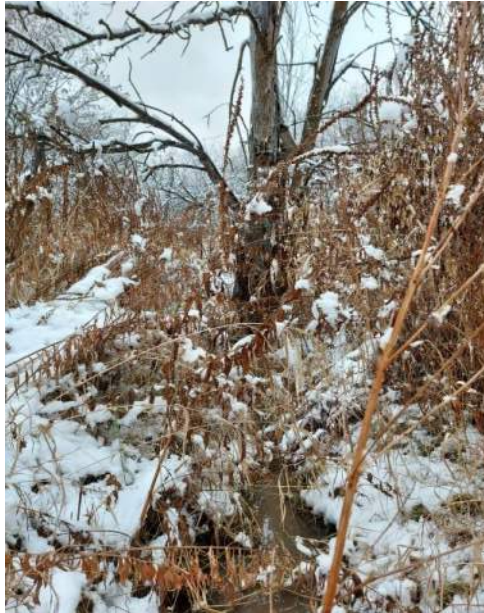
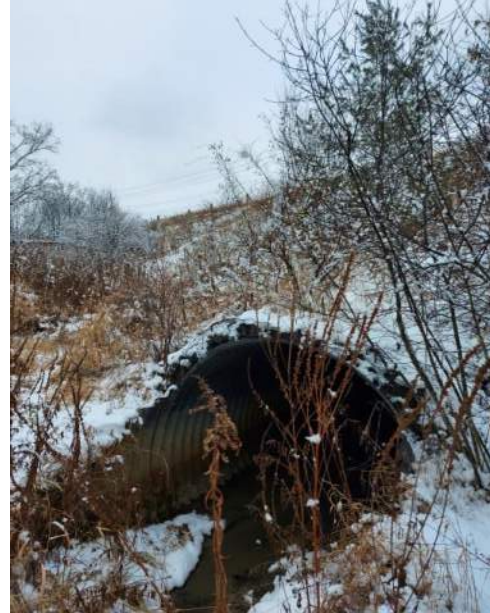
Figure 47

Existing conditions at **Crossing 24** on the south side of Russell Road. Left photo is facing south along the bank where erosion scars and slumping was observed; right photo is facing southeast.
