Bear Brook and Ramsay Creek Watersheds Fluvial Geomorphological Study

Existing Conditions Summary Report
Tewin Lands

December 12, 2024

GEO Morphix Project No. 21063

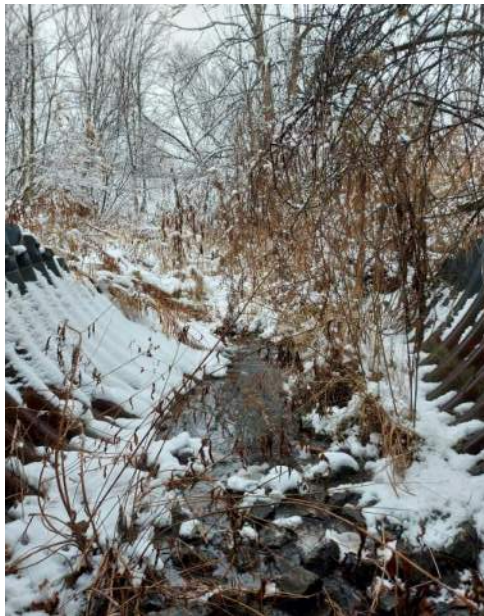
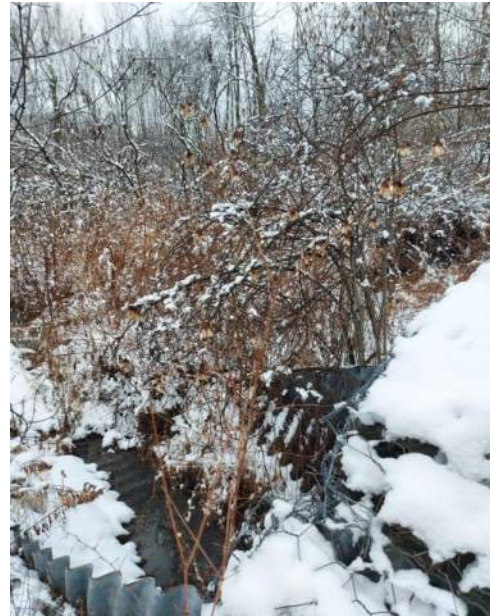
Figure 48

Existing conditions at **Crossing 25** on the north side of Russell Road. Left photograph is taken facing north; right photograph is taken facing south towards the mouth of the culvert.

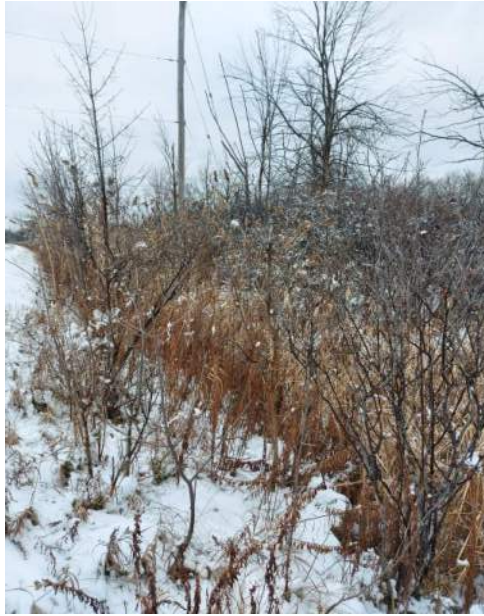
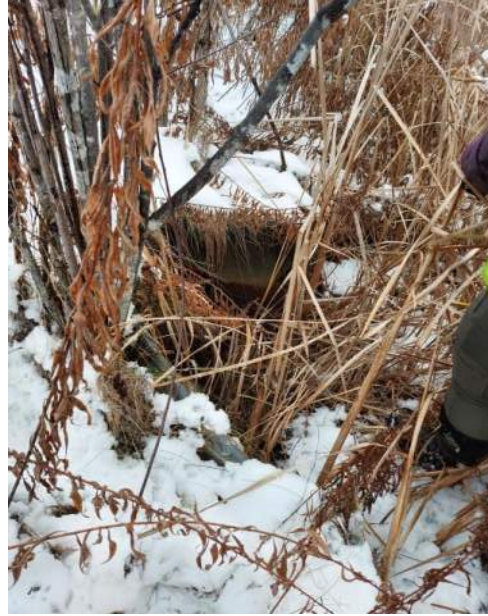
Figure 49

Existing conditions at **Crossing 25** on the south side of Russell Road. Left photo is taken facing south from within the culvert; right photograph is taken facing southwest.

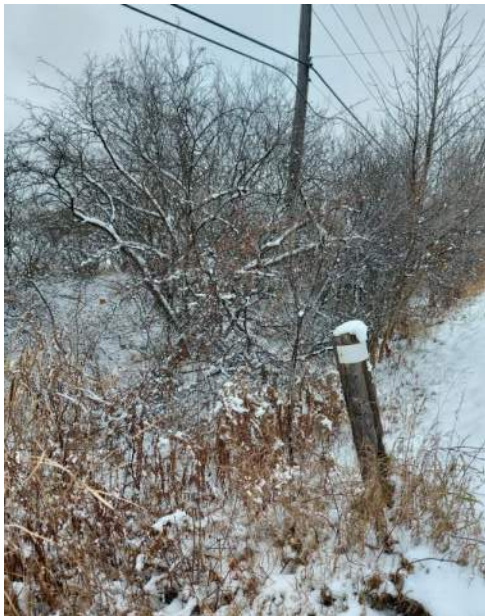
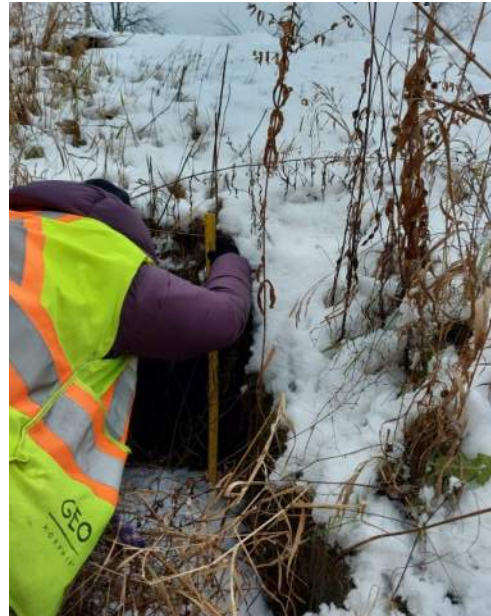
Fig50e 66

Existing conditions at **Crossing 26** on the north side of Russell Road. Left photograph is taken facing northwest along the roadside ditch; right photograph is taken facing southwest towards the mouth of the culvert.

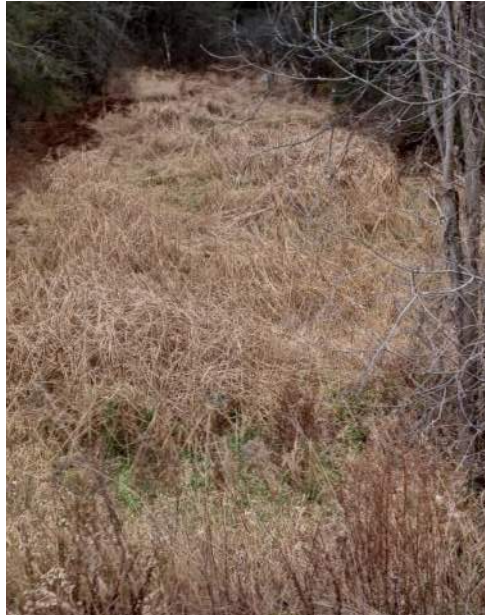
Figure 51

Existing conditions at **Crossing 26** on the south side of Russell Road. Left photograph is facing southeast along the roadside ditch; right photograph is facing north at the mouth of the culvert.

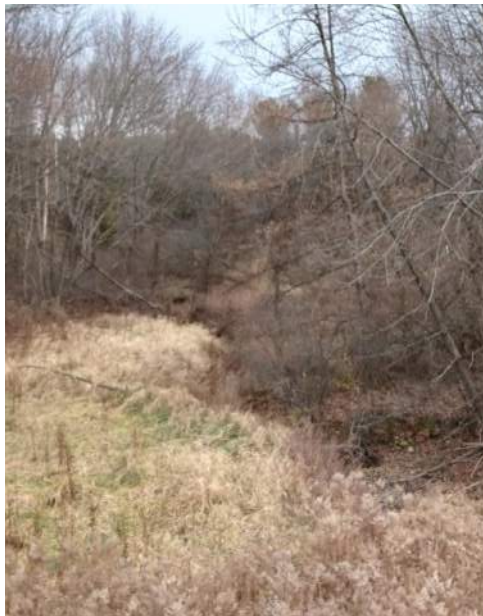
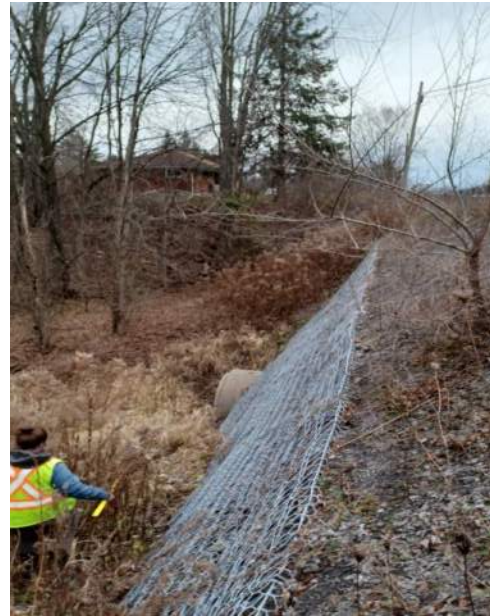
Figure 52

Existing conditions at **Crossing 27** on the east side of Ramsayville Road. Left photo is facing east, upstream; right photograph is facing northeast, down towards the mouth of the culvert. Channel lacked definition.

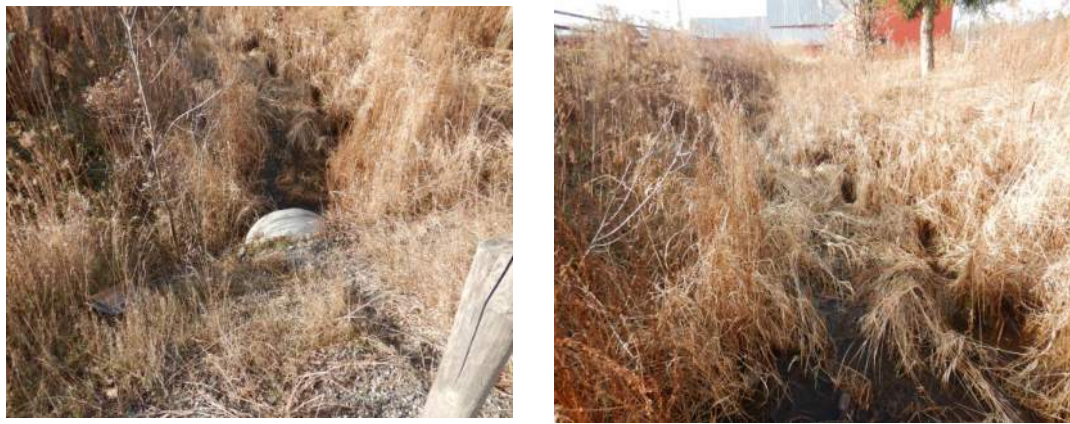
Figure 53

Existing conditions at **Crossing 27** on the west side of Ramsayville Road. Left photo is facing west; the right photo is facing northwest down towards the mouth of the culvert.

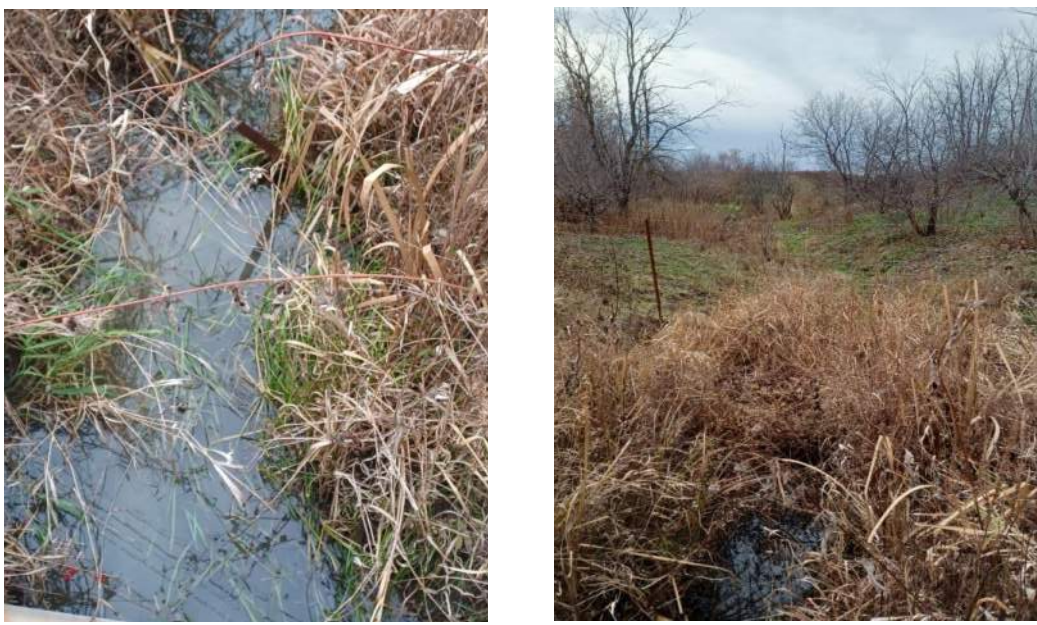
Figure 55

Existing conditions at **Crossing 28** on the east side of Ramsayville road. Left photo is facing east, downstream; right photograph is facing west at the culvert. Some erosion scars and slumping was observed downstream.

| Crossing ID | Culvert Type | Watercourse Type | Culvert Height | Water Depth | Culvert Depth | Bankfull Width | Bankfull Depth | Description |
|---|---|---|---|---|---|---|---|--|
| 028E | Corrugated steel | Stream | N/A | N/A | N/A | 2.77 | 0.4 | No concerning erosion observed. |

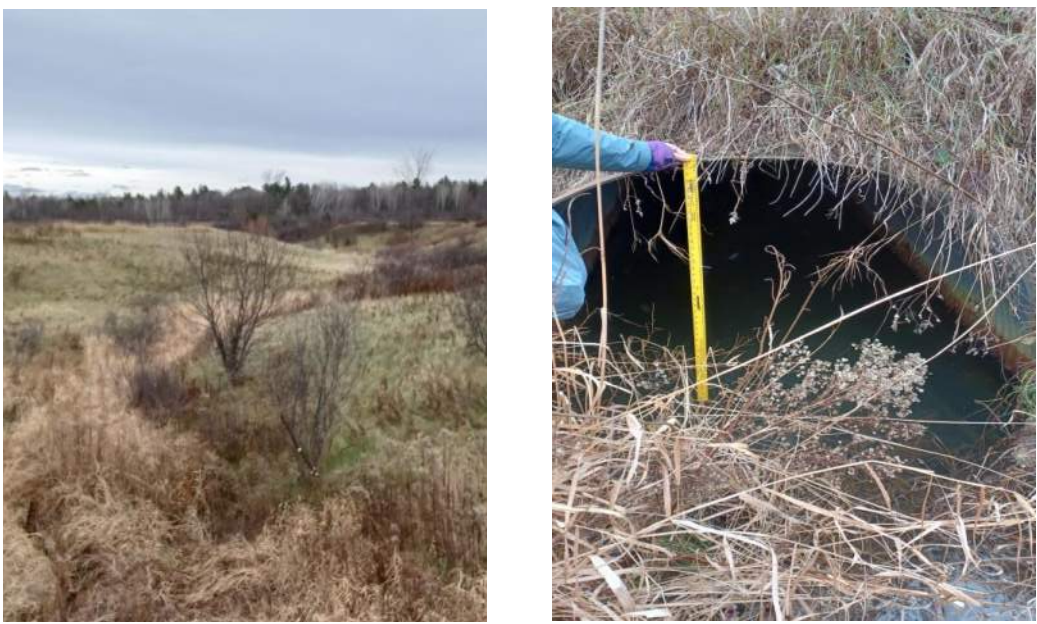
Figure 56

Existing conditions at **Crossing 29** on the west side of Ramsayville Road. Left photo is facing down at the mouth of the culvert; right photo is facing west.

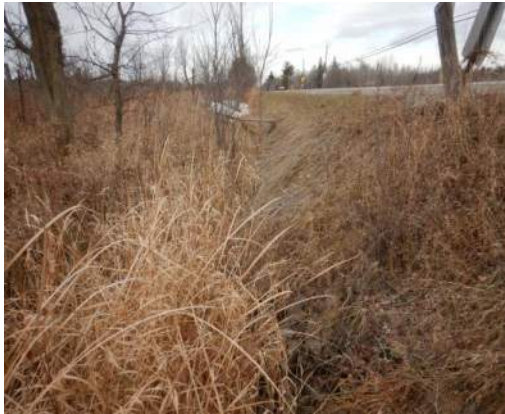
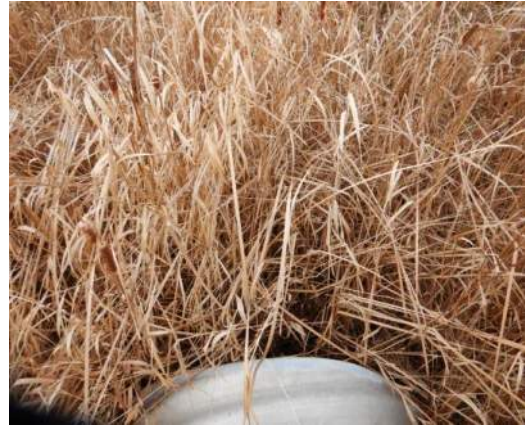
Figure 57

Existing conditions at **Crossing 29** on the east side of Ramsayville Road. Left photo is facing east; right photo is facing west into the mouth of the culvert.

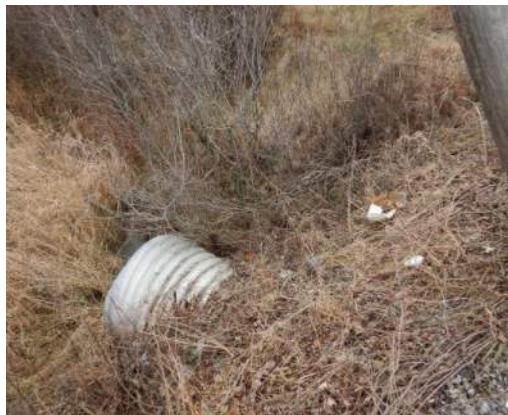
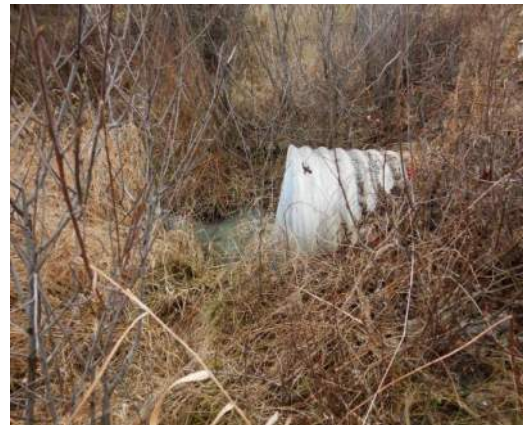
Figure 58

Existing conditions at **Crossing 30** on the west side of Ramsayville Road. Left photo is facing northwest along the roadside ditch; right photo is facing down at the mouth of the culvert.

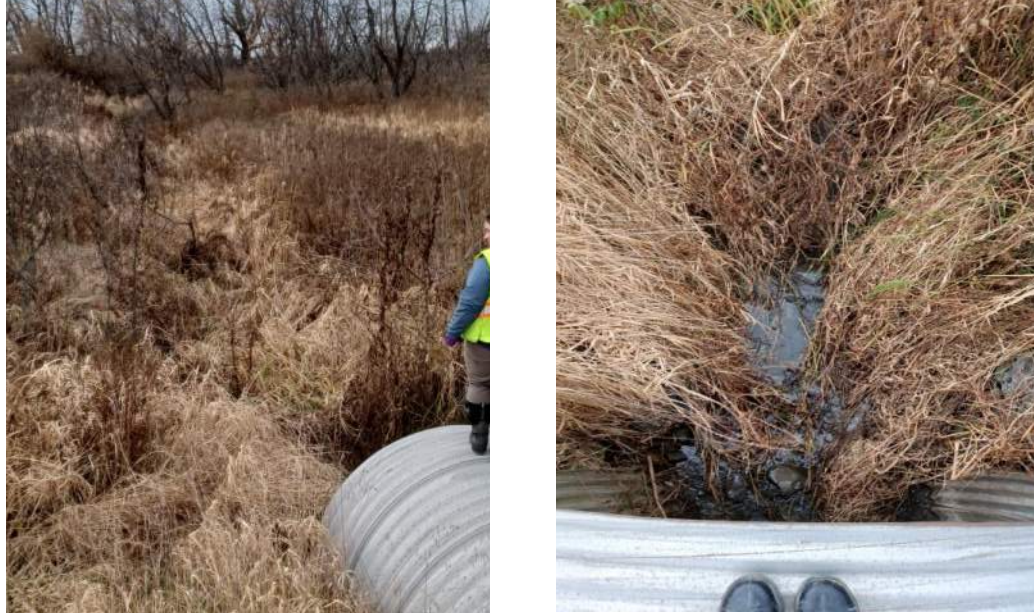
Figure 59

Existing conditions at **Crossing 30** on the east side of Ramsayville Road. Left photo is facing southeast; right photo is facing south.

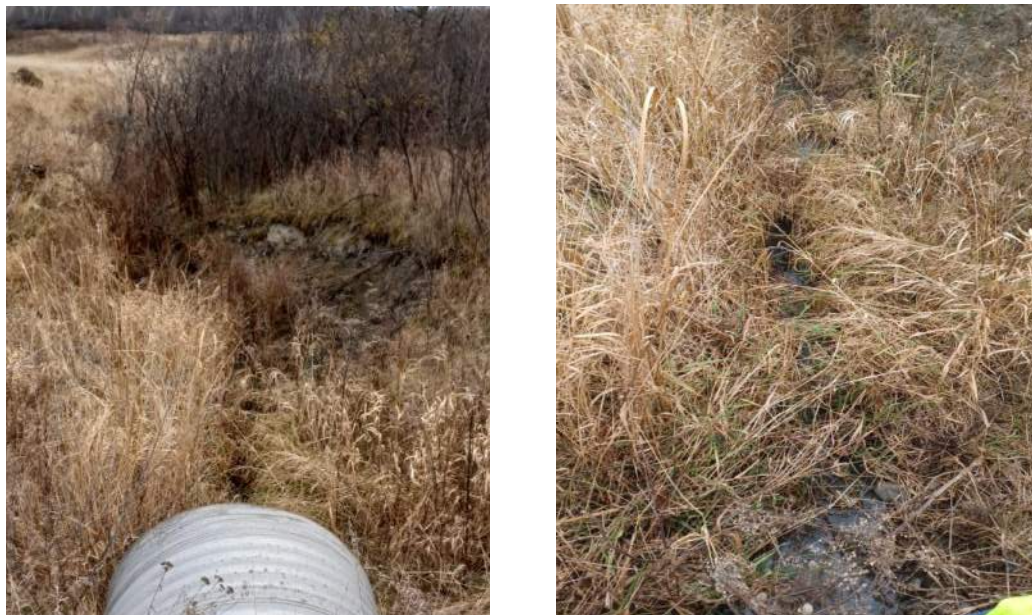
Figure 60

Existing conditions at **Crossing 31** on the west side of Ramsayville Road. Left photograph is taken facing west, upstream; right photograph is taken facing down at the mouth of the culvert.

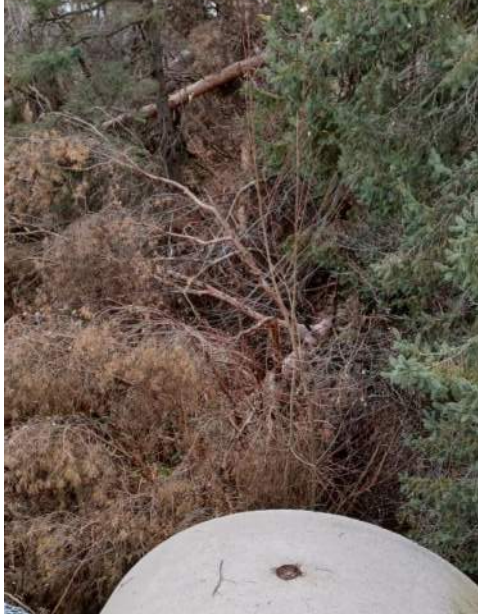
Figure 61

Existing conditions at **Crossing 31** on the west side of Ramsayville Road. Left photo is taken facing west; right photo is taken facing downwards at the mouth of the culvert.

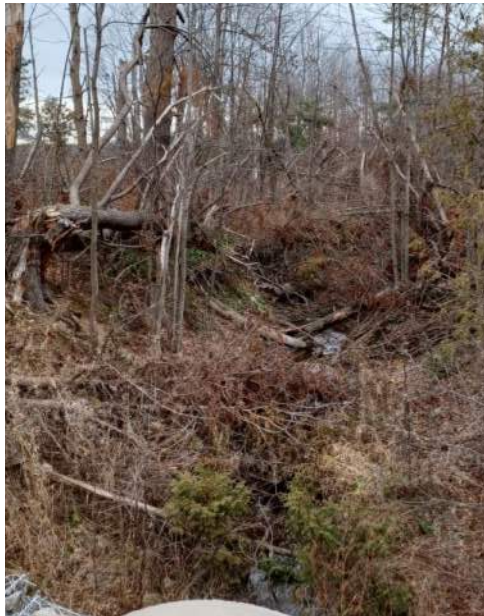
Figure 62

Existing conditions at **Crossing 32** on the west side of Ramsayville Road. Left photo is facing west, a large number of down trees from recent storm are present in the channel; right photo is facing down at the mouth of the culvert. An erosion scar was observed on the left bank.

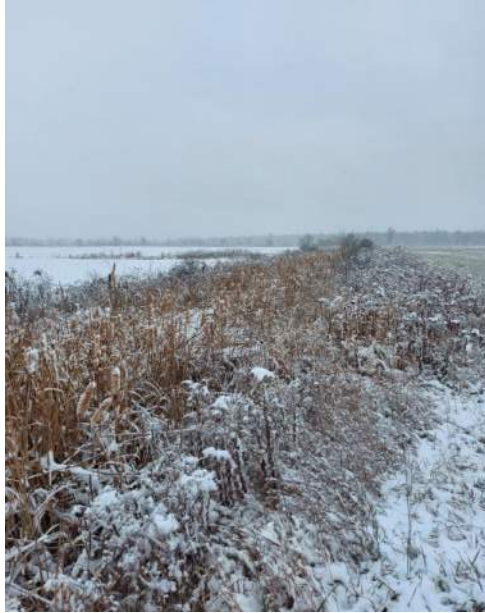
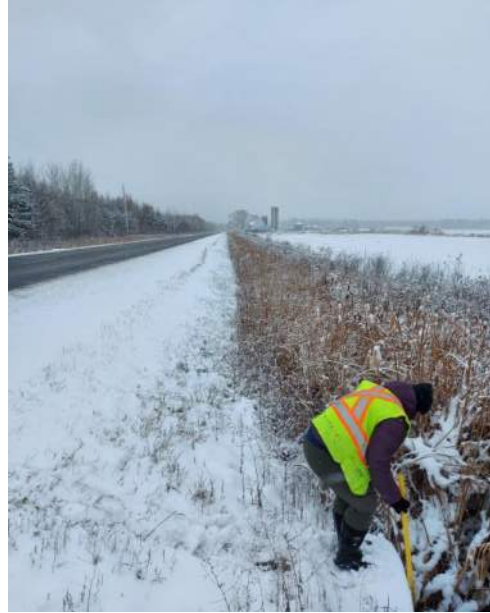
Figure 63

Existing conditions at **Crossing 32** on the east side of Ramsayville Road. Left photo is facing east, downstream; right photo is facing downwards. Erosion scars were observed.

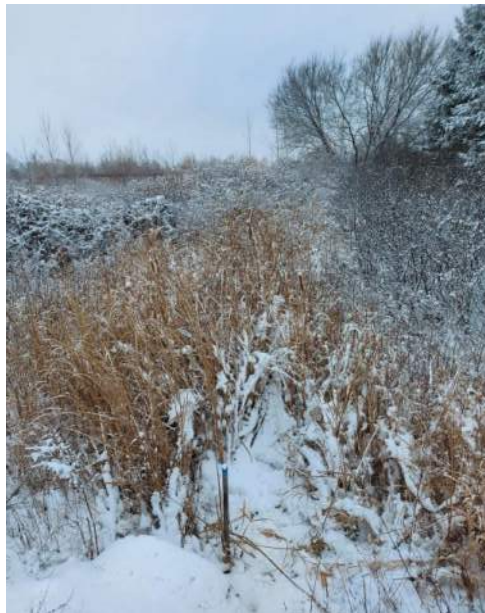
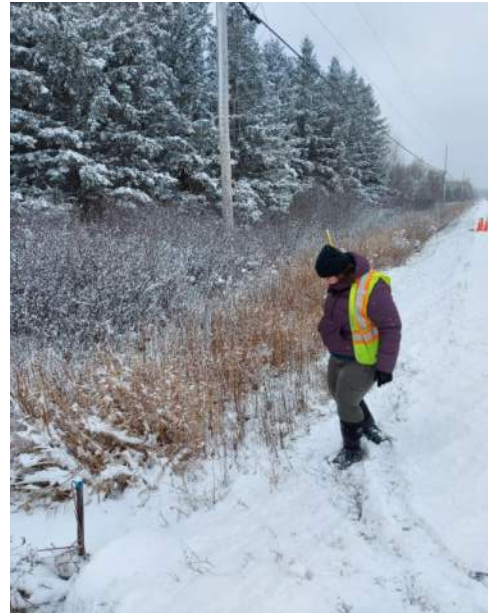
Figure 64

Existing conditions at **Crossing 33** on the north side of Leitrim Road. Left photograph is taken facing north, upstream; left photograph is taken facing southwest along the roadside ditch.

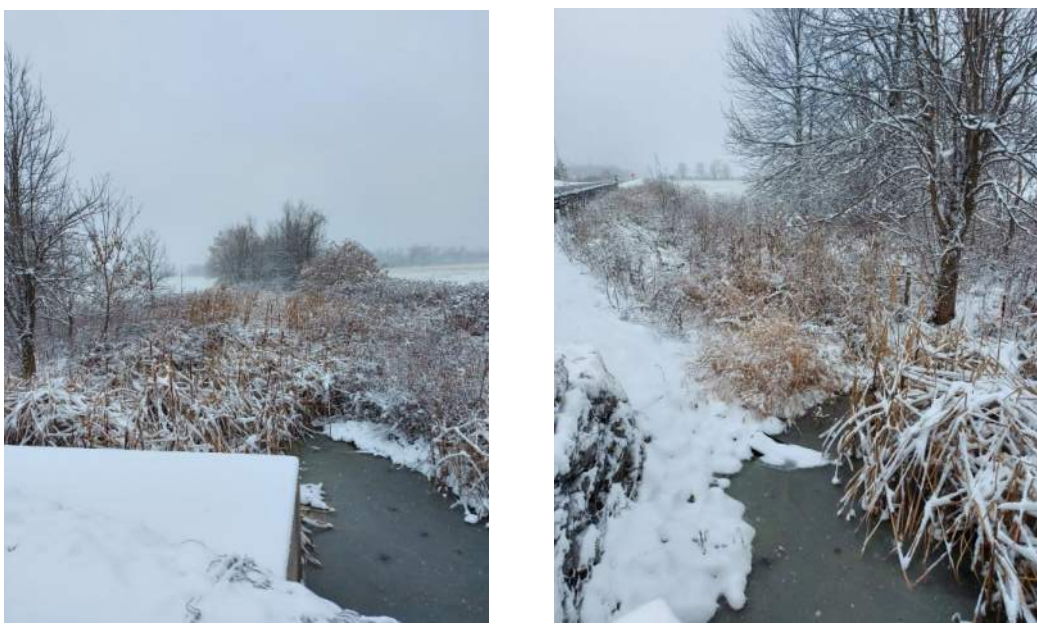
Figure 65

Existing conditions at **Crossing 33** on the south side of Leitrim Road. Left photo is taken facing southeast towards Crossing 17 along the roadside ditch; right photograph is taken facing southwest along the roadside.

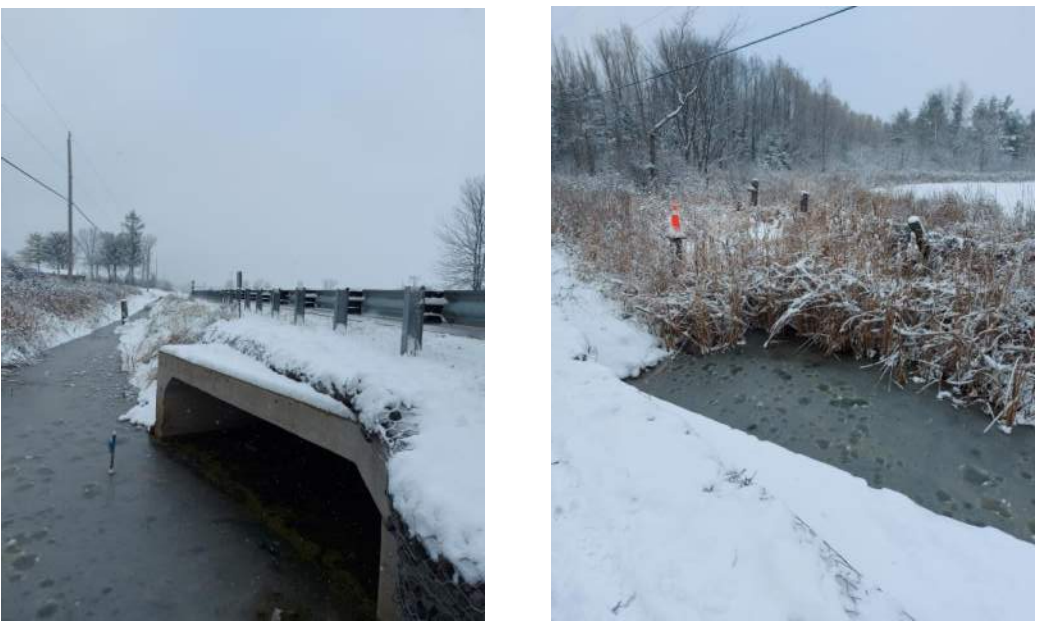
Figure 66

Existing conditions at **Crossing 34** on the north side of Leitrim Road. Left photo is taken facing northwest; right photograph is taken facing west along Leitrim Road.

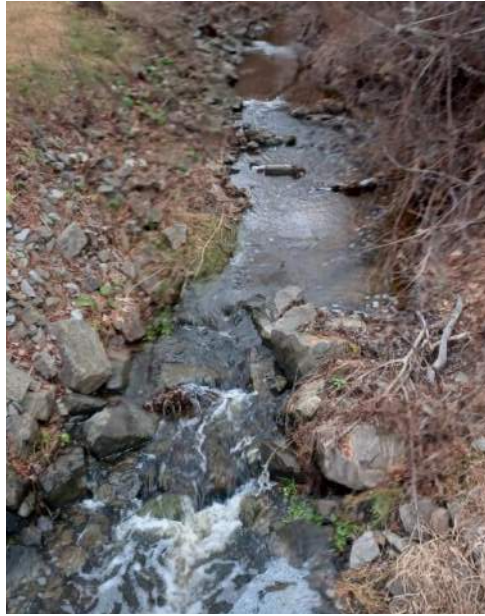
Figure 67

Existing conditions at **Crossing 34** on the south side of Leitrim Road. Left photograph is facing southwest along the roadside ditch; right photograph is taken facing southeast towards downstream.

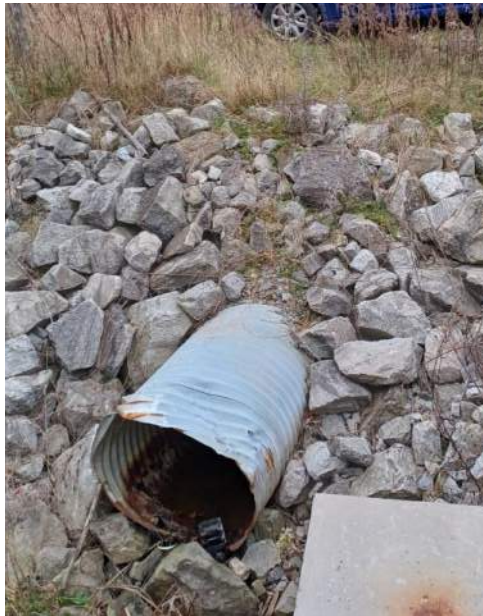
Figure 68

Existing conditions at **Crossing 35** on the west side of Ramsayville Road. Left photograph is taken facing west, upstream; right photograph is taken facing southwest at the roadside ditch. Some slumping was observed.

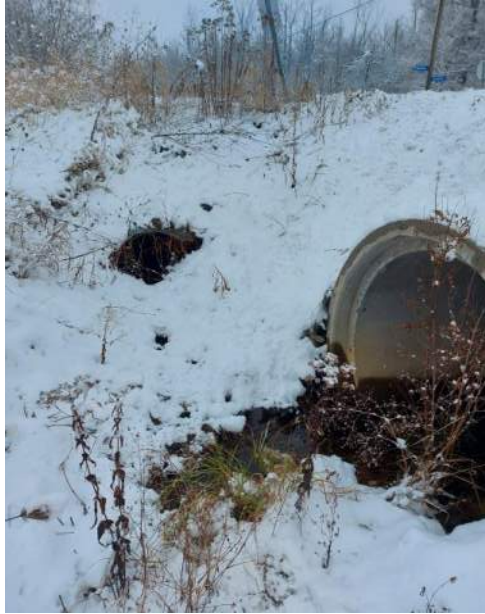
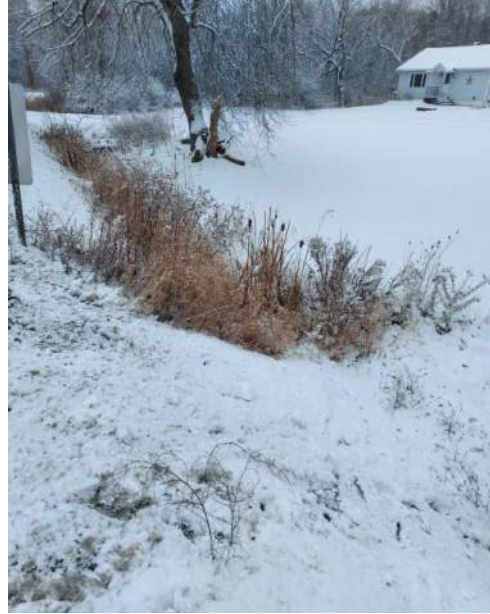
Figure 69

Existing conditions at **Crossing 36** on the west side of Ramsayville Road. Left photo is taken facing north at the input from the roadside ditch; right photograph is taken facing south along the roadside ditch.

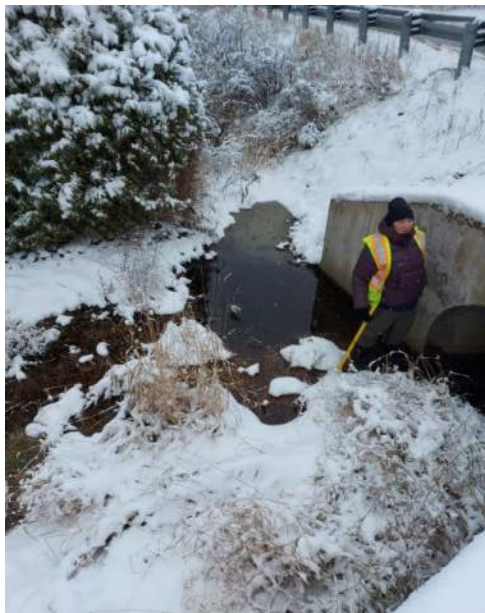
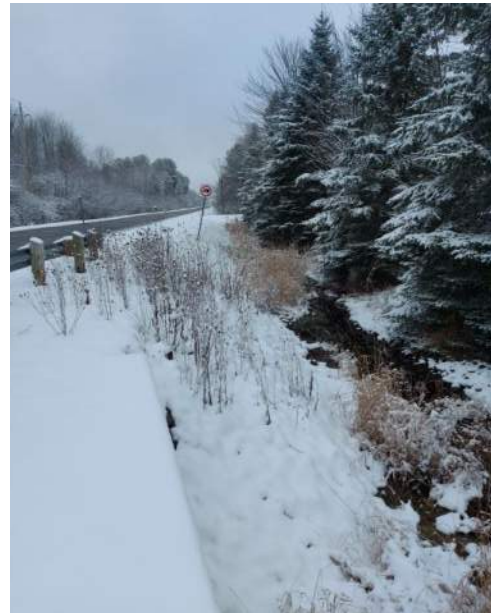
Figure 70

Existing conditions at **Crossing 36** on the southeast corner of Ramsayville and Piperville Roads. Left photograph is taken facing southeast; right photograph is taken facing northeast along the roadside ditch.
